SRE FUEL ELEMENT DAMAGE
FINAL REPORT

OF
THE ATOMICS INTERNATIONAL AD HOC COMMITTEE

(1961)

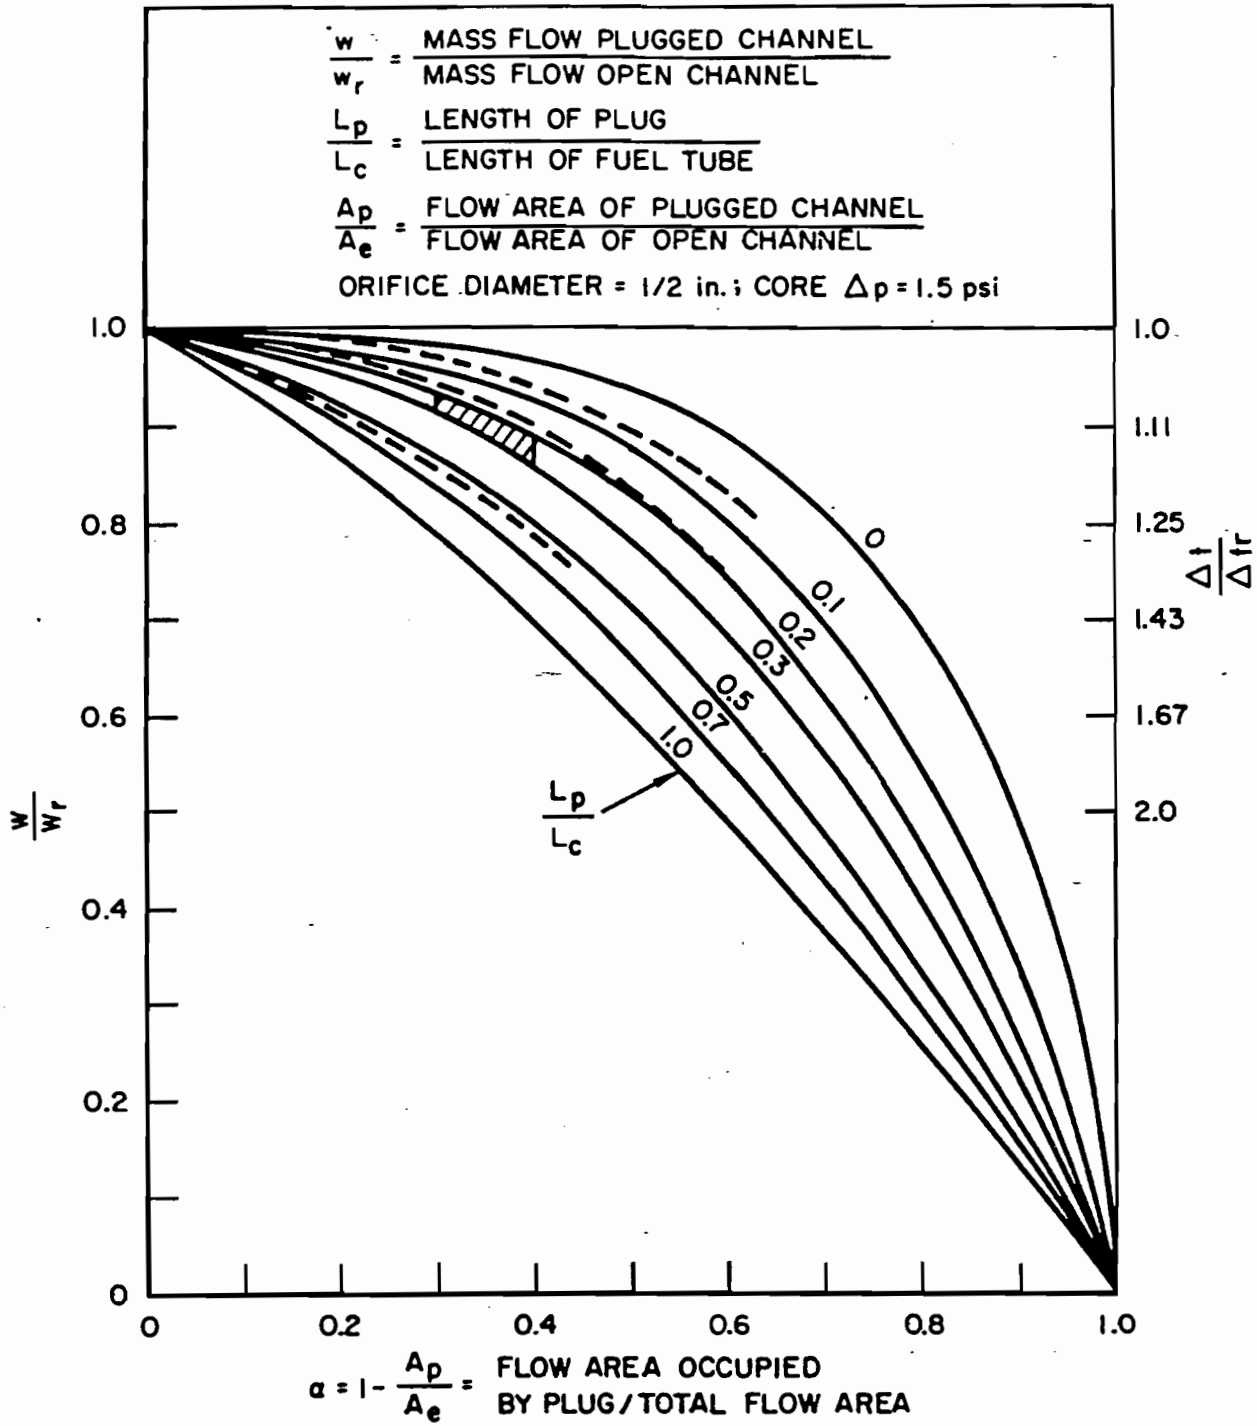
Figure III-4. Mass Flow Reduction in SRE Fuel Channel Due to Formation of Plugs in Fuel-Tube Region

The plugs must have been large in order to reduce flow in a given channel to one-third of nominal flow. The relationship of flow to plug geometry in a channel is indicated in Figure III-4. As shown in the figure, a very short plug (thin

plate) would have to occupy about 95% of the flow area around the fuel rods to reduce flow to one-third; if the plug were as long as the channel, it would have to occupy about 75% of the flow area to reduce flow to one-third. The calculations leading to Figure III-4 assumed no plug porosity. With some flow through the plug, the plug would have to occupy a still larger fraction of the channel to restrict flow a given amount. The few observations of the spongy plugging material, in channel R-24 and on top of the core, together with the data of Figure III-4, would indicate that the plugs were probably long (a few feet) and occupied most of the flow cross sectional area.

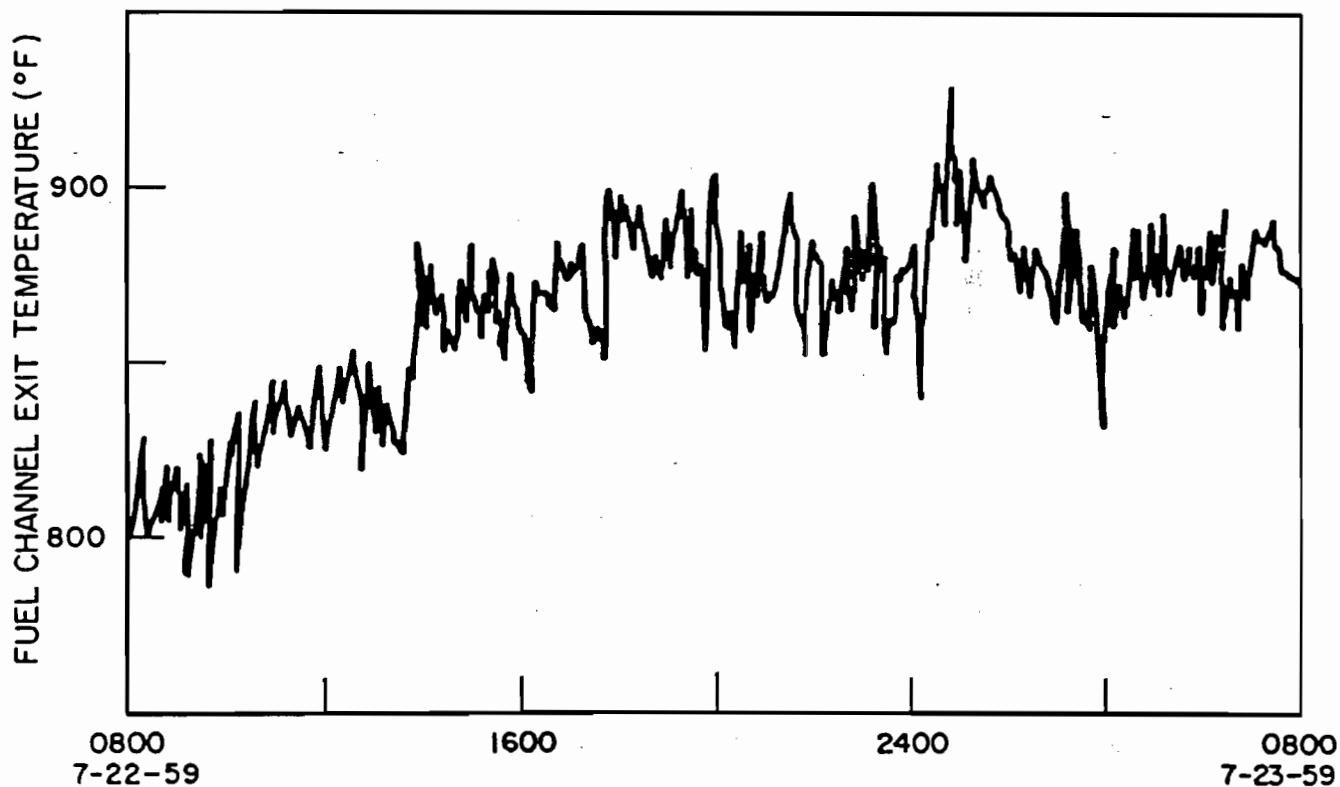
Figure III-5. Outlet Temperature for Channel R-24

A careful review of the chart from run 14 showed that all of the channels in which fuel failures occurred had shown fluctuations in outlet channel temperatures. The record of temperatures from channel R-24 for a typical 24-hr period is shown in Figure III-5. Fluctuation in outlet channel temperatures also occurred for a few hours in some channels in which the fuel elements did not fail. The element from R-25, in which temperature fluctuations occurred for only part of the run, suffered the least damage of the thirteen damaged elements. The temperature history for R-25 over a 24-hr period is shown in Figure III-6. Some indication of the relation between fuel temperatures at some regions of the element and the outlet channel temperatures can be gained from the data for R-55

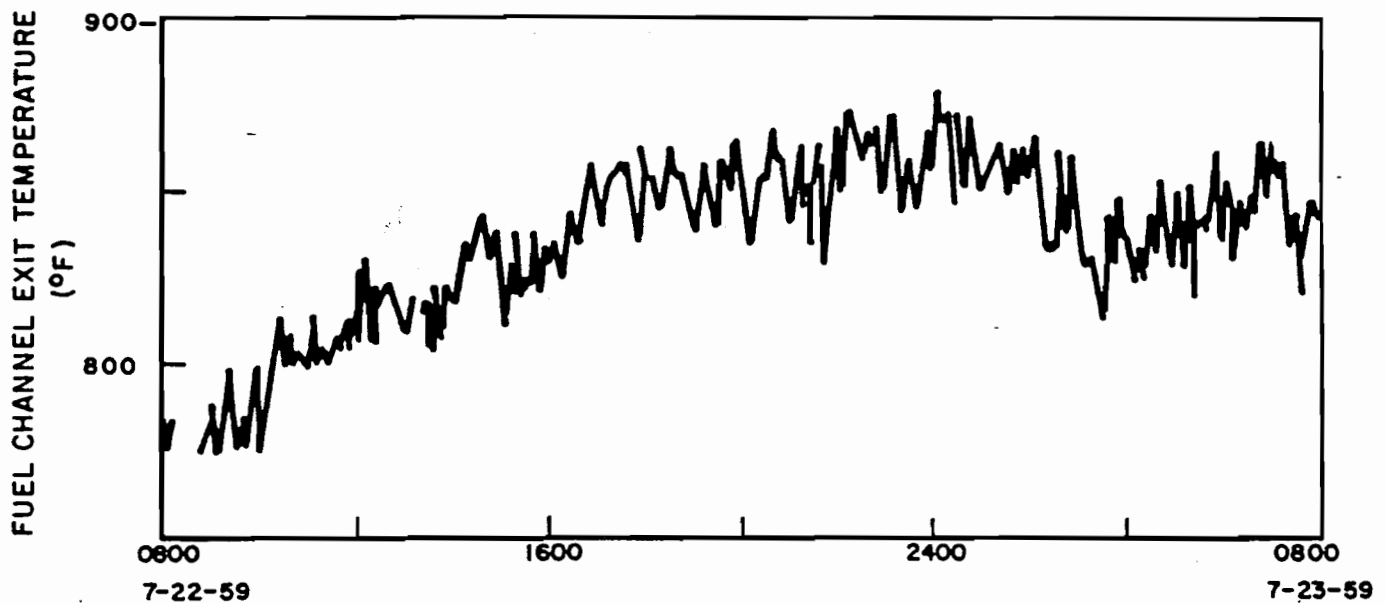
Figure III-7. Outlet Temperature for Channel R-55

shown in Figures III-7 and III-8. As indicated by the figures, the fuel temperature was cycling over a range of about 150°F while outlet channel temperature variation was about 50°F.
