## **Group AA**

## Site Summary – Building 4020

Building 4020  
Rockwell International Hot Laboratory  
Component Development Hot Cell (CDHC)  
Includes Building 4323, Guard Building  
Includes Building 4720, Substation

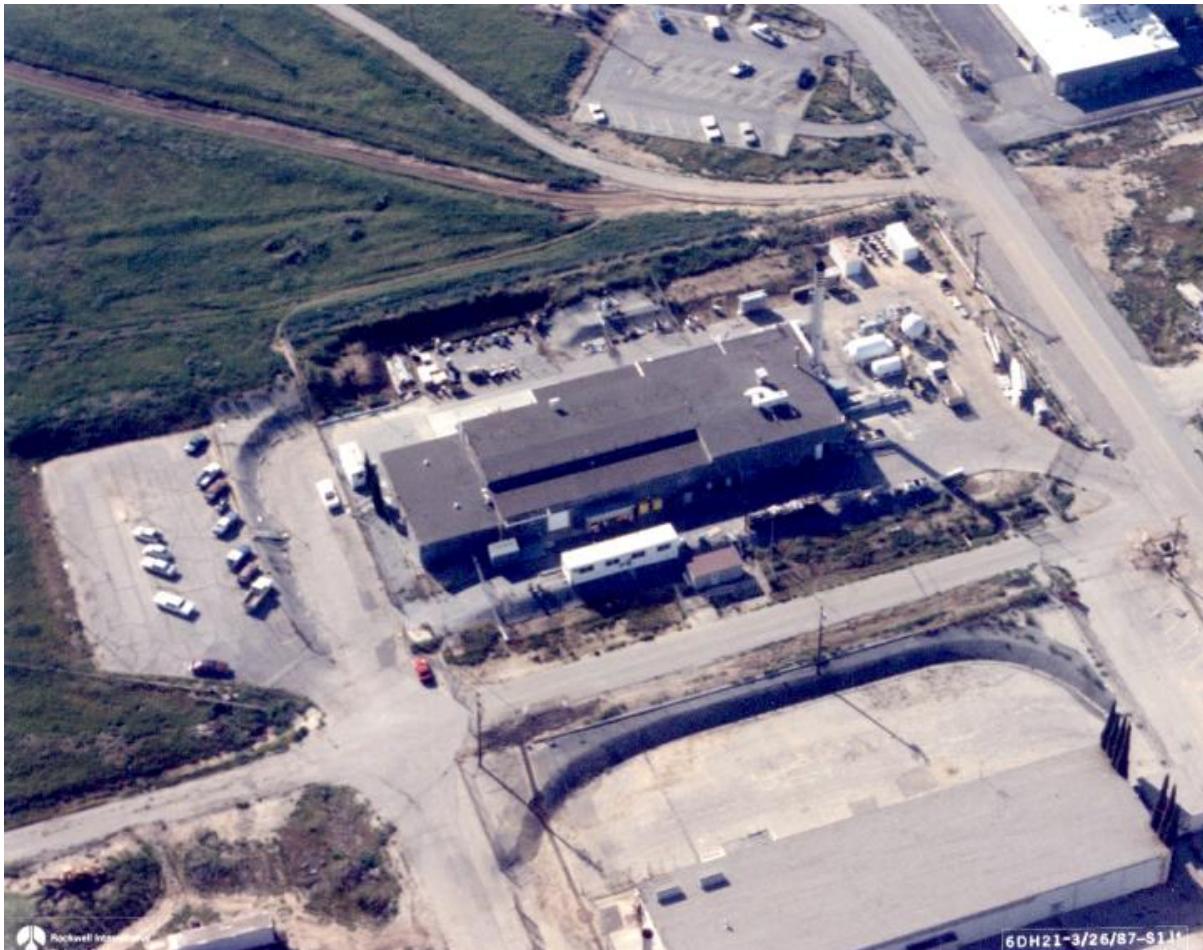
**Photograph – Building 4020**

- Building 4020 was completely demolished and the site was backfilled in 1996.<sup>1</sup>
- On January 31, 2005 DOE provided a letter to Boeing declaring that Boeing and ORISE surveys had confirmed that DOE and DHS approved soil cleanup limits had been met, and that the 4020 site was suitable for release for unrestricted use.<sup>7</sup>

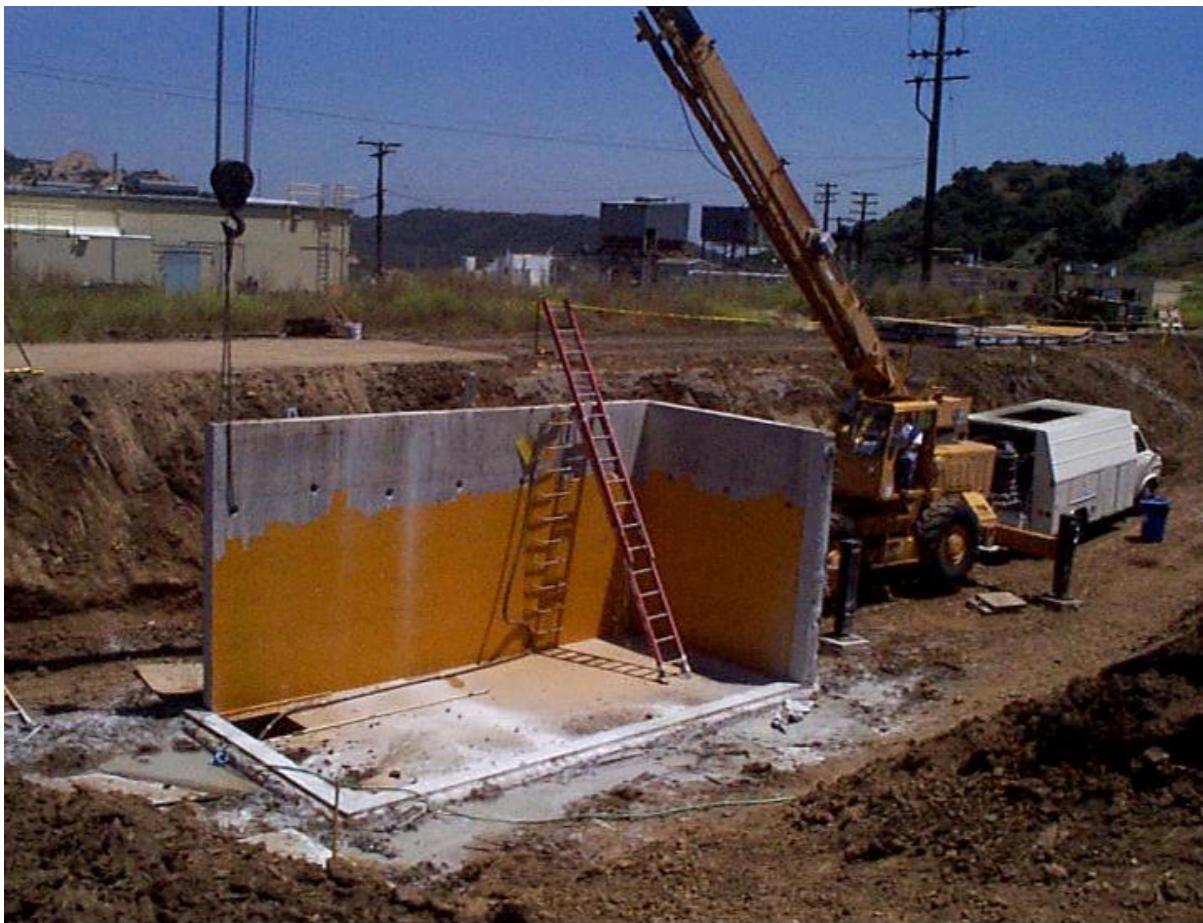
**Photograph – Building 4468**

- Building 4468 was demolished in 1997. The surrounding soil was excavated an additional 4 feet.<sup>1</sup>
- On January 31, 2005 DOE provided a letter to Boeing declaring that Boeing and ORISE surveys had confirmed that DOE and DHS approved soil cleanup limits had been met, and that the 4020 site was suitable for release for unrestricted use.<sup>8</sup>

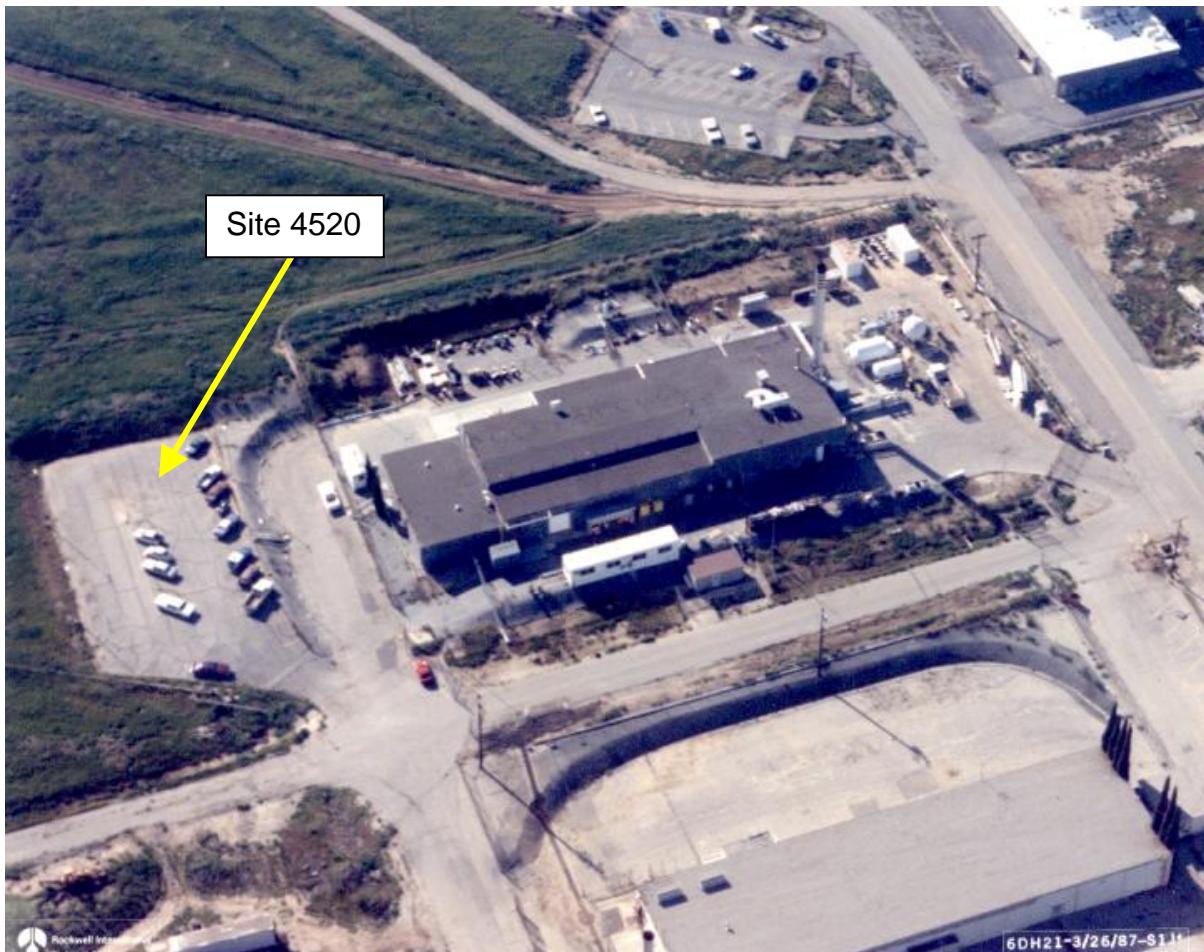
**Photograph – Site 4520**

- Site 4520 was removed in 1996 as part of the Hot Lab facility D&D effort and is now a vegetated field.
