Group E

Site Summary Group E
 AREA IV
 Santa Susana Field Laboratory, CA

Site Summary – Building 4014

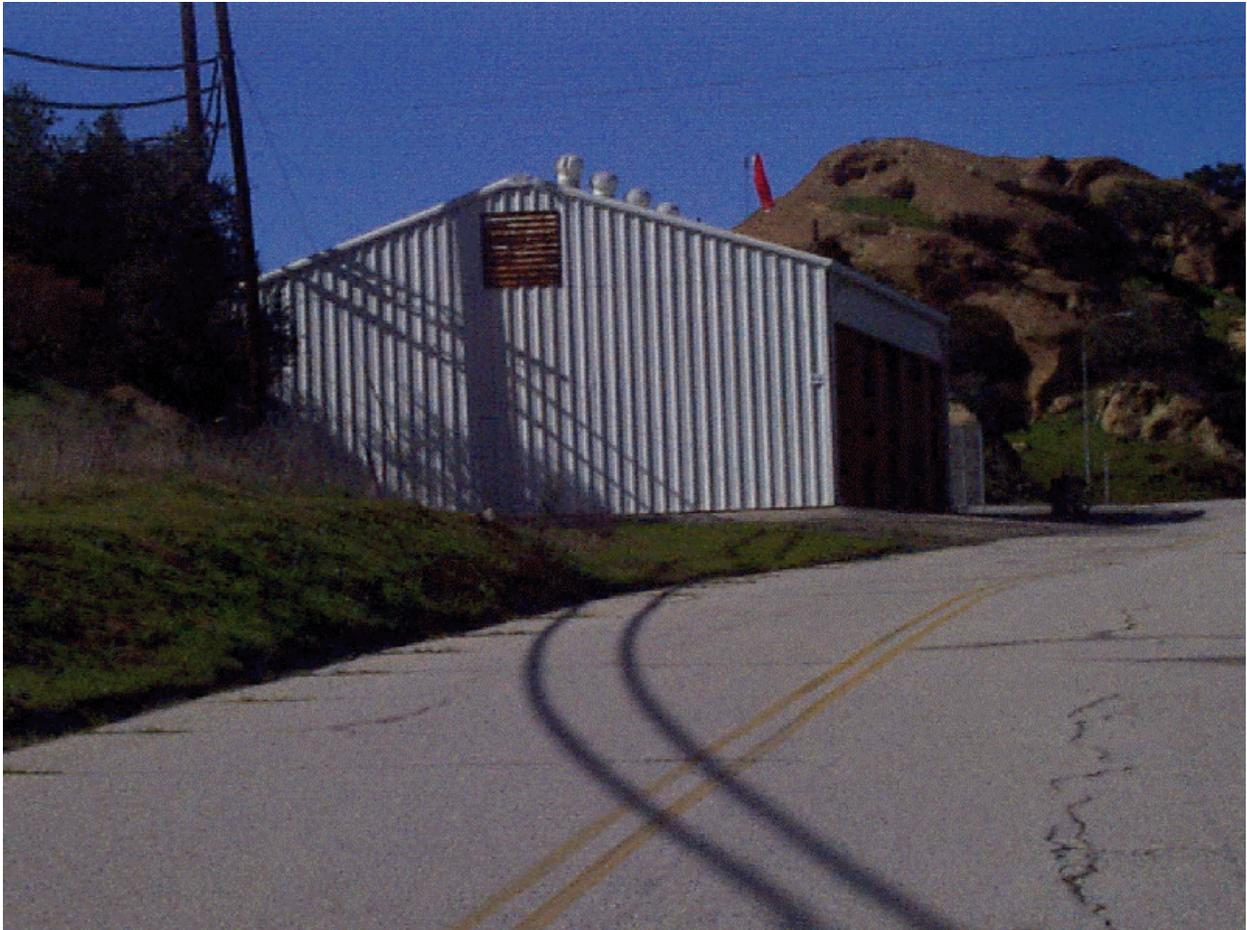
Photograph – Building 4014

- This site was included in the Area IV Radiological Characterization Survey, conducted in 1994 through 1995.⁵
 - Scope/Purpose: Designed to locate and characterize any previously unknown areas of elevated radioactivity in Area IV.
 - Background: 15.6 $\mu\text{R/hr}$.
 - Acceptable Limit: Less than 5 $\mu\text{R/hr}$ above background.
 - The survey found the area to be below acceptable limits.

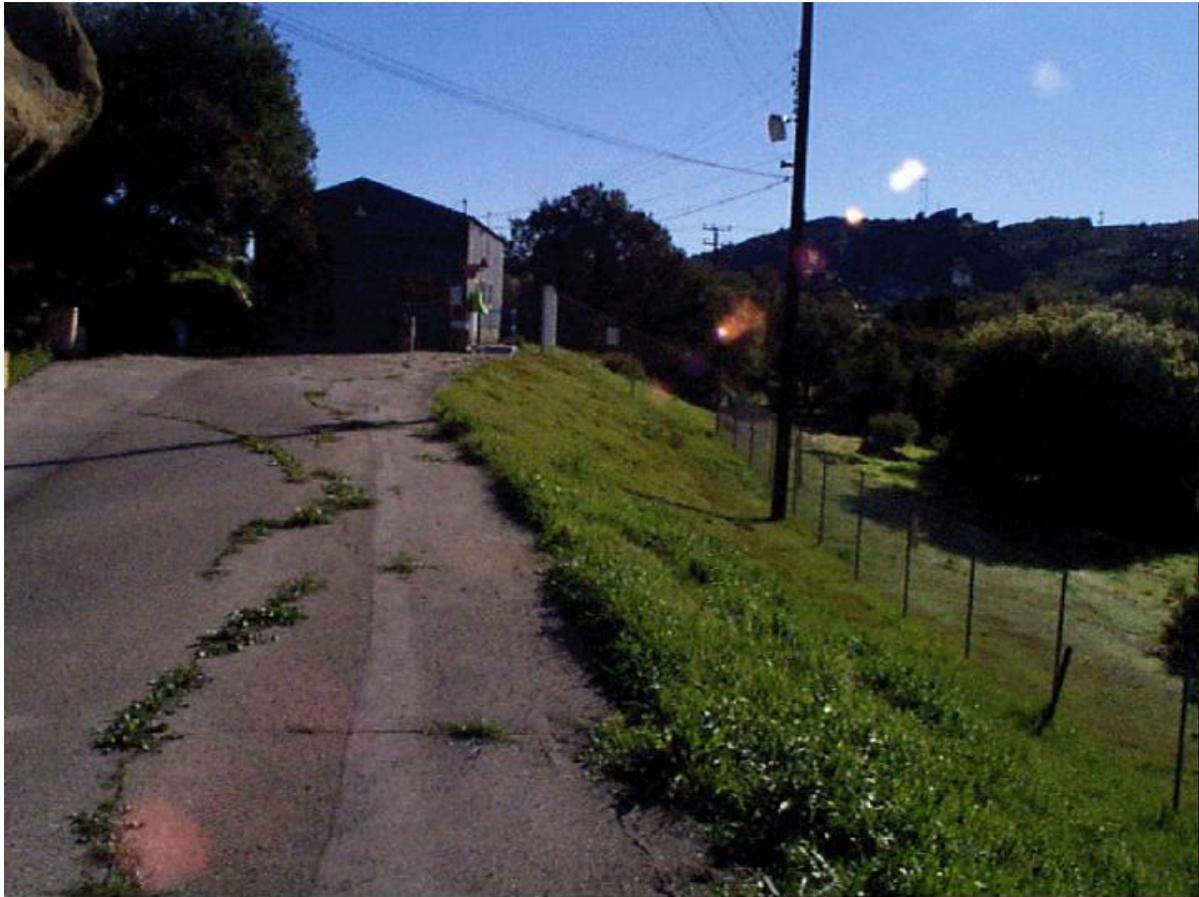
Photograph – Building 4029

- Survey results were below the acceptable limits.
 - Source wells were contaminated (2,800 α -dpm/100 cm²) and it was recommended that they be remediated during the final decommissioning and demolition (D&D) of the facility.

- The survey concluded that with the exception of the wells, the facility is clean of any residual radioactive contamination.
- DHS performed verification sampling in 1995.

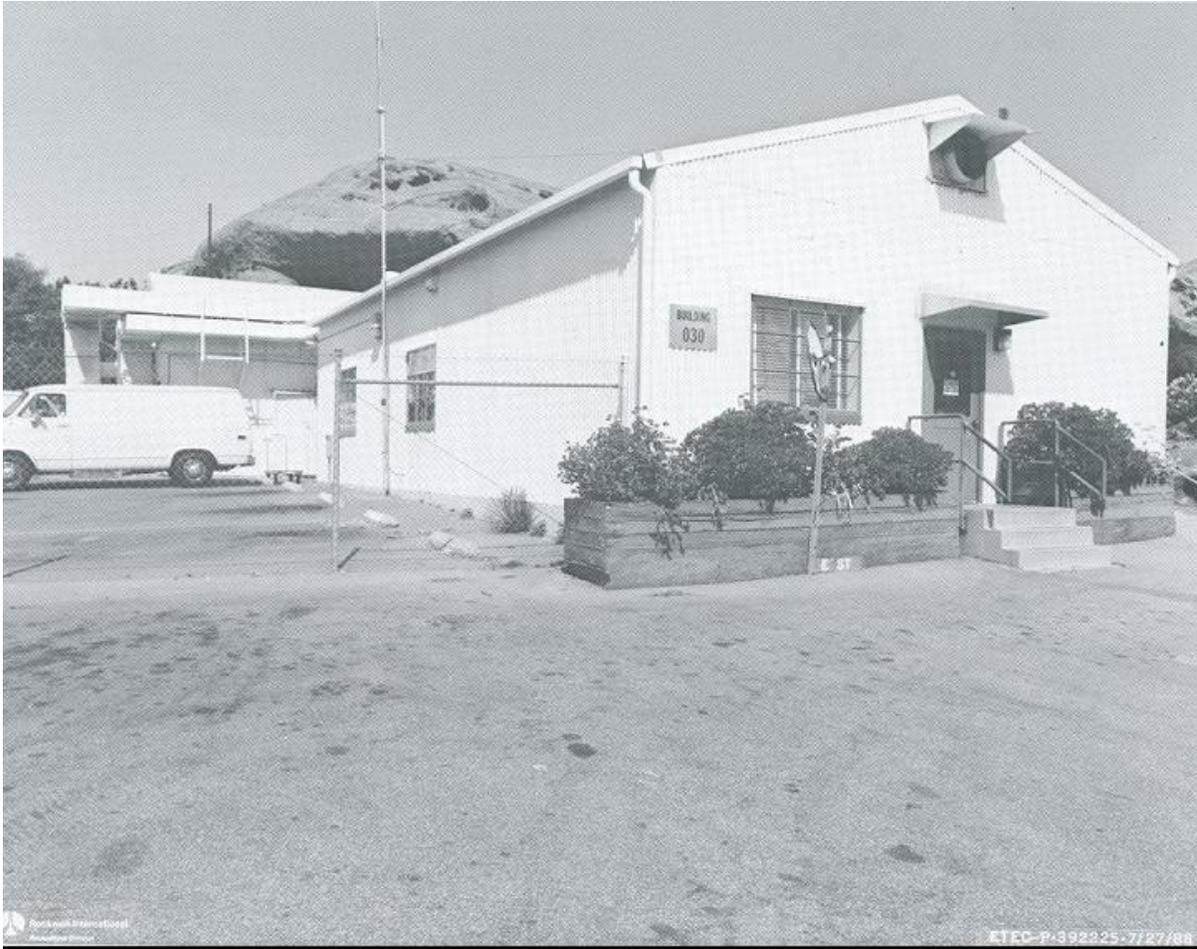
Photograph – Building 4030

- Tritium Smear Survey on Building 4030 and associated equipment, March 29, 1966.⁵
 - Maximum sample: 75,000 dpm.
 - Tritium contamination was detected.
 - Areas of contamination were decontaminated.

- Total Alpha Surface Activity: less than 55 dpm/100cm².
 - Total Beta Surface Activity: less than 1,400 dpm/100cm².
 - One sample of total tritium activity exceeded the average guideline (5,000 $\beta\text{-}\gamma$ dpm/100 cm²) for beta-gamma emitters (6,600 dmp/100 cm²), and ORISE recommended additional sampling be performed in this area.

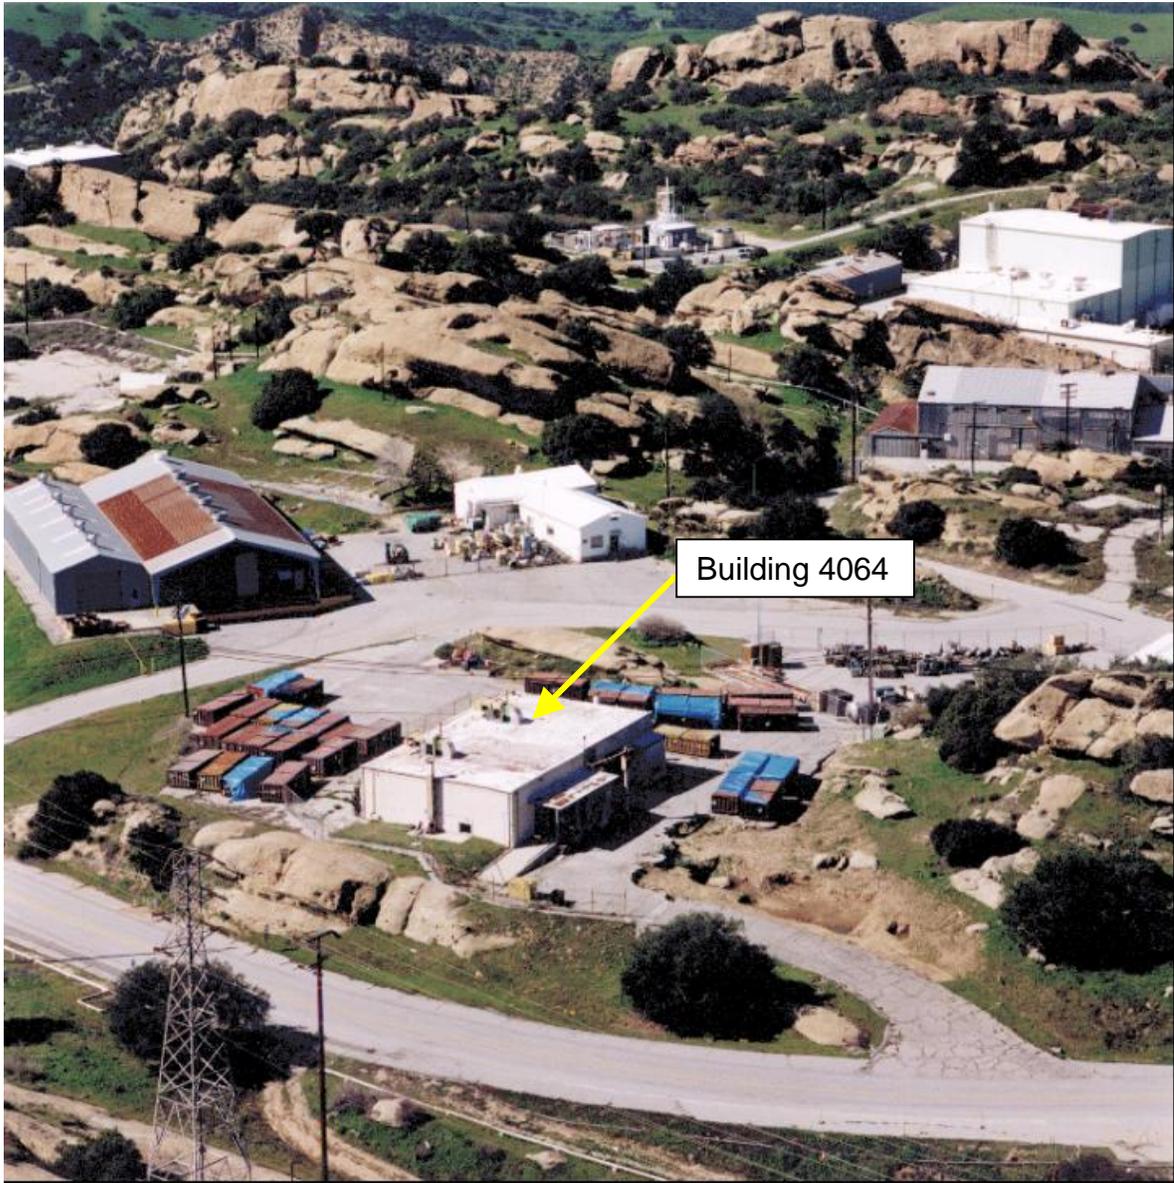
Photograph 1 – Building 4064

- Derived Concentration Guideline Level (DCGL): 5000 dpm/100cm².
- Survey results for the interior walls and floors were below the acceptable limits.
- Miscellaneous building features were surveyed by indication only. The light fixtures, a floor mop and the fume hood were found to be contaminated.

- The area within the fenced storage yard was surveyed for ambient gamma. A contaminated area was found bordering and outside of the eastern fence. This area, measuring approximately 300 square feet, was significantly contaminated with rate readings of 50-100 μ R/hr at one meter. Soil samples from the vicinity showed elevated Cs-137 activity (2,500 pCi/g, DCGL 100 pCi/g). Further remedial action for that area was required.

- ORISE performed a final verification survey in December 1992, during which three Cs-137 hotspots in the Building 4064 Side Yard were discovered. One hotspot was found to contain 210 pCi/g of Cs-137. The second was measured at 35.1 pCi/g, and the third was measured at 27.7 pCi/g. (Allowable limits for Cs-137 were 7.08 pCi/g average in 100 m² or 70.8 pCi/g maximum in 100 m².) Following additional remediation of these areas, ORISE conducted an additional verification survey and published its findings in 1993.⁶

- Remedial action occurred in 1990. The top layer materials for the side yard were removed and the residual activity was analyzed and compared to previous data. It was concluded that radiation and contamination levels in the side yard and other surrounding areas are well below acceptable regulatory limits.⁴
