Program Title CLOSURE OF ETEC (R21-RF)

Document Title FINAL REPORT DECONTAMINATION AND DISMANTLEMENT OPERATIONS AT SSFL BUILDING 4019 FOR RELEASE WITHOUT RADIOLOGICAL RESTRICTIONS

Document Type D&D Report

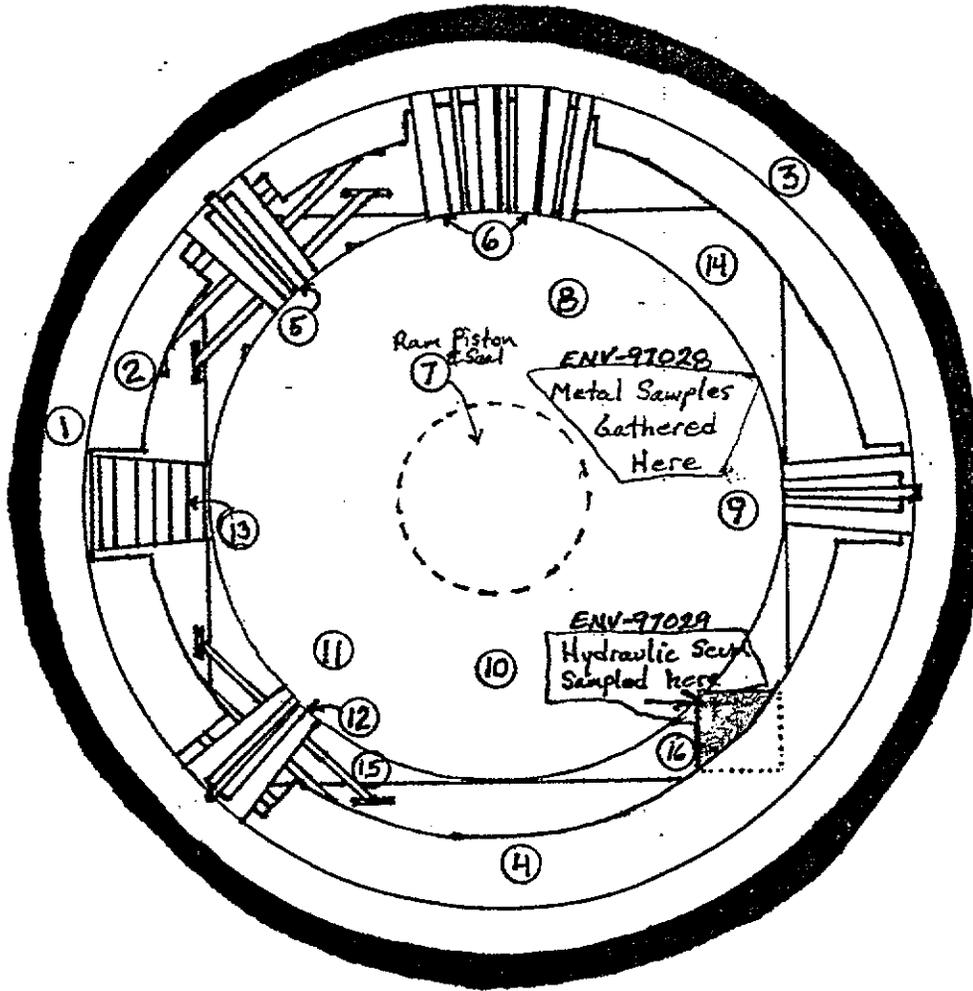
Figure 4-2. 1997 Rocketdyne Survey Map of Building 4019 Test Vault

In June 1997, the test vault cover plugs were removed and a confined space entry was conducted to perform a radiation survey. This survey by Rocketdyne Radiation Safety consisted of taking activity readings, smear samples and material samples at the 16 locations identified in **Figure 4-4**. The activity levels were between 12 and 14  $\mu\text{R/hr}$  at all locations. The smear and material samples had no detectable activity above background levels.

① - Smear Sample locations  
Radiation readings in all areas - 12 to 14  $\mu$ R/hr
