## Group I

Site Summary Group I  
AREA IV  
Santa Susana Field Laboratory, CA

## Site Summary – Building 4021

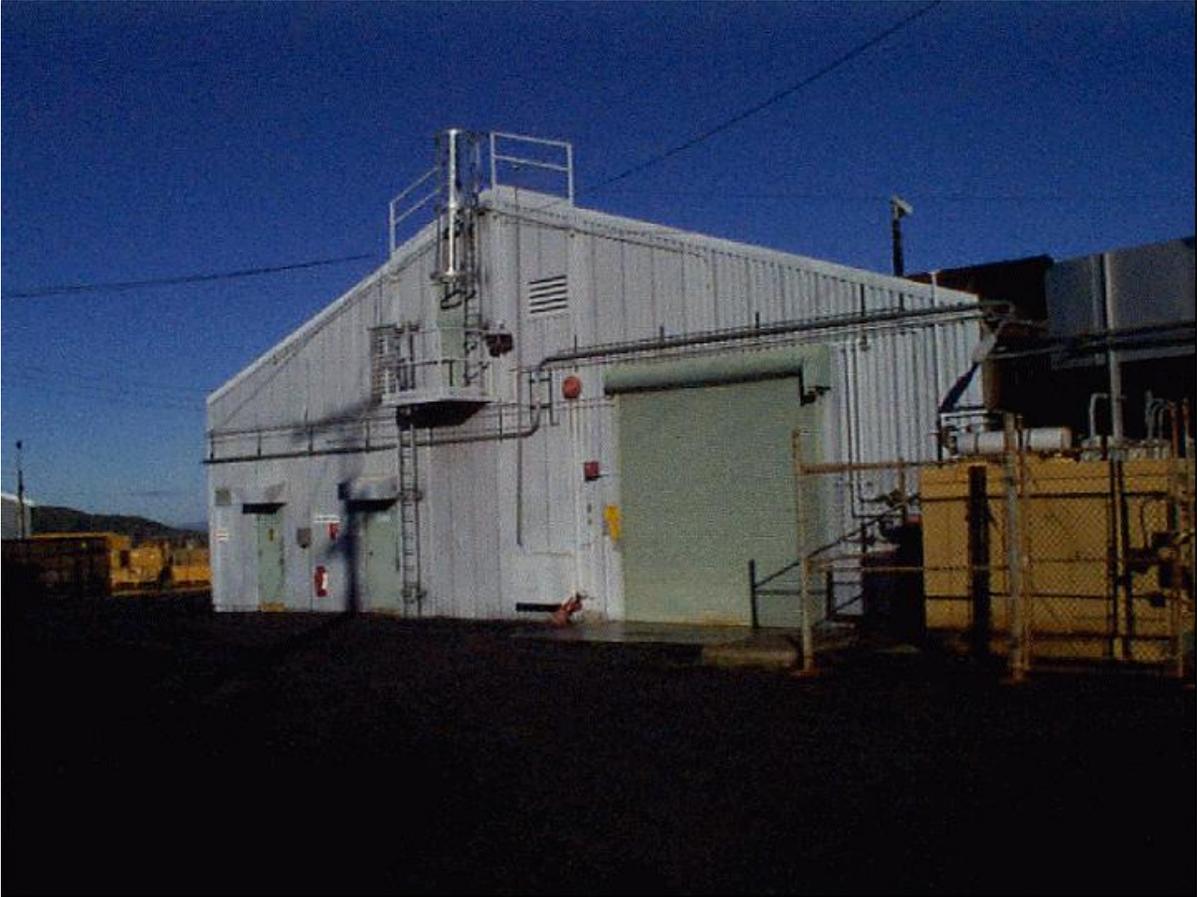
Photograph – Building 4021

- Radioactive materials were handled in Building 4021 primarily in the form of mixed fission products and fuels.
- Multiple incidents have occurred at this facility. The following are incidents which may have involved releases to the environment:
  - On June 10, 1964, an explosion and fire broke out in a storage can as a result of a sodium reaction. Contaminated smoke caused increased levels of airborne contamination, though the smoke did not escape the building (A0408).
  - On July 21, 1964, an explosion and fire broke out in a storage can as a result of a sodium reaction. Contaminated smoke caused increased levels of airborne contamination, though the smoke did not escape the building (A0413).
  - On December 22, 1964, a component from the Sodium Reactor Experiment was taken to Building 4021 for decontamination. The component had water in

- On November 3, 1976, the leach field connected to the building was found to be contaminated at levels up to 200 mrad/hr (A0056).
- On February 15, 1978, the contaminated leach field flooded with rainwater, resulting in the release of water contaminated with Sr-90 at a level of  $4 \times 10^5$   $\mu\text{Ci/ml}$  gross beta activity (A0064).

- In 1976, contamination of the leach field was discovered and decontamination and removal plans were prepared. Levels of contamination were as high as 115,000 pCi/g.

- Decontamination and removal activities occurred from 1976 to 1978. Approximately 36,250 cubic feet of contaminated soil and sludge were shipped to radioactive waste disposal sites. An estimated 0.6 mCi of radioactive material remains sequestered in inaccessible recesses and three contaminated cracks in the bedrock.

- The site was left with a minor amount of radioactive material in three cracks in the sandstone rock (estimated 0.6 mCi). The cracks are over 10 feet below the surface and were sealed with bituminous asphalt mastic.

- Building 4021 is active.
- The Building 4021 leach field was recommended for release for unrestricted use by the Department of Energy (DOE).<sup>2</sup>

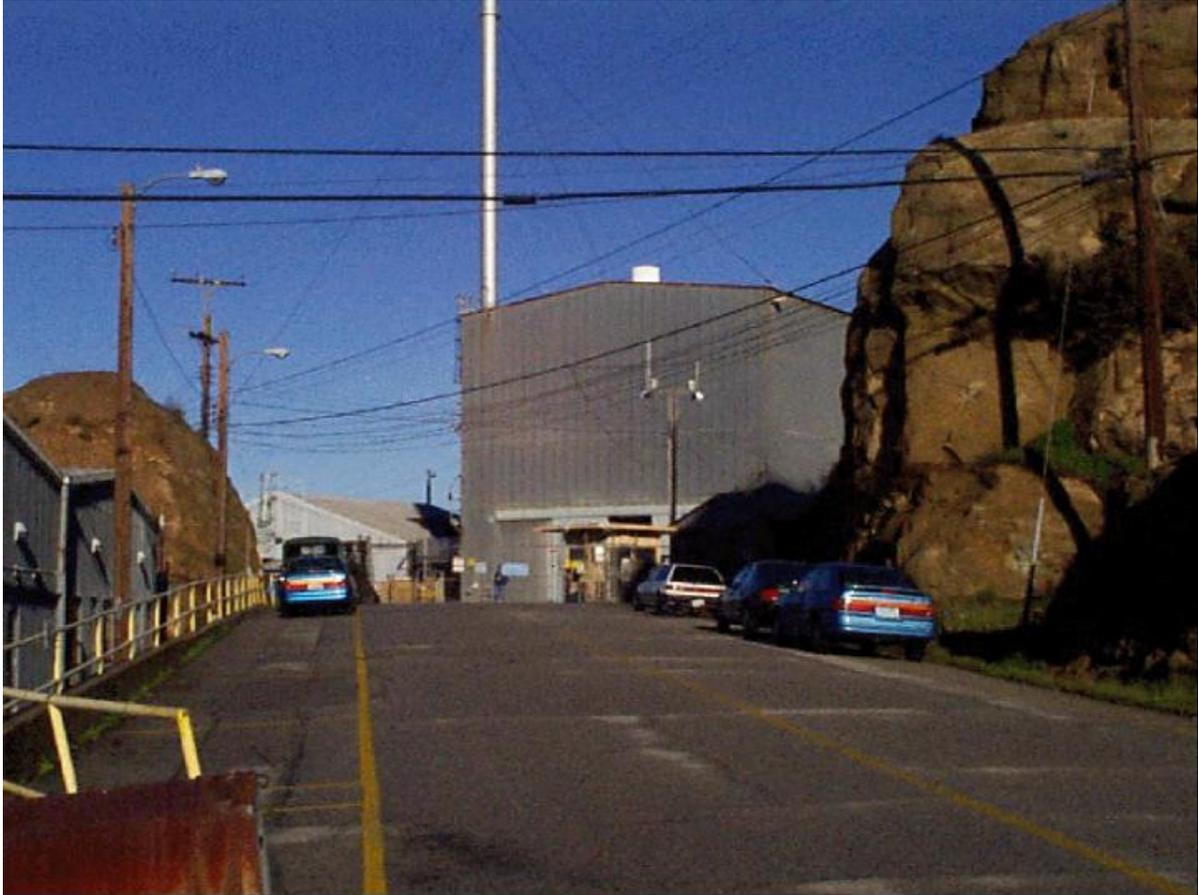
Photograph – Building 4022

- On December 29, 1965, drums of contaminated sodium exploded in a rain storm and burned the outside of the building (A0588).
  - On May 21, 1967, a drum of uranium carbide sludge exploded on a truck outside of the building, contaminating asphalt and evaporator equipment. Contamination levels ranged from 300 to 5,000 dpm/100 cm<sup>2</sup>. Decontamination of the asphalt and equipment was successful (A0615).

- On May 22, 1978, the sump pump stopped working and contaminated liquid flowed out of a holdup tank, contaminating asphalt, which later contaminated eight truck tires placed on the pavement. Both the tires and the asphalt were decontaminated (A0070).
- On August 14, 1979, a shipping box loaded on a waste truck for offsite disposal leaked radioactive liquid containing Cs-137 and Sr-90 on the asphalt outside RMHF. The area was successfully decontaminated shortly after the incident (A0314).
- Because of the operational and incident history of this building, as well as the entire RMHF facility, the building and its surroundings will be surveyed and decontaminated at the time of RMHF closure.

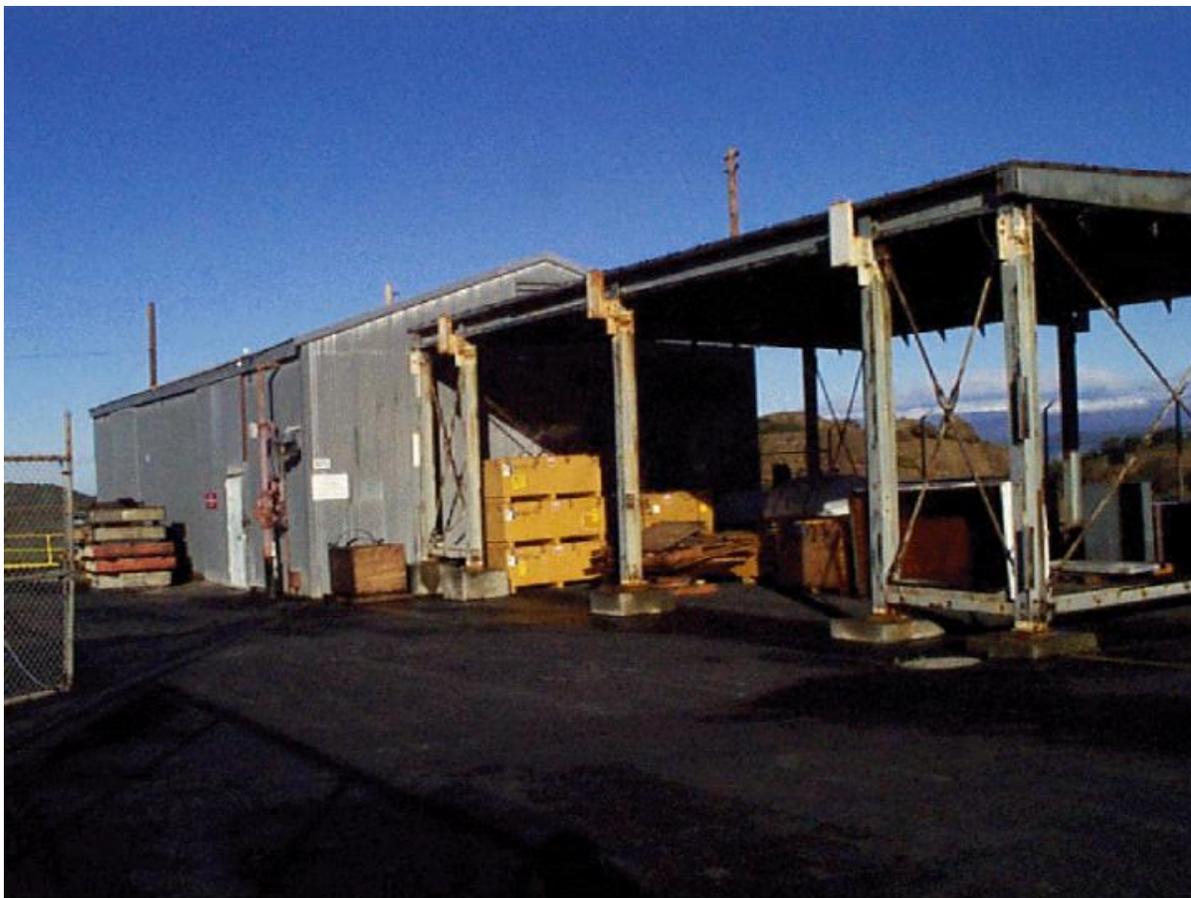
Photograph – Building 4075

- Radioactive waste was stored in this building. Possible contaminants include: uranium, thorium, plutonium isotopes and mixed fission products.
- The following is an incident which may have involved a release of contamination to the environment:
  - On August 15, 1988, a forklift driver punctured a drum of radioactive sand. The sand spilled out onto the floor of Building 4075; however, surveys indicated that no detectable contamination occurred as a result (A0188).

- There have been several surveys of the entire RMHF complex, including Building 4075, during its operation. The results of these surveys are summarized in the 4021 site summary.
- Routine quarterly radiological surveys are conducted to verify that Building 4075 has not become contaminated above the limits established by 10 CFR 835.<sup>3</sup>

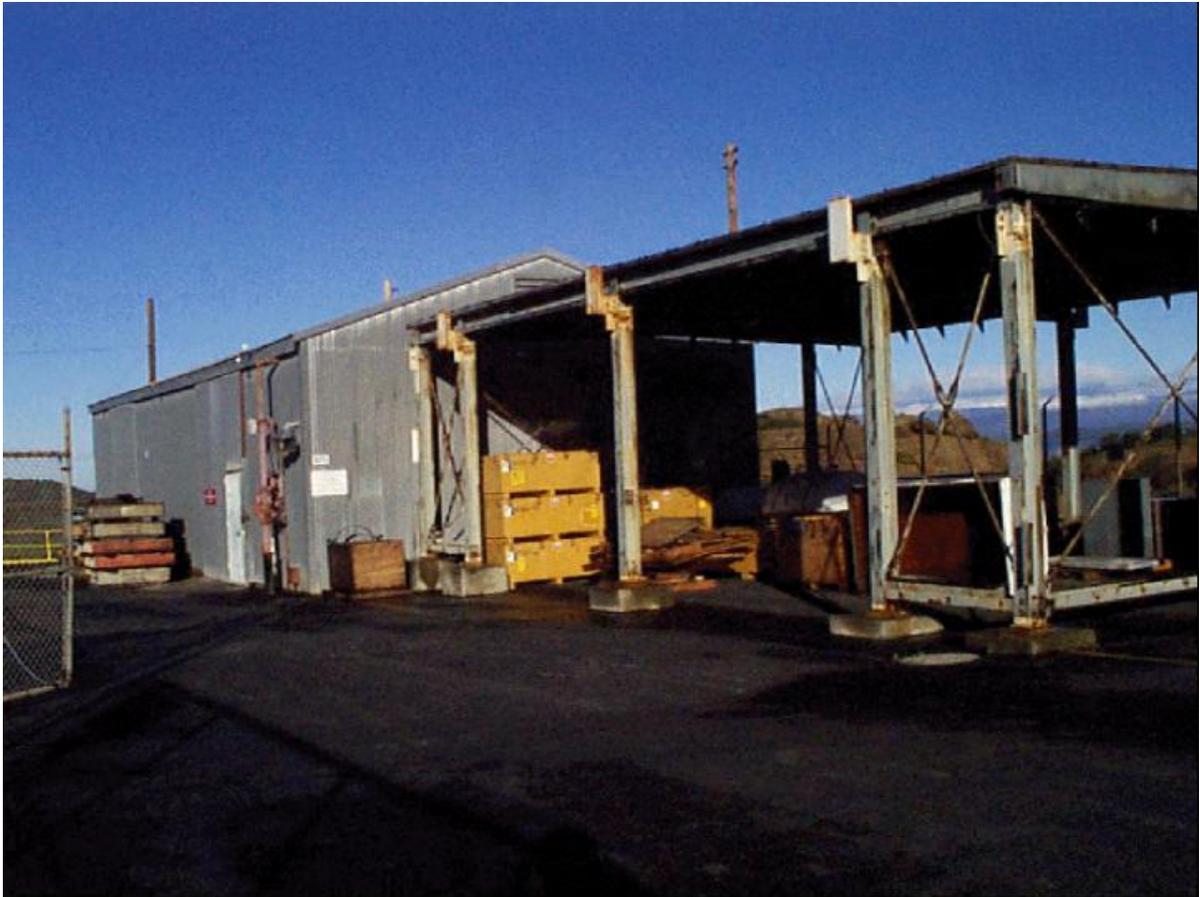
Photograph – Building 4563

- Radioactive waste was stored here pending shipment to a disposal facility. <sup>3</sup>
- The most probable contaminants of concern are uranium, plutonium, thorium isotopes and mixed fission products.
- There are no Incident Reports associated with Building 4563. <sup>4</sup>

- There have been several surveys of the entire RMHF complex, including Building 4563, during its operation. The results of these surveys are summarized in the 4021 site summary.
- Routine quarterly radiological surveys are conducted in the area to verify that Building 4563 has not become contaminated above the limits established by 10 CFR 835. <sup>5</sup>

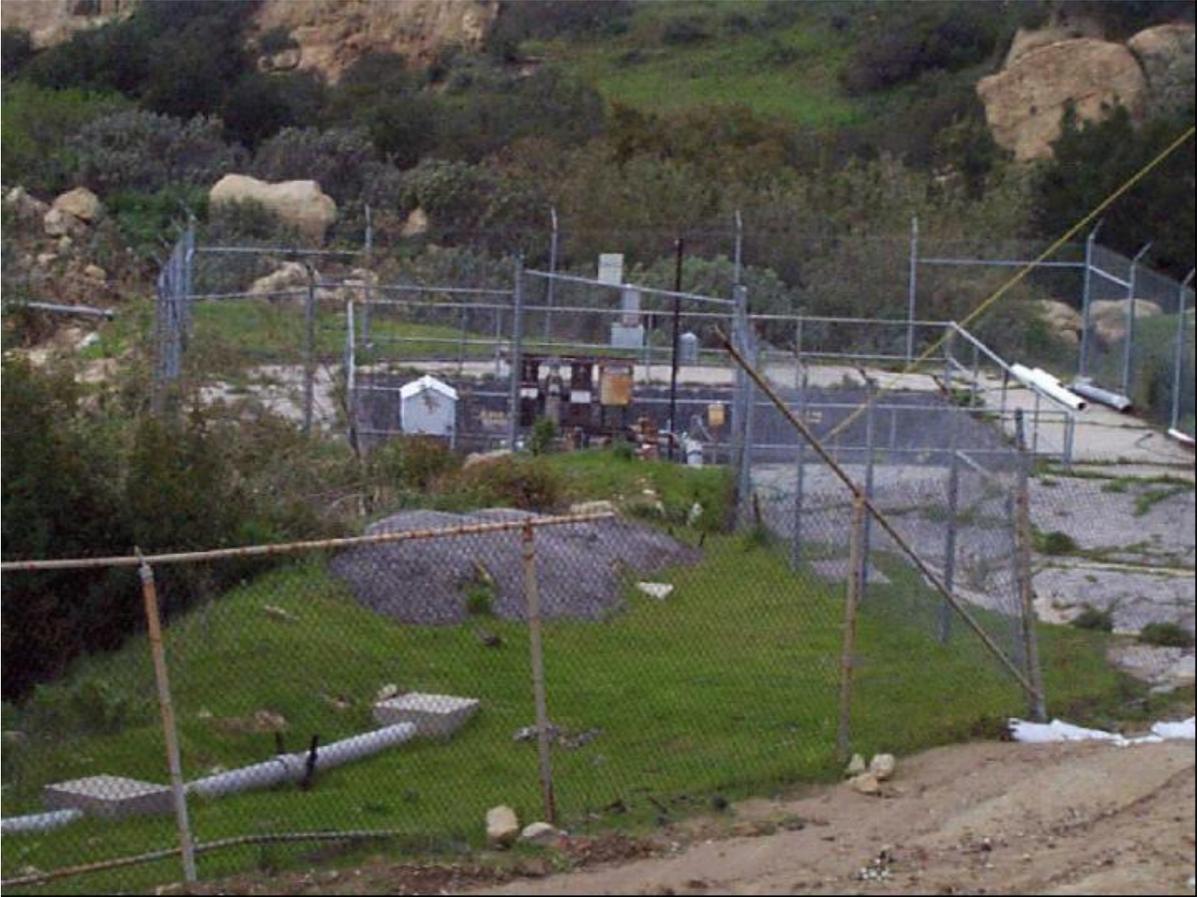
Photograph – Site 4614

- Radioactive contamination exists in the pond as a result of known spills that have occurred at the RMDF/RMHF.
- There have been two notable radiological incidents associated with Site 4614:
  - On January 17, 1979, leakage from the flocculation tower associated with Building 4021 contaminated the drainage ditch and the pond itself with less than 0.4 mCi of Sr-90 and Cs-137 (A0077).
  - On January 9, 1980, a water hose broke, causing the Building 4021 tank to overflow, which then drained to the pond. This incident resulted in the released of about 100 gallons of liquid containing  $1 \times 10^{-2}$  mCi of mixed fission products (A0080).

- There have been several surveys of the entire RMHF complex, including Site 4614, during its operation. The results of these surveys are summarized in the 4021 site summary.
- Due to operational history, Site 4614 is likely contaminated.
- Site 4614 is monitored and alarmed by a NaI gamma exposure meter. Any alarms result in immediate sampling of the water. All alarms in the past 14 years have been false alarms caused by power supply and telephone line problems during wet weather. No activity has been detected in the water. Water pumped from this pond into the Santa Susana Field Laboratory (SSFL) water reclamation system is ultimately sampled according to the National Pollutant Discharge Elimination System (NPDES) permit.<sup>2</sup>

- During the dry season when the pond dries up, the sediment is removed from the lined pond and analyzed for contamination prior to being disposed of as radioactive waste. Low levels of Cs-137 are frequently found (e.g. 34 pCi/g in 2003).<sup>4</sup>

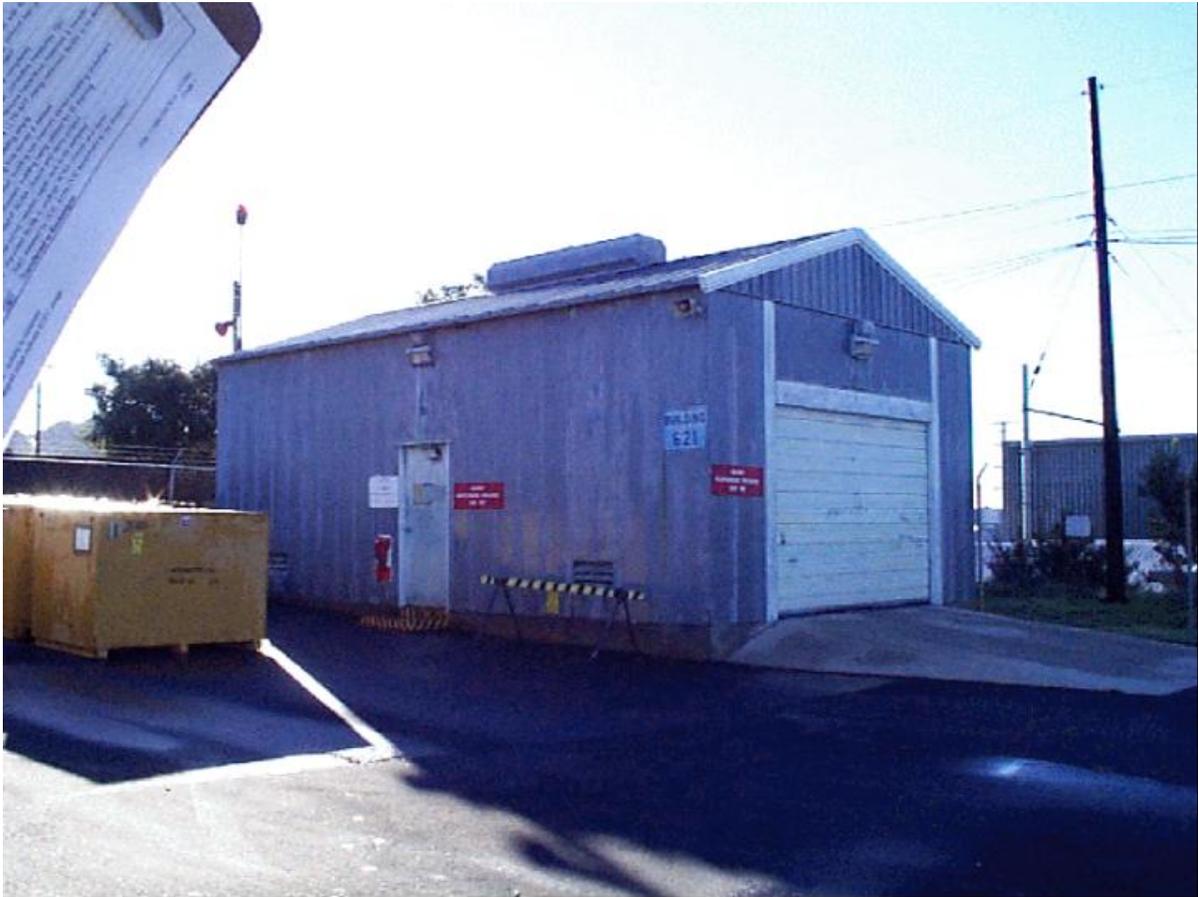
Photograph – Building 4621

- Radioactive material was stored in this facility, primarily in the form of mixed fission products from various site wastes.
- Use Authorization Series 107 authorized the storage of two Krypton-85 Aerosol Neutralizers at this location. One is specified to contain one  $\mu\text{Ci}$  and the other two  $\mu\text{Ci}$ . Both are gaseous and sealed in a Thermo-Systems Model 3012 Neutralizer.<sup>3</sup>
- An incident occurred at this facility which may have involved a release to the environment:
  - On September 4, 1975, a 132 mCi Ra-266 source was discovered lying on the ground outside Building 4621. The source was not labeled, nor was in it a shielded container. Following its discovery, the source was properly marked and stored in a secure condition (A0053).

- There have been several surveys of the entire RMHF complex, including Building 4621, during its operation. The results of these surveys are summarized in the 4021 site summary.
- Routine radiological surveys are conducted in Building 4621 to verify that the building has not become contaminated above the limits established by 10 CFR 835.<sup>4</sup>
