AI-ERDA-13159

KEWB FACILITIES  
DECONTAMINATION AND DISPOSITION  
FINAL REPORT

By  
B. F. UREDA

CONTRACT: AT(04-3)-701  
ISSUED: FEBRUARY 25, 1976

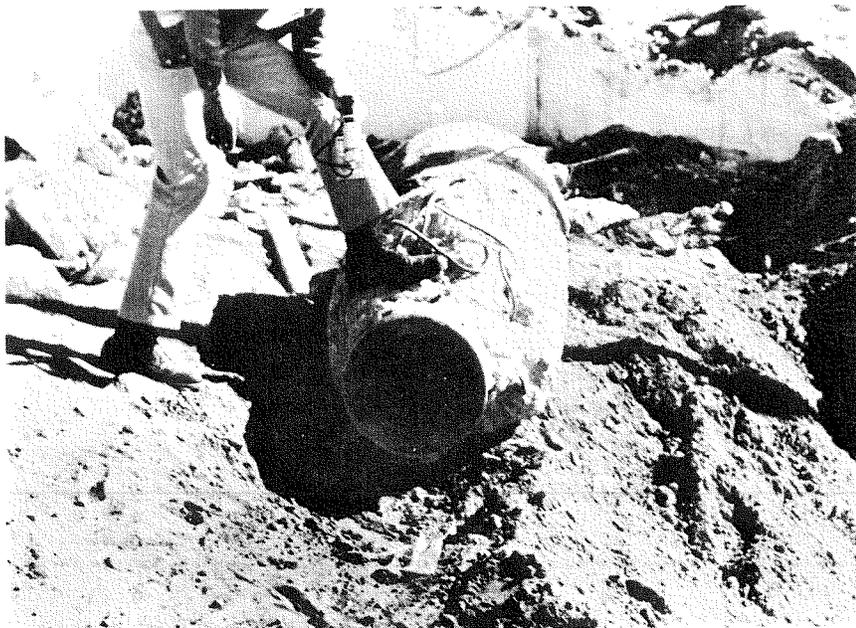
Figure 11. Pit Liner From Fuel Handling Room

A fuel storage tank located in a 5-ft deep, 1-ft-diameter pit in the Fuel Handling Room was removed. The pit had a metal liner which was found to be contaminated. Since the inaccessibility of the inner surfaces of the liner made decontamination impractical, the liner was removed by demolishing the floor adjacent to the pit with a Hoe-Ram and lifting the liner out with a crane. Figure 11 shows the liner encased in concrete after removed by the contractor. The liner was transferred to the RMDF for disposal.

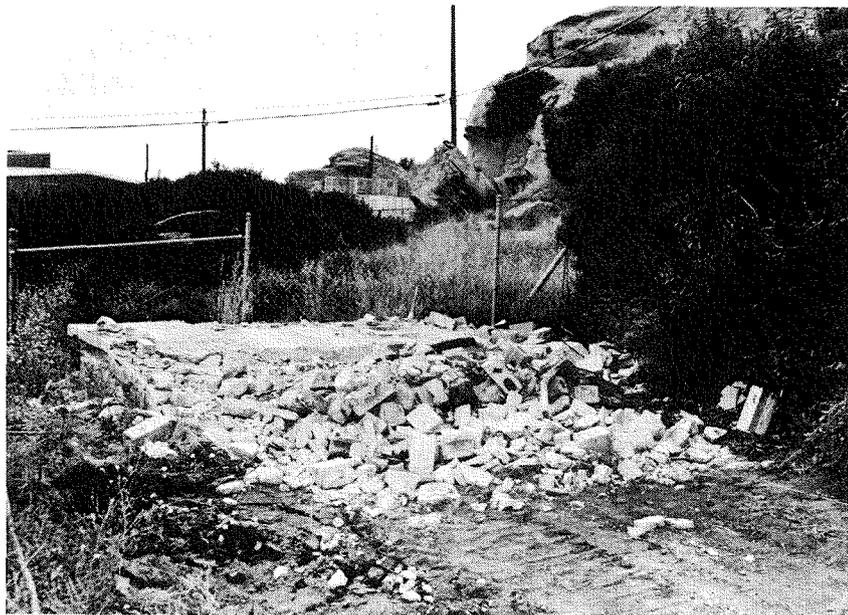
Figure 12. Waste Storage Building  
Demolition

The Waste Storage Building 123 was surveyed and found free of contamination. Several small casks stored in this facility were sent to the RMDF for future use. The building, concrete pad, and storage pits were later completely demolished and removed. Figure 12 shows the building rubble.

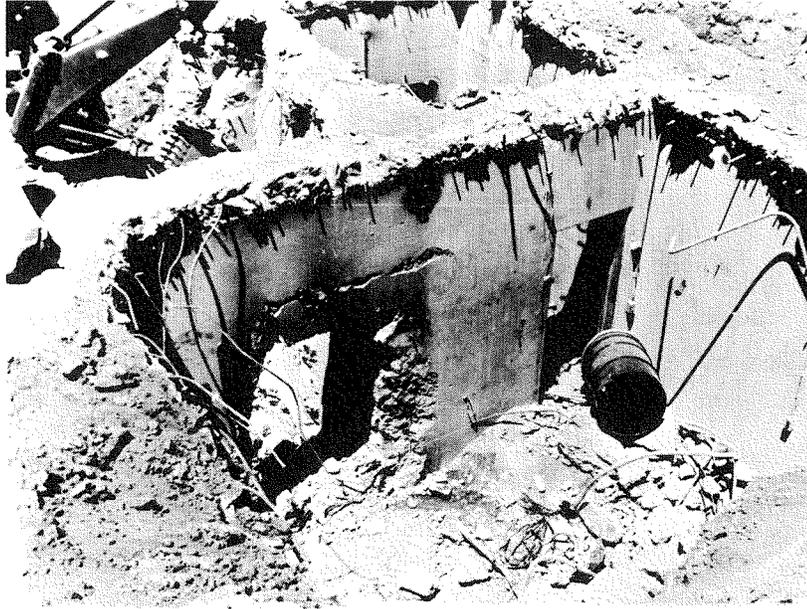
Figure 19. Activated Concrete Removal  
From West Wall of Reactor Room

The analyses described in Tables 1 and 2 indicated the presence of low-level induced radioactivity in portions of the concrete structure. Since concrete activation was not anticipated, the Plan and the Detailed Procedures did not establish acceptable specific activity levels for activated concrete remaining following D&D efforts. In keeping with ALAP principles, all possibly activated concrete was removed, reducing the radiation level of the site to natural background levels. The removal was accomplished in two steps. First, a vertical recess in the wall 1 ft by 4 ft by ~ 10 in. deep, and an excavation in the floor directly beneath the reactor position, 18 in. by 18 in. by 10 in. deep, were chipped out with a jack hammer. The concrete debris was collected in 55-gal drums and sent to the RMDF. Analysis results for samples of the concrete collected from the wall recess during the jack hammering are shown in Table 3.

The levels of concrete activation shown in Figure 3 for the depth and positions indicated, represent approximate natural radioactivity levels in concrete. However, to be certain that all induced radioactivity had been removed, the demolition contractor, using the Hoe-Ram, removed (Figure 19) a 5 ft by 5 ft section of the 2-ft-thick reactor wall, and a 3 ft by 3 ft by 12 in. deep section of the floor. This debris was also collected in 55-gal drums and sent to the RMDF for subsequent shipment to Beatty, Nevada for burial.
