**STIR FACILITY
DECONTAMINATION AND DISPOSITION
FINAL REPORT**

ERDA Research and Development Report

STIR FACILITY
DECONTAMINATION AND DISPOSITION
FINAL REPORT

CONTRACT: AT(04-3)-701
ISSUED: AUGUST 26, 1976

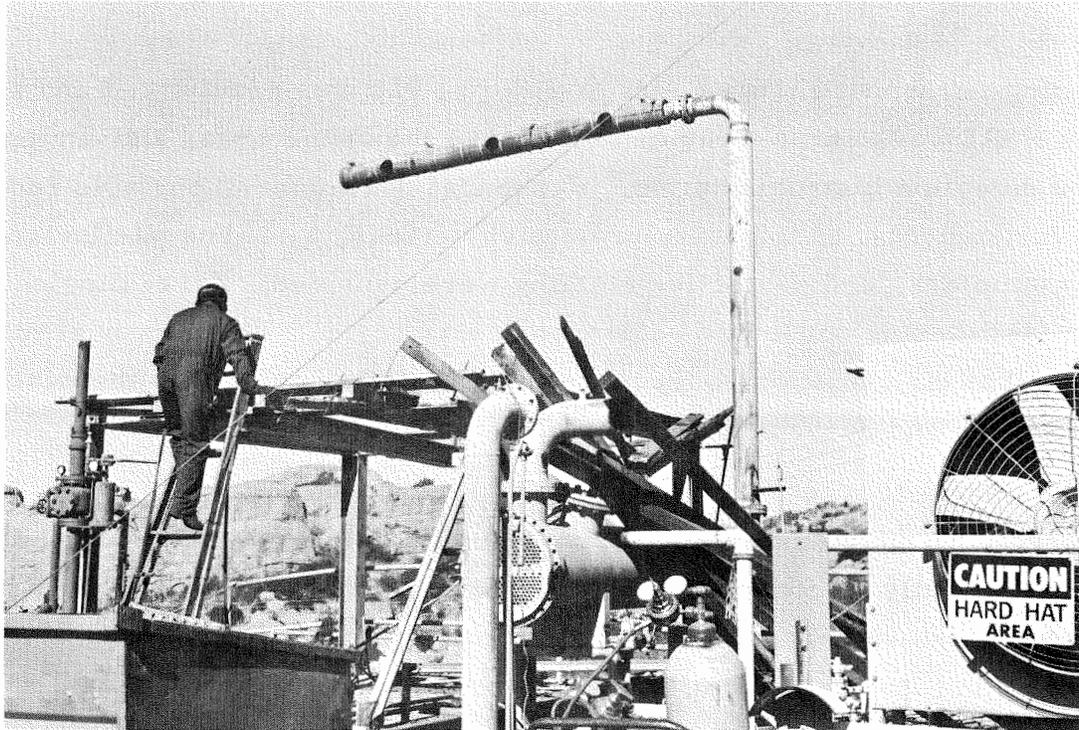
Figure 10. 1-Mw Water-Cooling Tower and Heat Exchanger Dismantling

The 50-kw reactor water cooling system and the primary (reactor side) of the 1-Mw reactor water cooling systems were dismantled. The secondary side of the 1-Mw system was removed by the salvage contractor. The piping, valves, and pumps were nonradioactive, and were disposed of as salvage. The 50-kw refrigeration water cooler was found to contain low levels of radioactivity in the water trapped inside the unit. The unit was removed from the facility and transferred to storage for possible reuse.

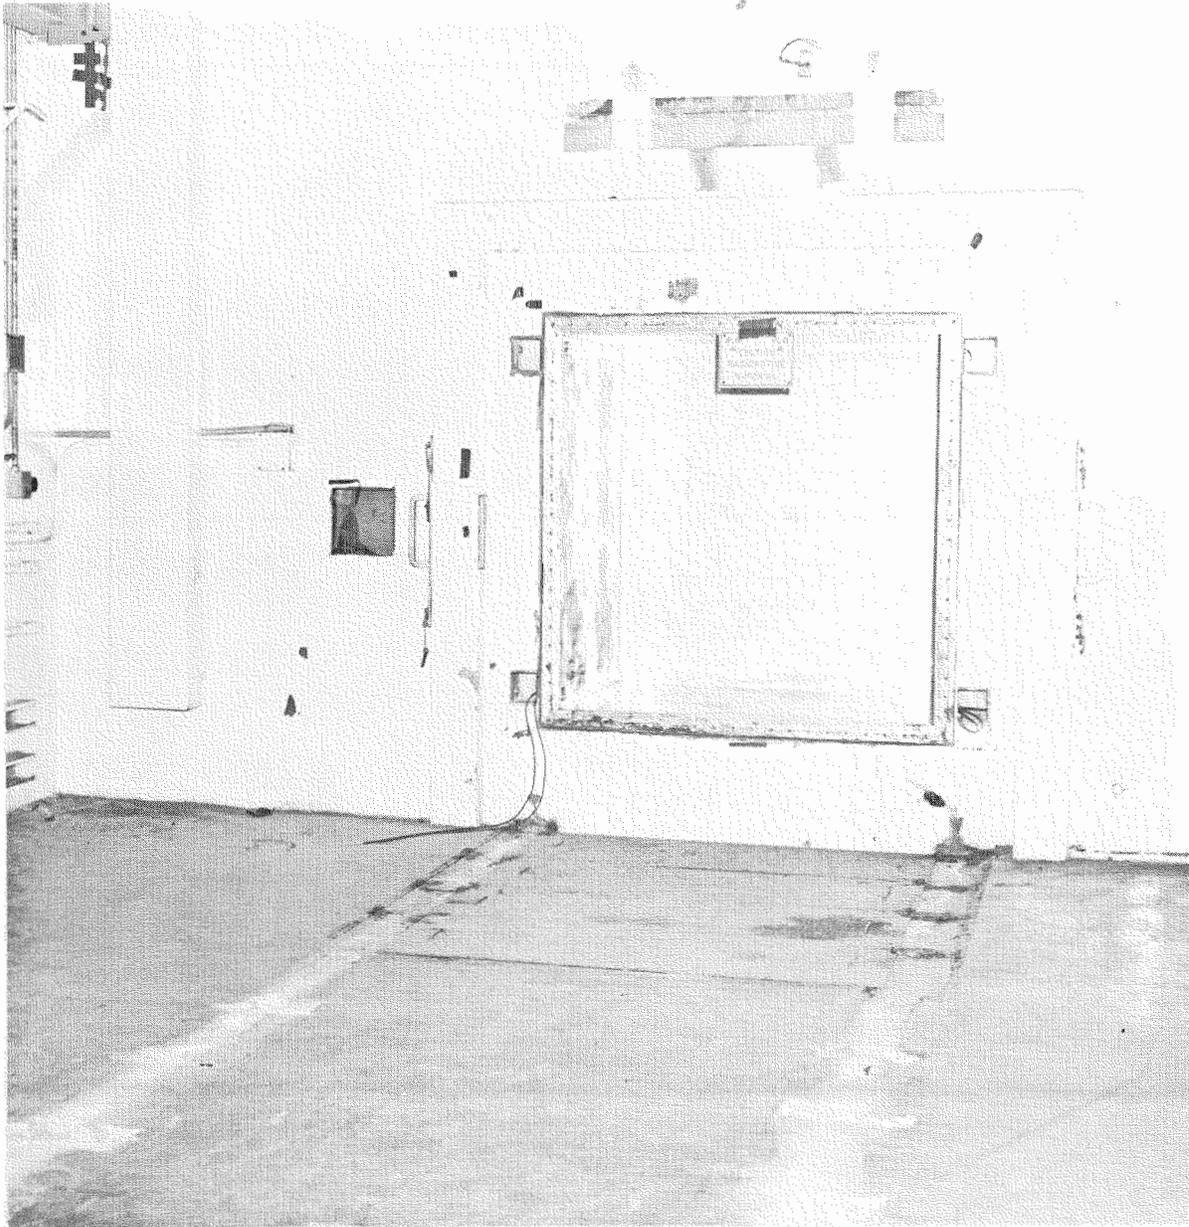
7704-62147

Figure 25. Thermal Column Liner After Removal of Graphite Logs

Plastic sheeting was spread over the floor area, directly in front of the thermal column, in preparation for disassembly of the thermal column. The lead shielding was removed from the thermal column front face (Figure 7). The boral sheet, which was nonradioactive, was then removed, exposing the graphite logs. Radiation levels associated with the graphite logs ranged from 15 mrad/hr at the ends exposed to the test vault to 50 mrad/hr at the ends nearest to the reactor. The graphite logs were removed, placed in shipping containers and sent to the RMDF for subsequent shipment to Beatty, Nevada for burial. Six thousand pounds of graphite logs were removed. The thermal column liner (Figure 25) was wiped down to remove loose contamination. The radiation level, after wiping, at the thermal column back wall was 500 mrad/hr in the center and 200 mrad/hr at the edges. The plastic sheeting on the floor was picked up and placed in the shipping boxes. The test vault area was then vacuumed.

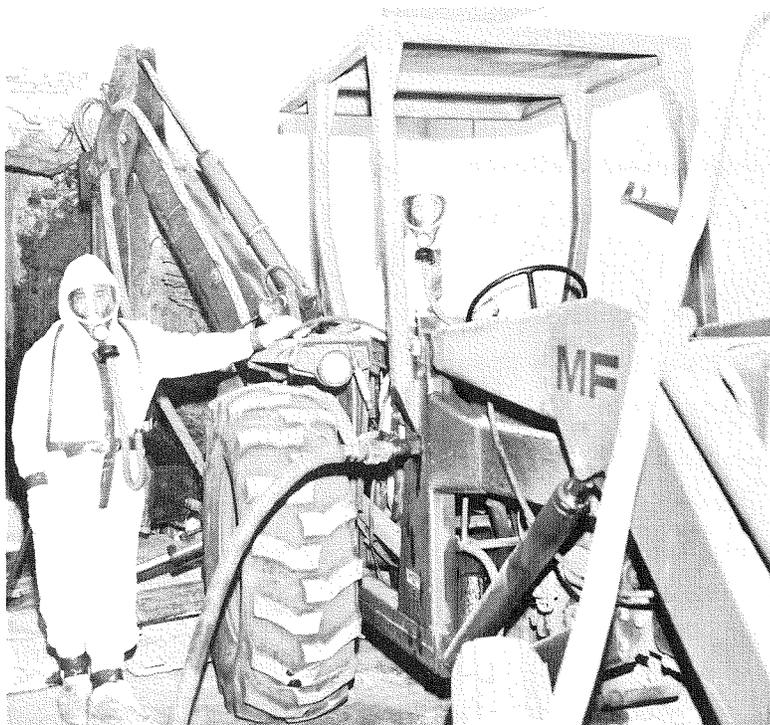
7704-62248

Figure 36. STIR-Hoe-Ram Crew Suited Up for Removal of Activated Concrete

A specification defining the extent of the required activated concrete removal was prepared. Bids from demolition contractors were obtained and the contract was awarded to the lowest bidder. The activated concrete was broken out using an air driven, hydraulically positioned Hoe-Ram. The Hoe-Ram is a large jack hammer with a 4-in. diameter bit. Figure 35 shows the Hoe-Ram in action. Water was sprayed on the rubble to decrease the amount of airborne dust. Figure 36 highlights the personnel protective clothing and equipment required during the concrete removal. The concrete rubble was placed in boxes and sent to the RMDF for shipment to off-site burial. Sealed boxes of radioactive concrete rubble are shown in Figure 37. These boxes were later steel-banded prior to shipment. Figures 38, 39, 40, 41, and 42 are closeup views of the activated concrete excavation.

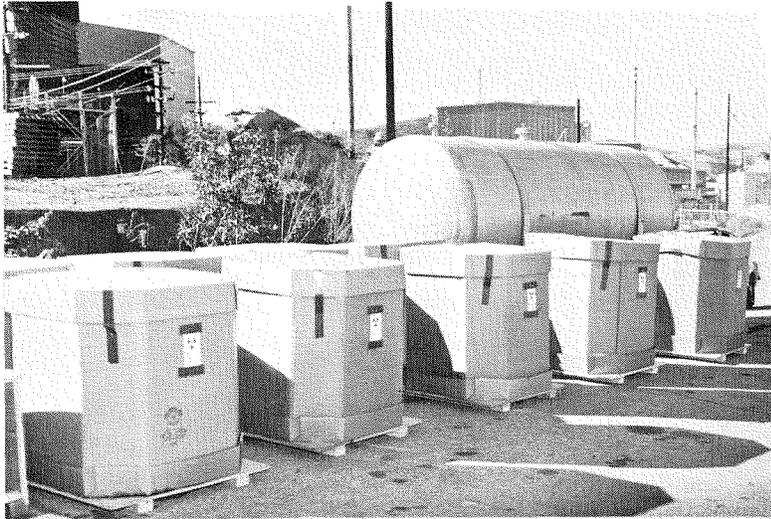
7704-62247

Figure 37.
Rubble Containers for
Activated Concrete

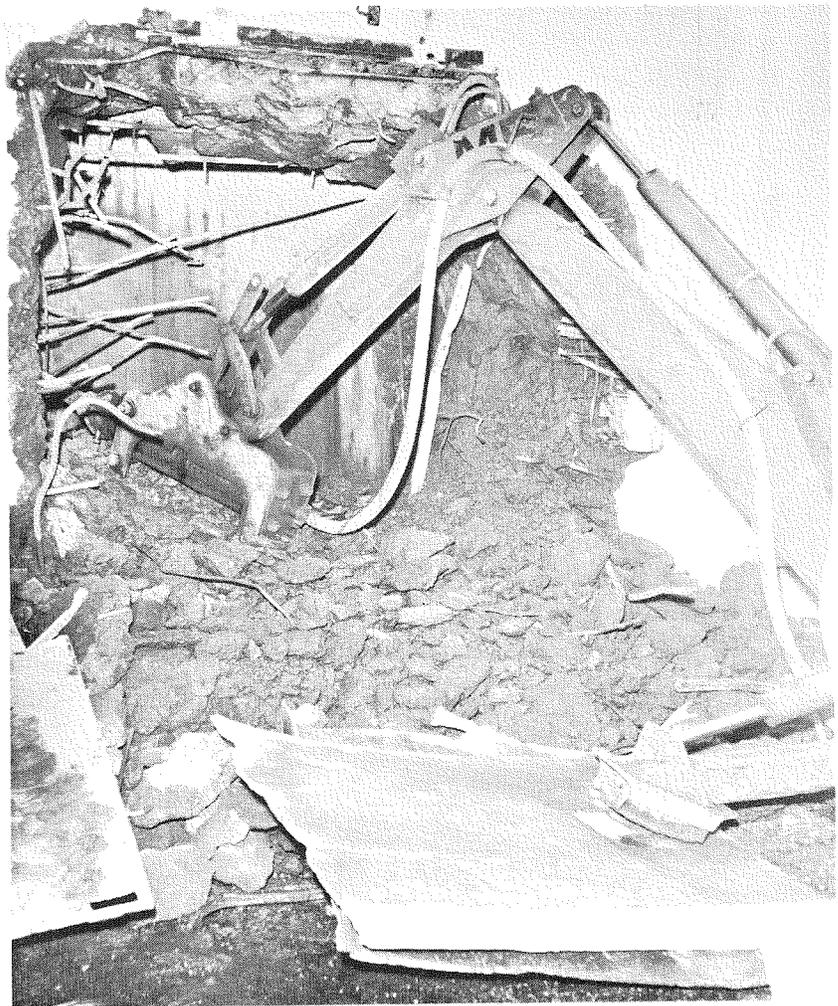
7704-62246

Figure 38.
Activated Concrete
Removal
