ESG-DOE-13403

**SODIUM REACTOR EXPERIMENT
DECOMMISSIONING
FINAL REPORT**

DOE Research and Development Report

The Sodium Reactor Experiment (SRE) located at the Rockwell International Field Laboratories northwest of Los Angeles was developed to demonstrate a sodium-cooled, graphite-moderated reactor for civilian use. The reactor reached full power in May 1958 and provided 37 GWh to the Southern California Edison Company grid before it was shut down in 1967. Decommissioning of the SRE began in 1974 with the objective of removing all significant radioactivity from the site and releasing the facility for unrestricted use.

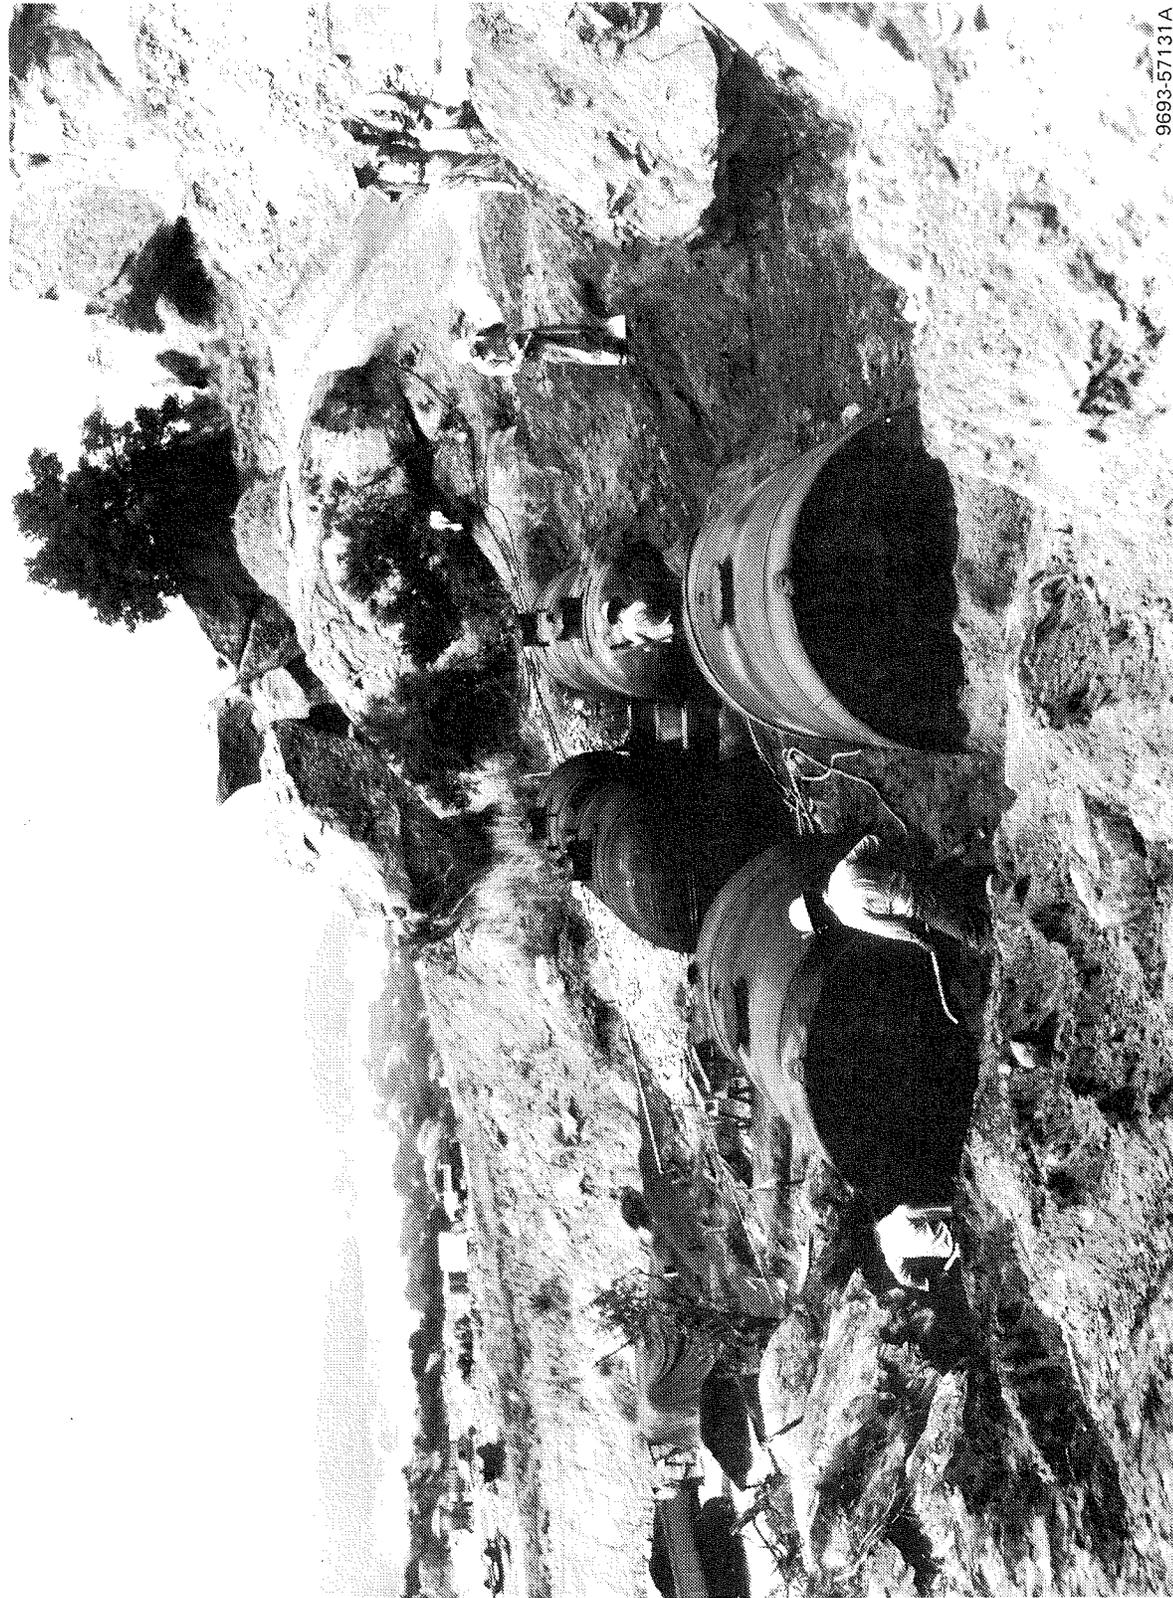
9693-57131A

Figure 23. Installation of the Six Radioactive Waste Decay Tanks

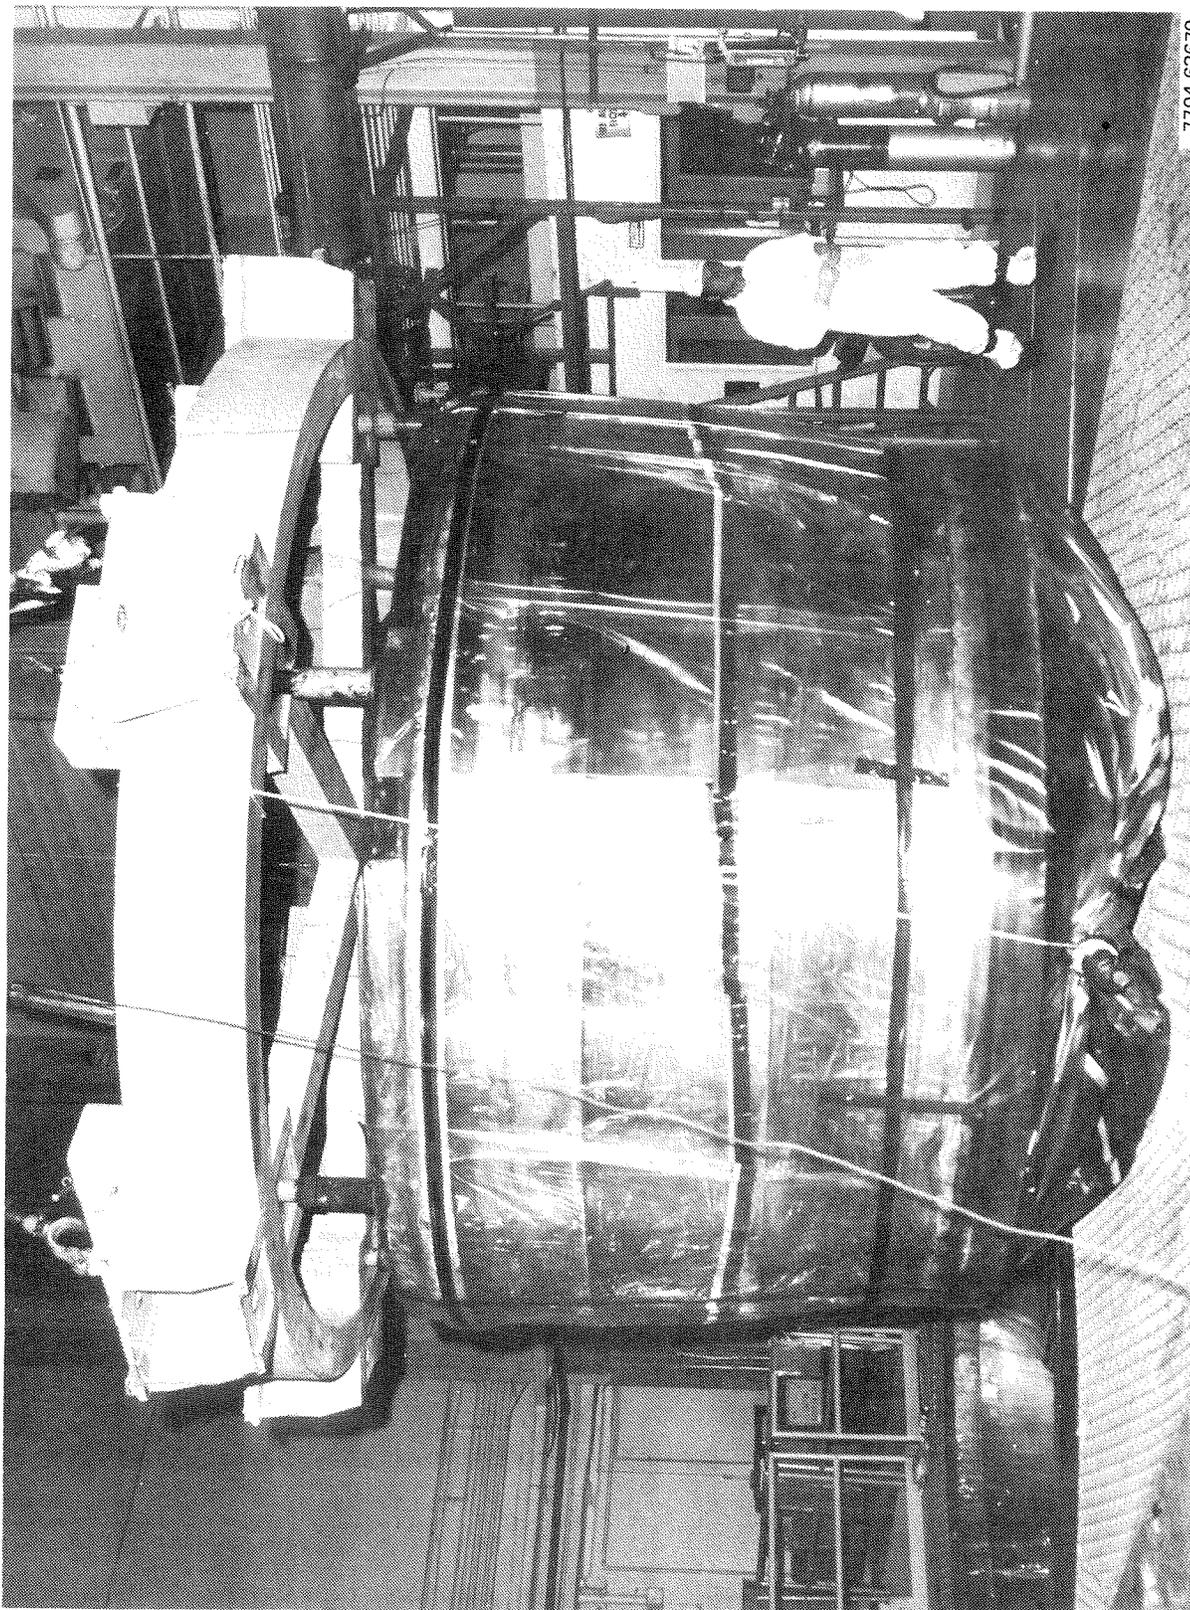
Figure 26. 140-in.-diameter Plug Removal

shields were then removed, boxed, and transferred to the RMDF for further disassembly and to react residual sodium (Figure 27). The plug was then decontaminated, painted, and wrapped for disposal without further size reduction. Figure 28 shows the 140-in.-diameter shield plug being shipped for disposal.

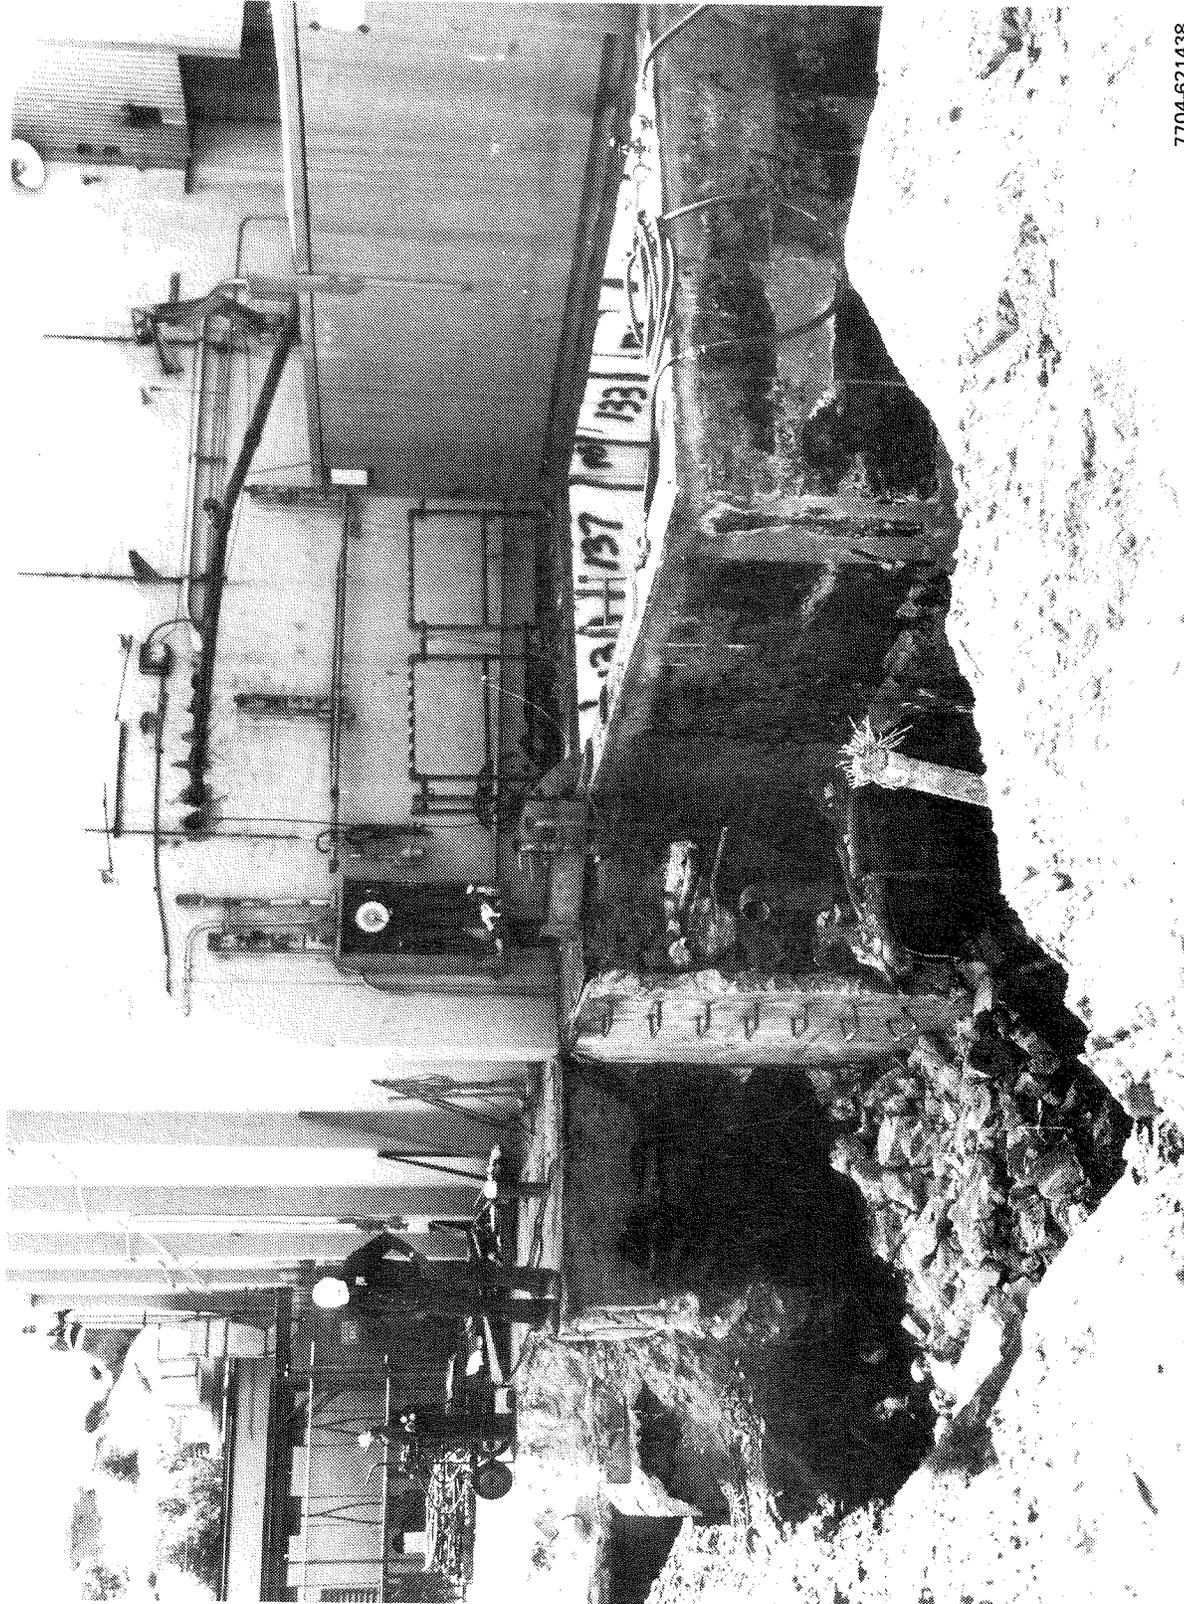
Figure 46. Initial Excavation at Northeast Corner of the SRE High Bay

During this excavation, contamination above the Table 3 limits was found in the soil surrounding the footing at the northeast corner of the high bay. Further excavation uncovered contamination as high as 13,000 pCi/g located in cracks in the bedrock east and north of the high bay (see Figure 48). Figure 49 shows the excavation along the east face of the building. Contaminated

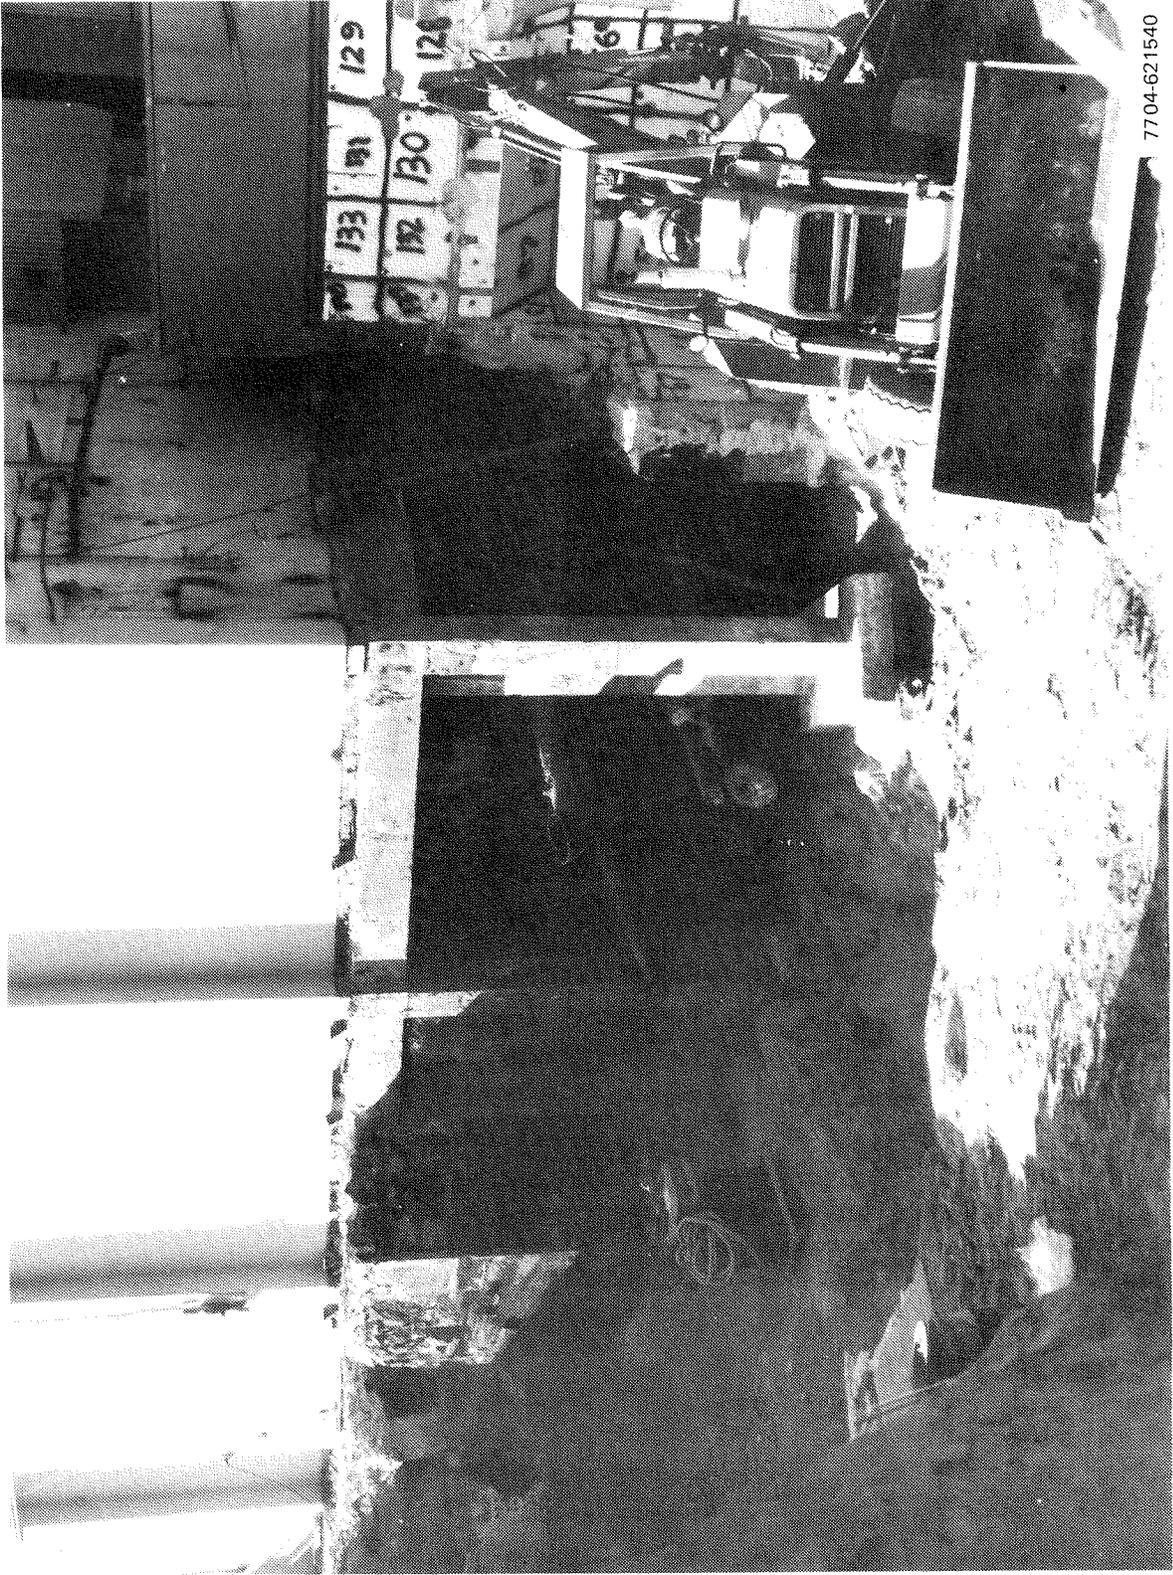
7704-621540

Figure 49. Excavation East of SRE High Bay

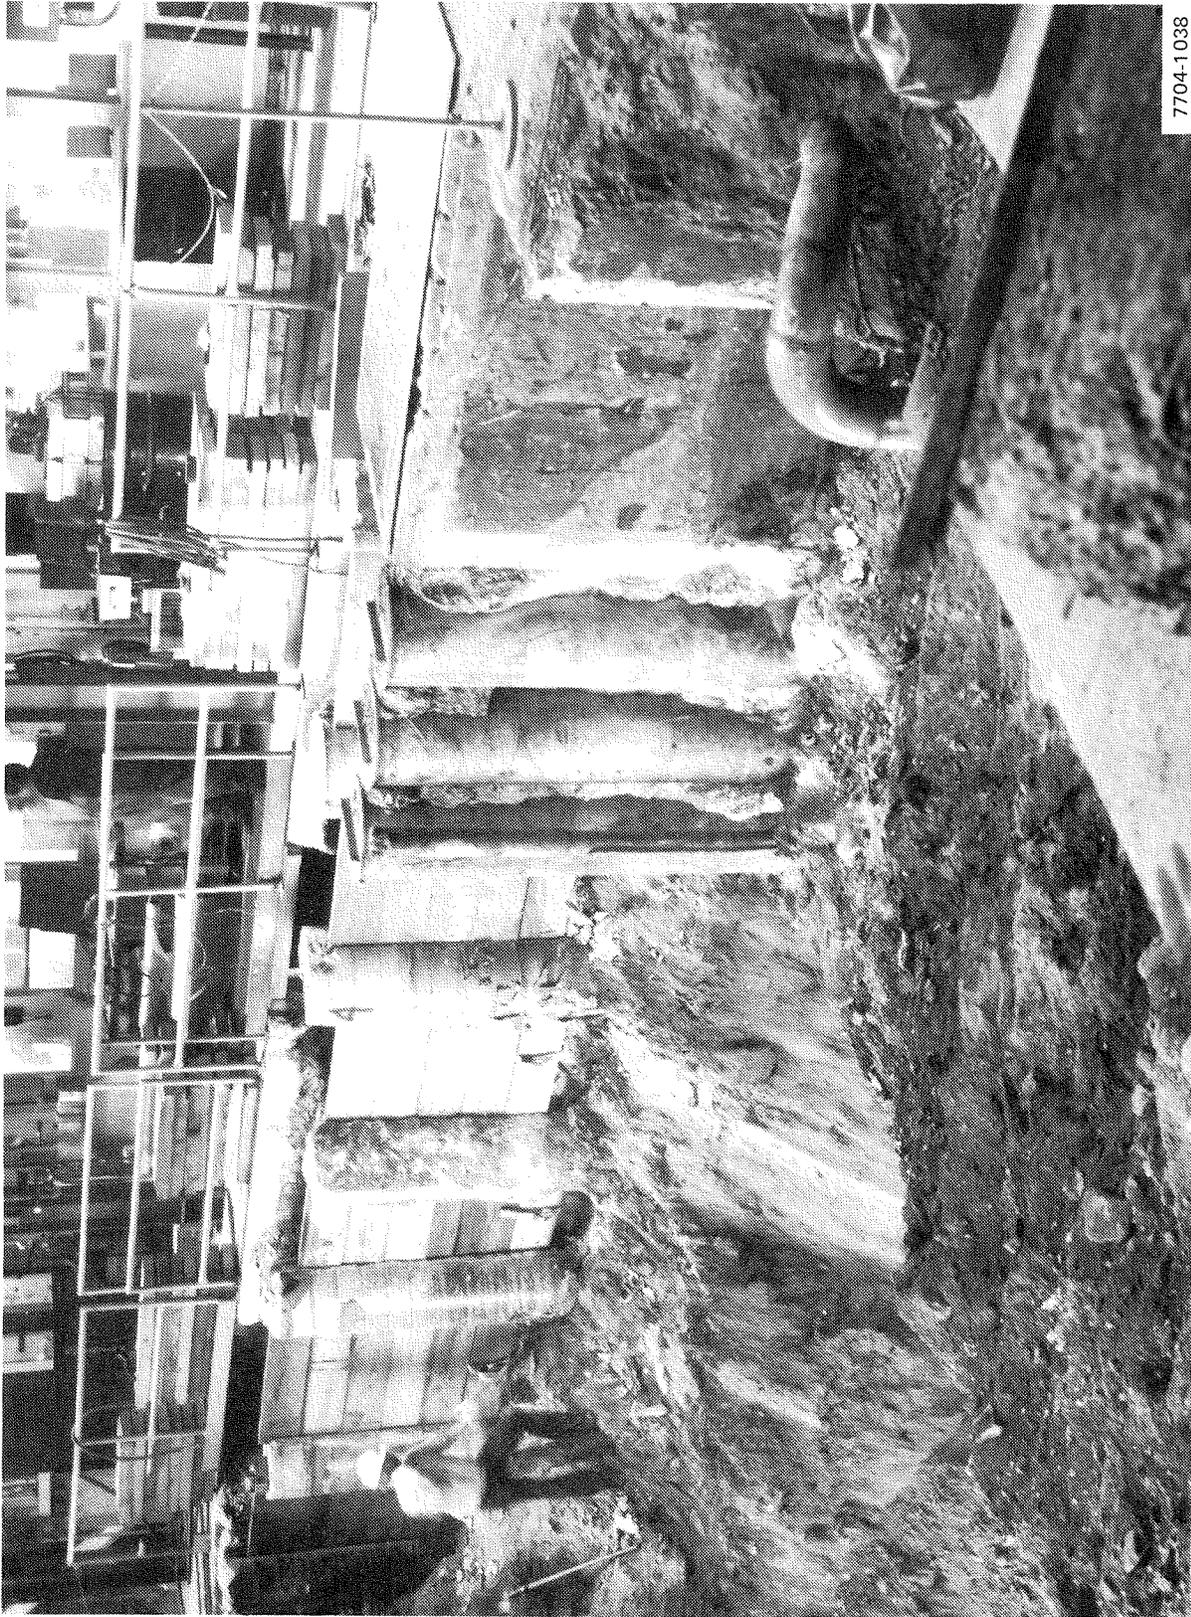
7704-1038

Figure 53. Installation of Wooden Shoring in High-Bay Retaining Wall

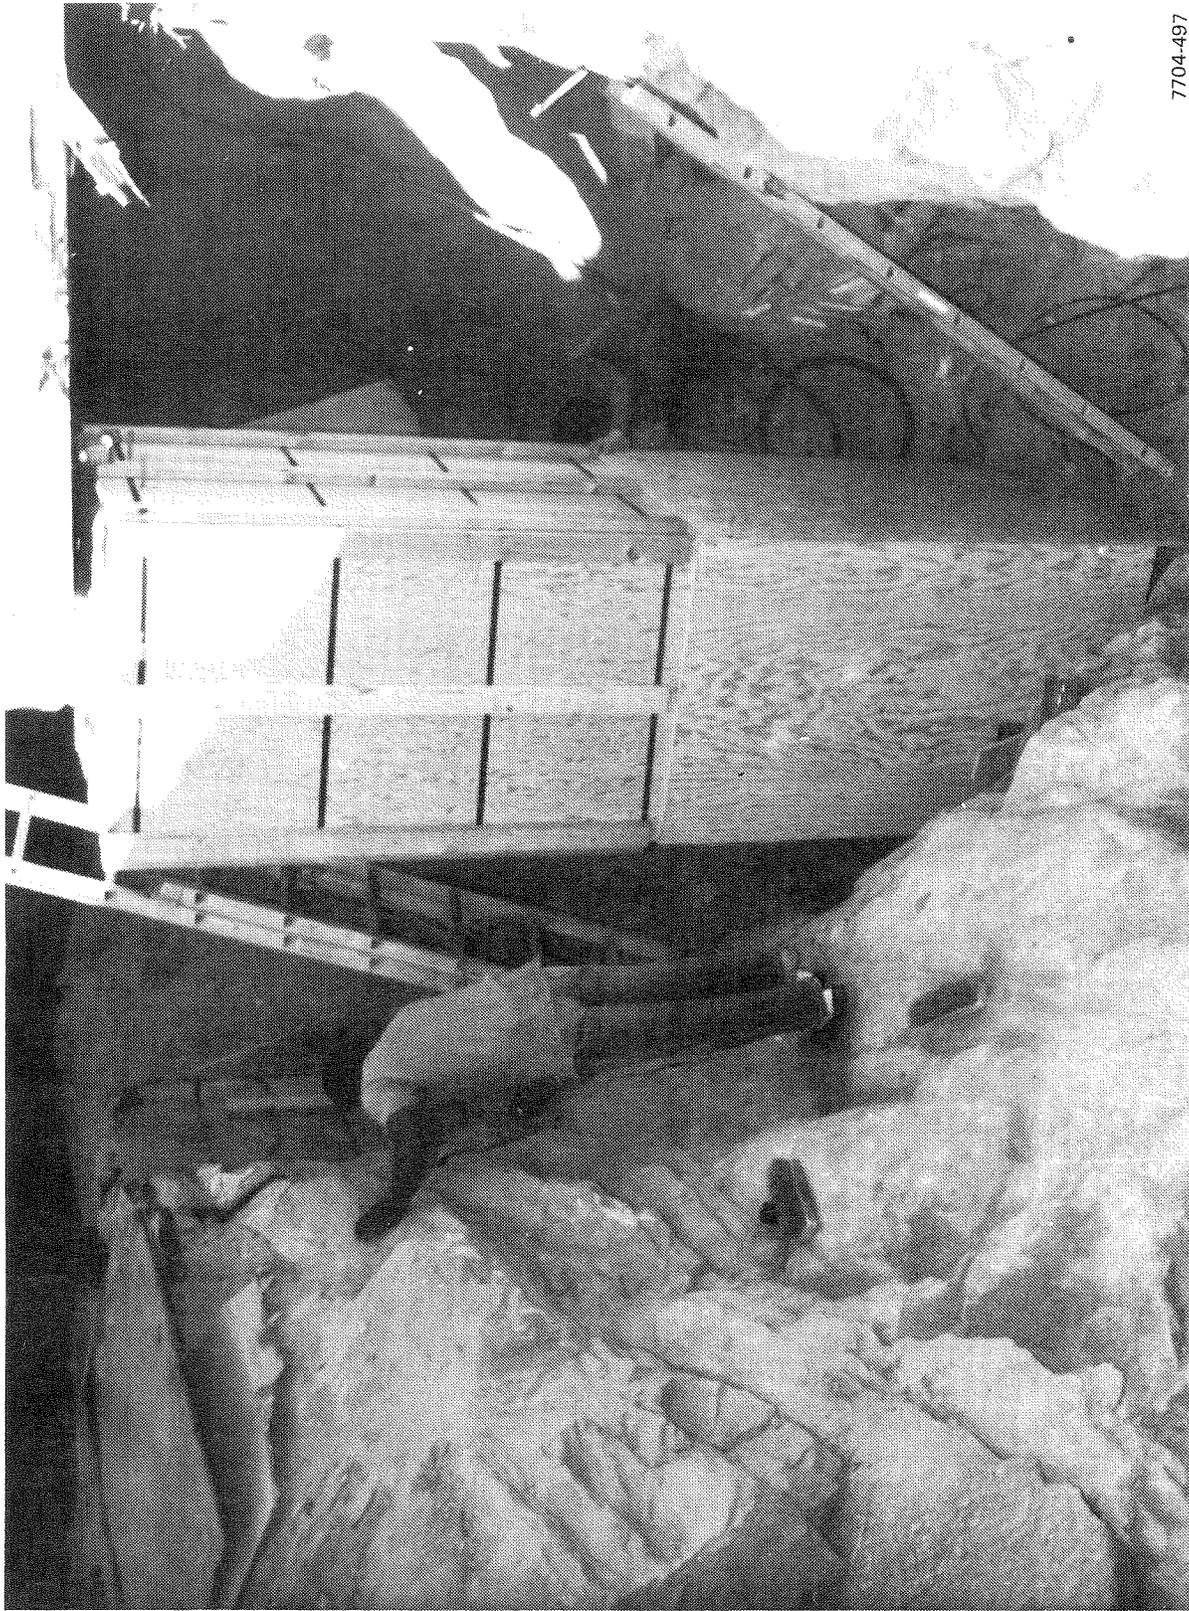
7704-497

Figure 56. Construction of Form for Replacement Foundation under High-Bay Column 11D

The excavation east of Column 11D was opened once access through this area was no longer required. The contaminated bedrock directly under the column footing was removed and a new concrete foundation was installed. Excavation of contaminated soil was continued east of the facility. A 6- by 10- by 12-ft-deep hole was excavated below Column 11D to remove all of the contaminated bedrock. Figure 56 shows a part of this excavation.

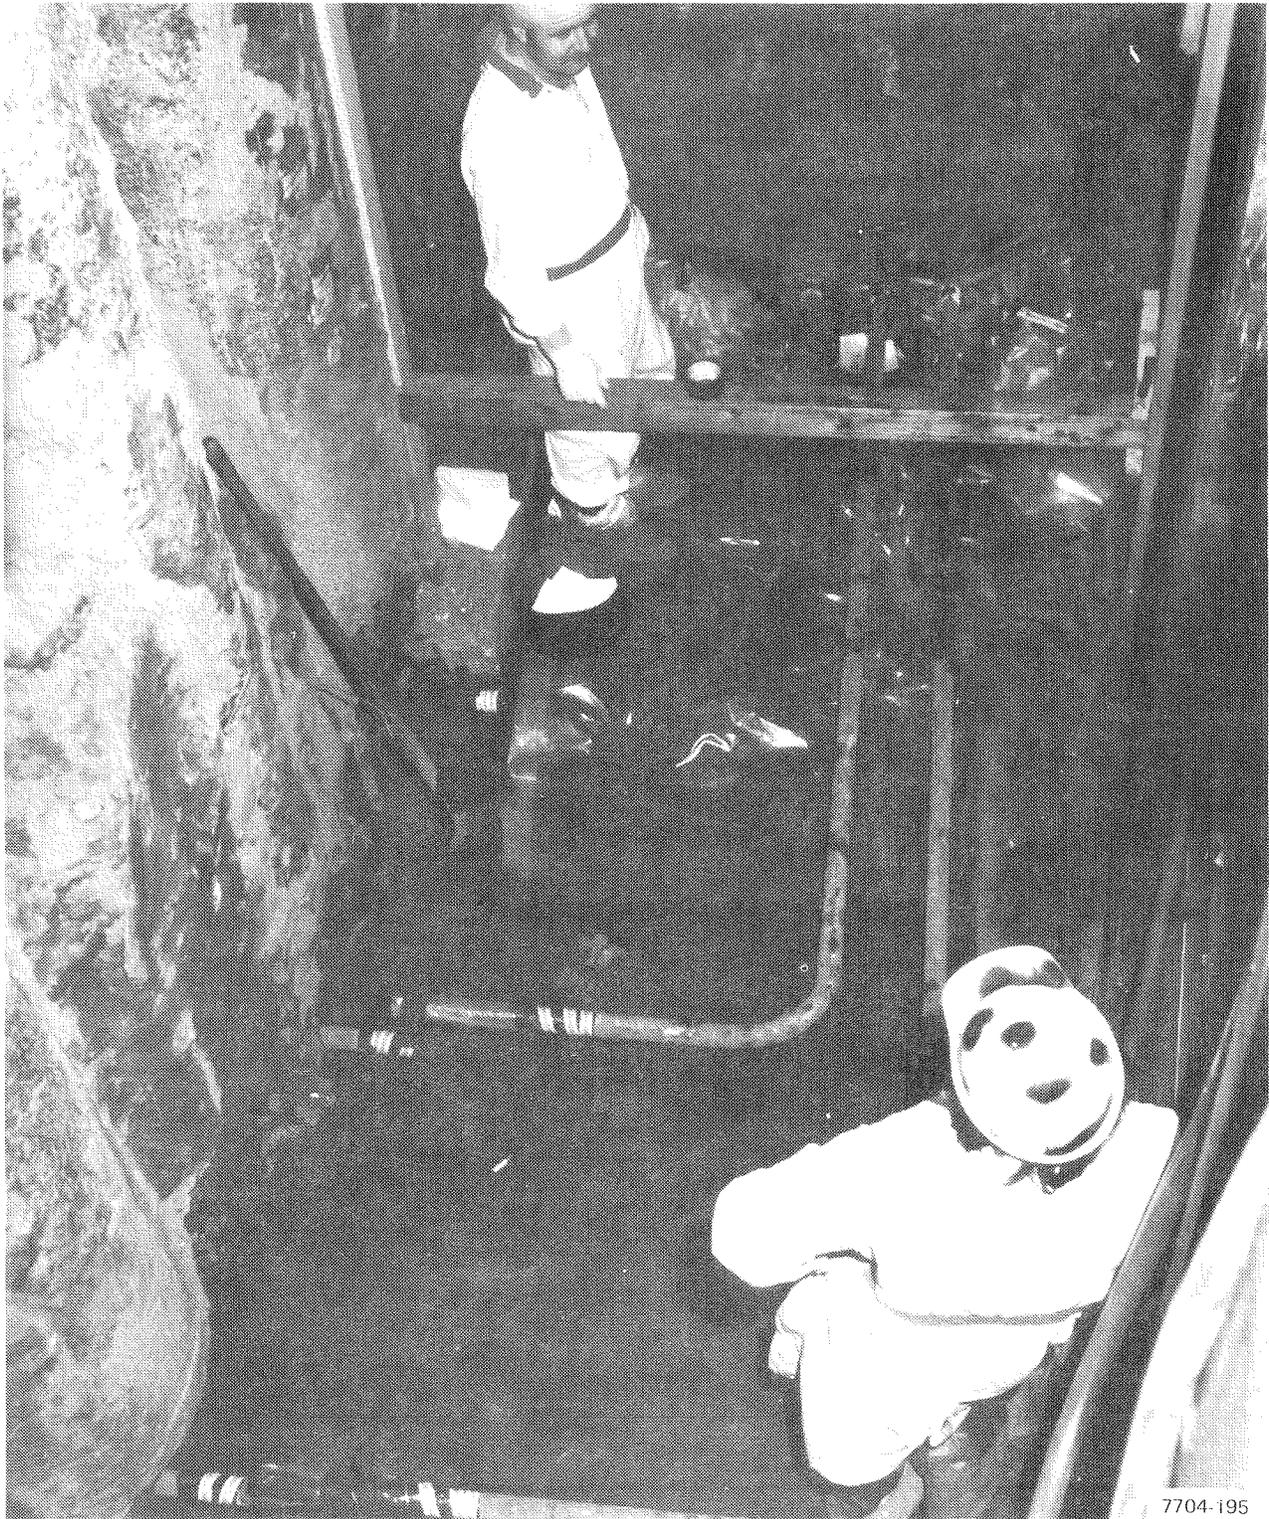
Figure 64. Wash Cell Drain Line Removal

When the sleeves were uncapped, they were found to contain 2 to 4 ft of water. Analysis of samples indicated levels above the maximum permissible concentration for mixed fission products. The small side diameter of the sleeves made decontamination of the interior surface virtually impossible. It was decided to remove the sleeves. The Hy-Ram was used to expose the top section of the two units. It quickly became apparent that the small backhoe/Hy-Ram combination would not be capable of excavating a hole deep enough to reach the bottom of the sleeves. The preliminary excavation also showed that the two units were most likely encased in concrete for their entire length.

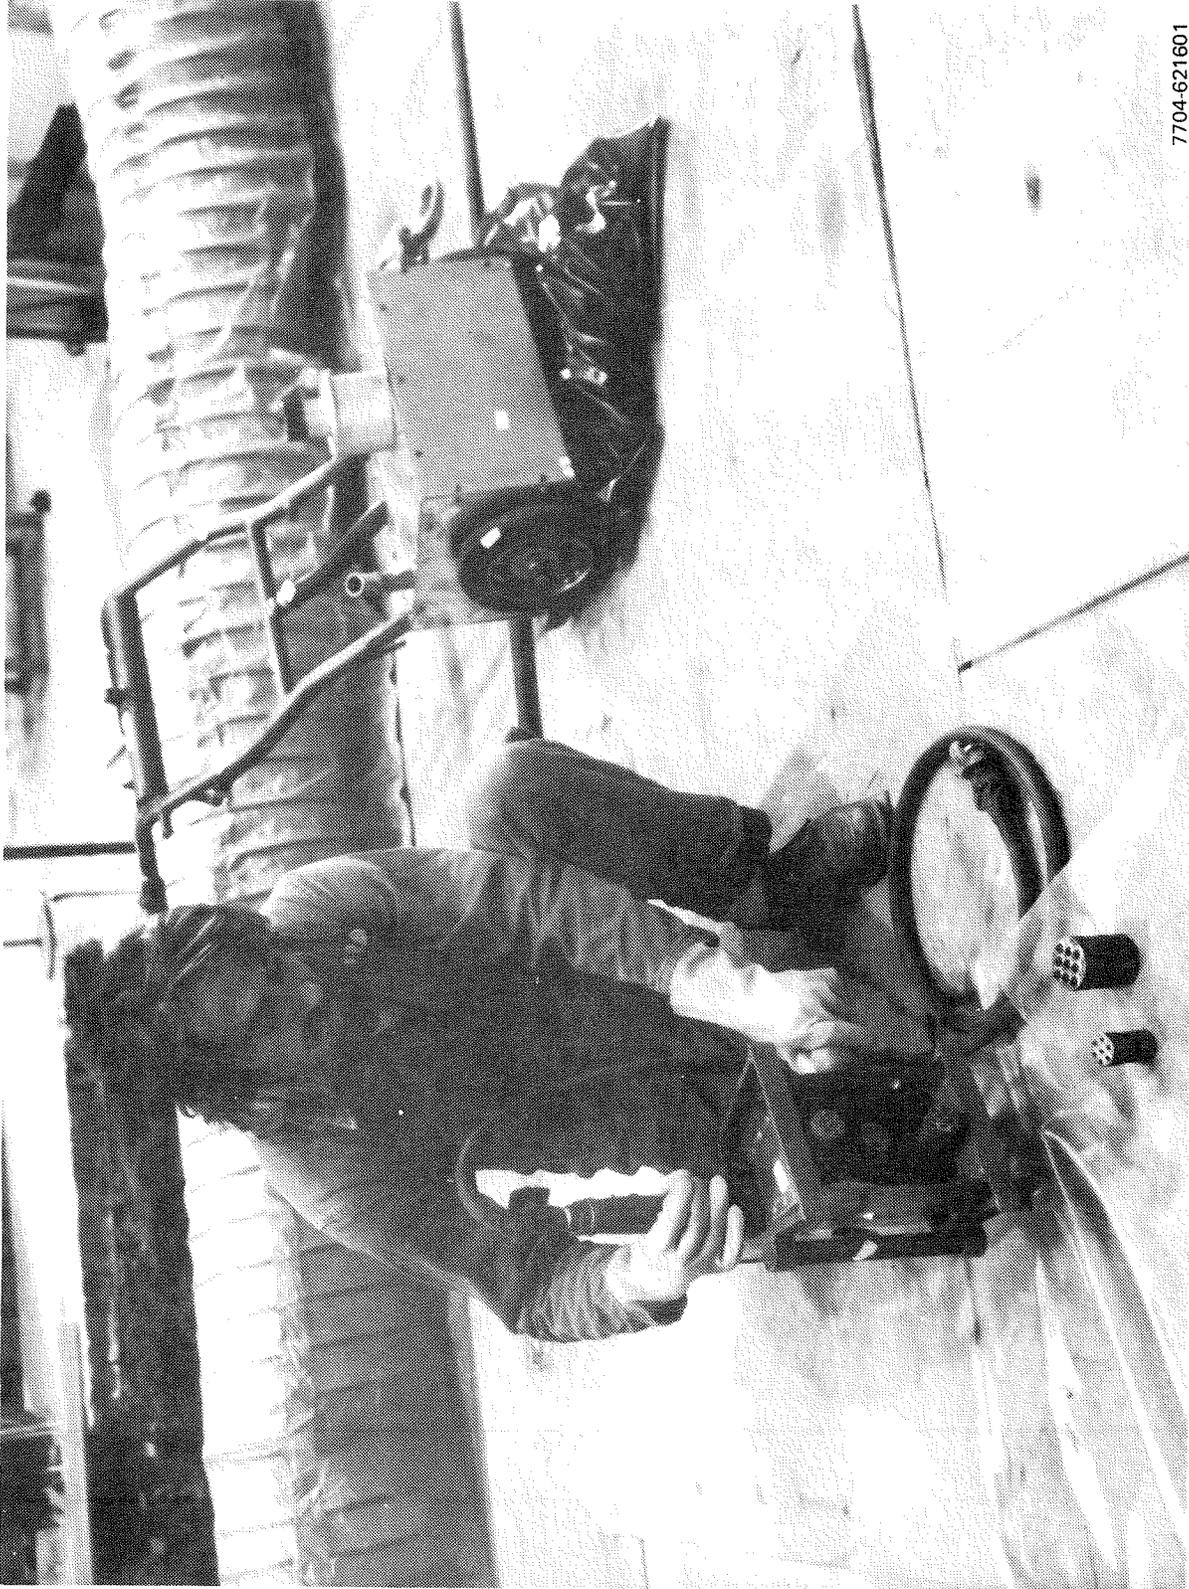
7704-621601

Figure 79. Floor Scabblers Used at SRE

The best and most versatile tool was found to be a scabbler. The scabbler is an air-driven, multiheaded concrete scarifying tool. Figure 79 shows two units: a three-headed hand-held model and a five-headed floor model. In actual use, the smaller hand-held unit was preferred. A guard was installed over the sides, and the hose from a portable radioactive vacuum system was

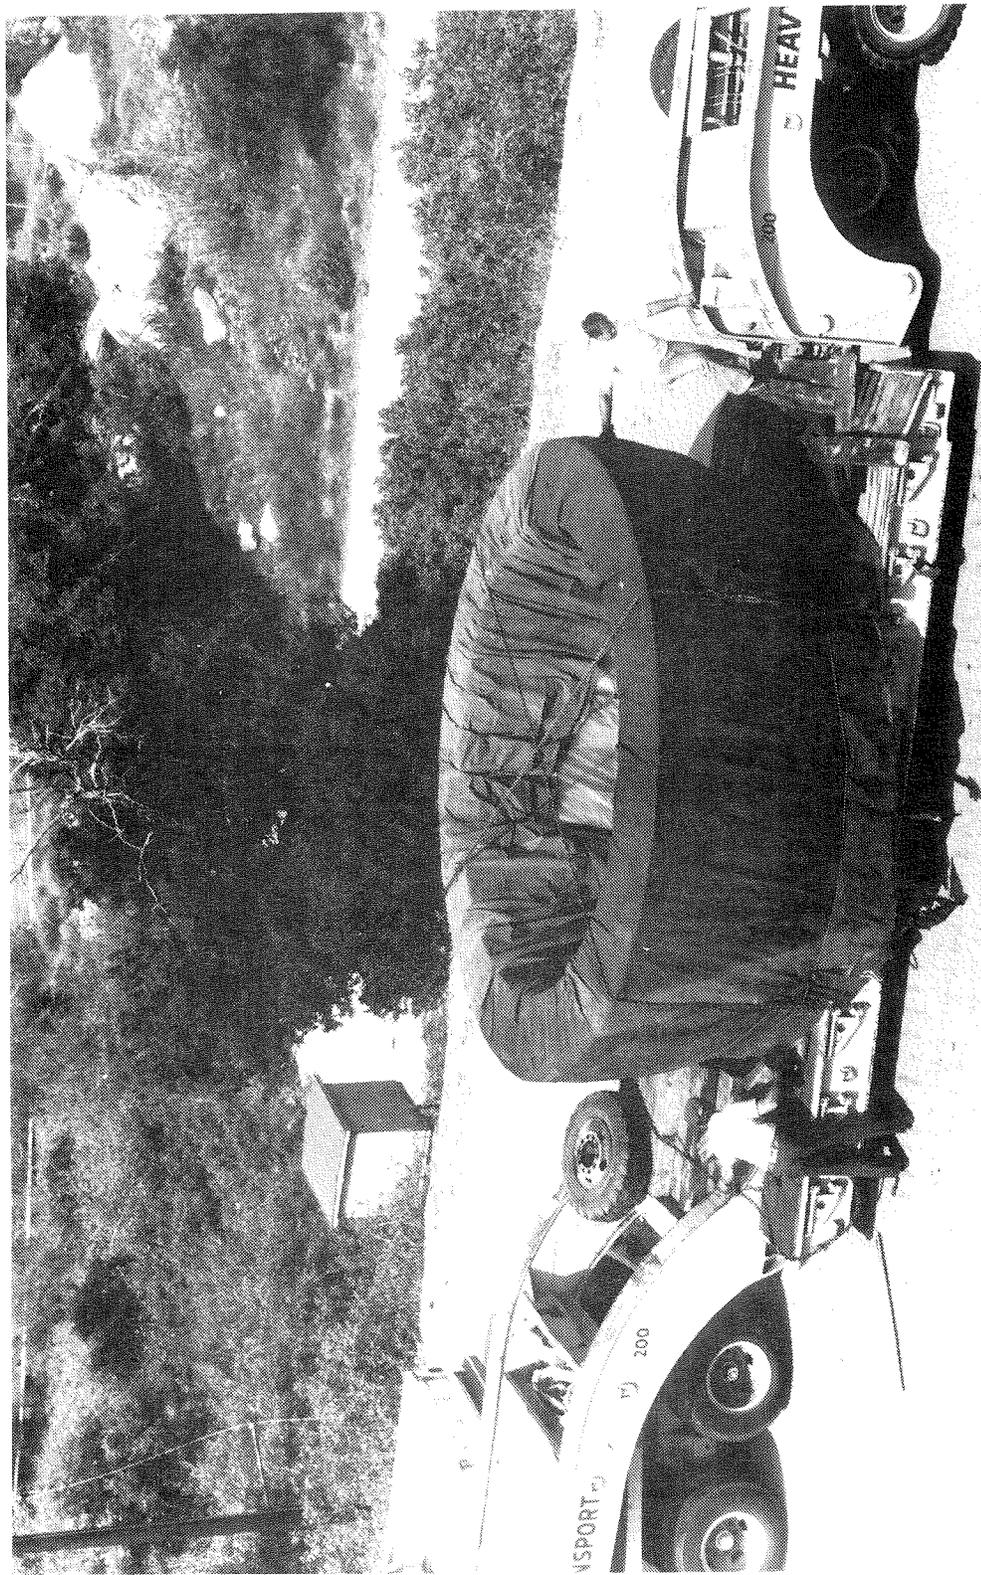
7704-62810

Figure 80. Ring Shield on Transport Vehicle

Transportation of radioactive waste from the SRE site was contracted to carriers licenced to receive and transport radioactive materials. Normally, a shipment was transported in a covered trailer 40 ft or 44 ft long. The quantity of each shipment was restricted by a 40,000-lb weight limit. Special transport vehicles were required to ship oversize or overweight loads. Figure 28 shows the reactor vessel shield plug being shipped to burial. Figure 80 shows the ring shield on a special transport vehicle. Radioactive waste from the SRE was shipped to two burial sites.

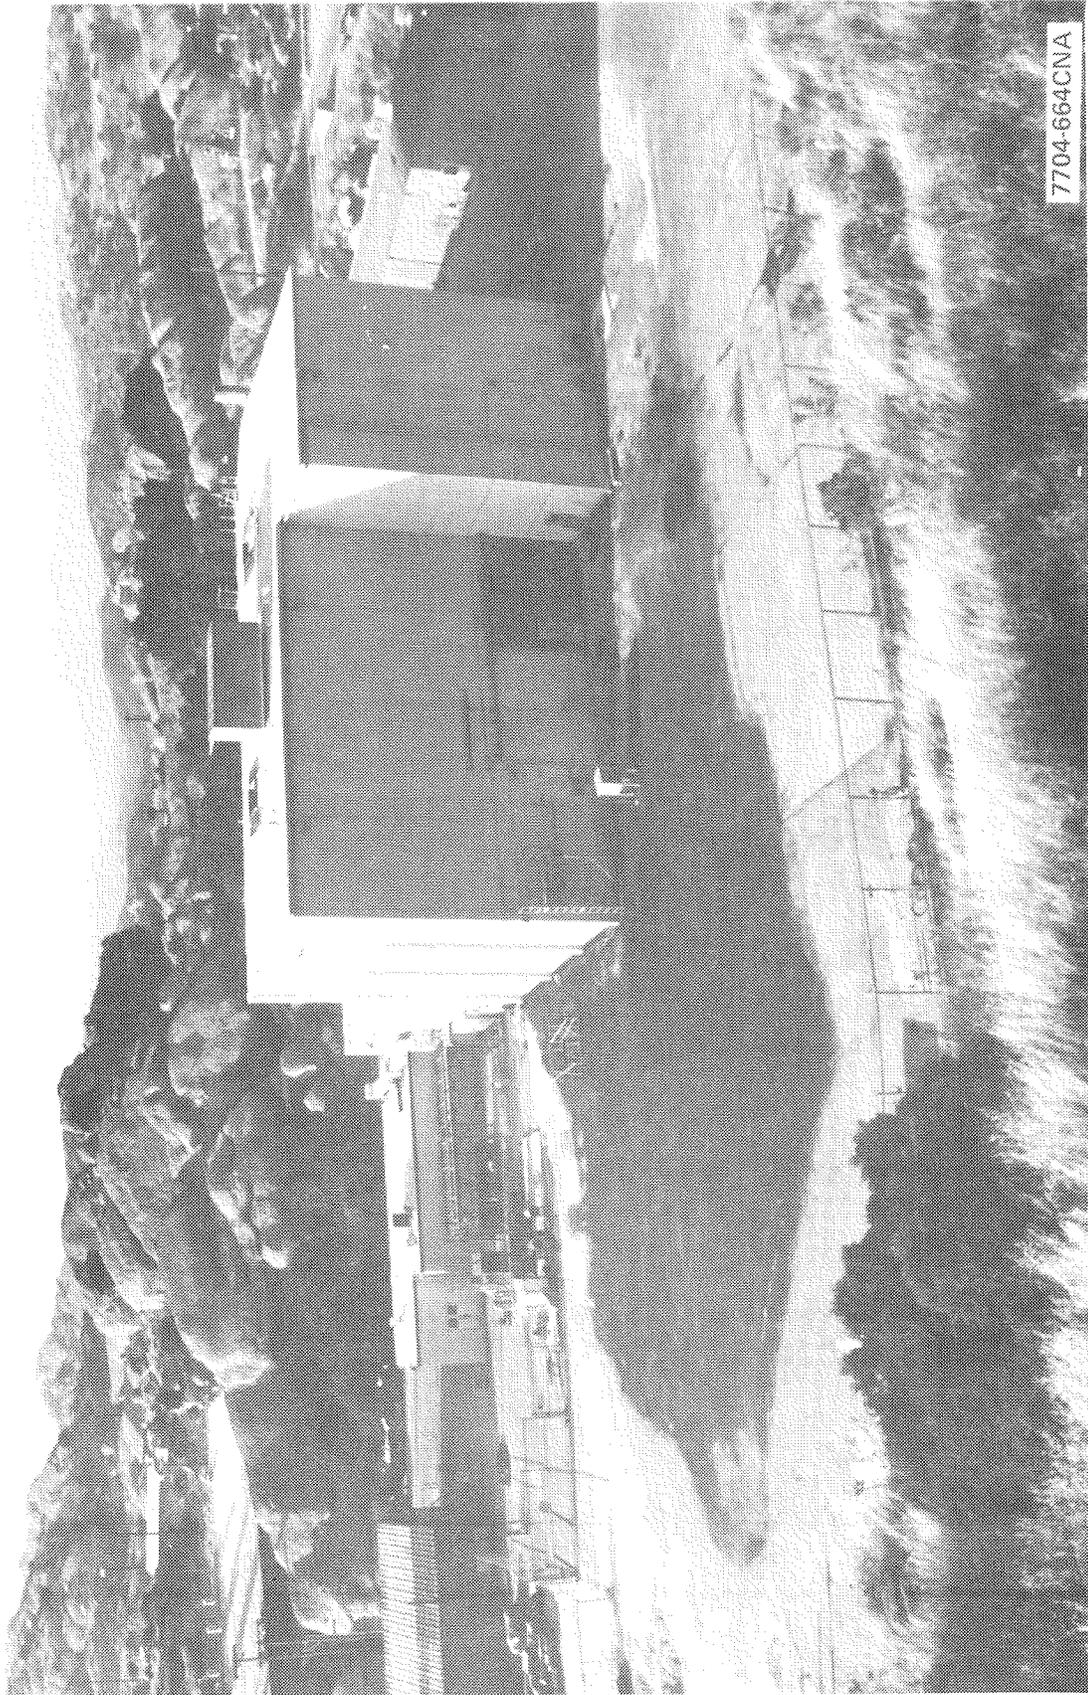
Figure 87. SRE at Completion of Decommissioning

The excavations were backfilled with clean soil and rubble, and the area was paved. The reactor room walls and ceiling were decontaminated by sand-blasting. The SRE interior was repainted, the floor was repoured, and lighting fixtures were replaced.
