GO Number 97055	S/A Number 37154	Page 1 of 24	Total Pages 24	Rev. Ltr/Chg. No. See Summary of Chg. N/C	Number EID-04364
Program Title CLOSURE OF ETEC (R21-RF)					
Document Title FINAL REPORT DECONTAMINATION & DECOMMISSIONING OF INTERIM STORAGE FACILITY 4654					
Document Type D&D Report			Related Documents		
Original Issue Date 5-27-99		Release Date RELEASE 5-27-99 W		Approvals	
Prepared By/Date <i>Satish N. Shah</i> Satish N. Shah / May 20, 1999		Dept. 117	Mail/Addr T038	Date	
IR&D Program? Yes <input type="checkbox"/> No <input checked="" type="checkbox"/>		If Yes, Enter Authorization No.		R. D. Meyer <i>RDMeyer</i> 5-25-99 P. H. Horton <i>[Signature]</i> 5/25/99 S. E. Reeder <i>Sam Reeder</i> 5-25-99 P. D. Rutherford <i>P. D. Rutherford</i> 5/26/99 M. E. Lee <i>RDMeyer M. Lee</i> 5/26/99	
Distribution			Abstract

The Decommissioning work of 4654 was documented in ESG-DOE-13507 "Interim Storage Facility Decommissioning Final Report" in 1985 (Ref. 1). This report updates the information provided in the Decommissioning Final Report.

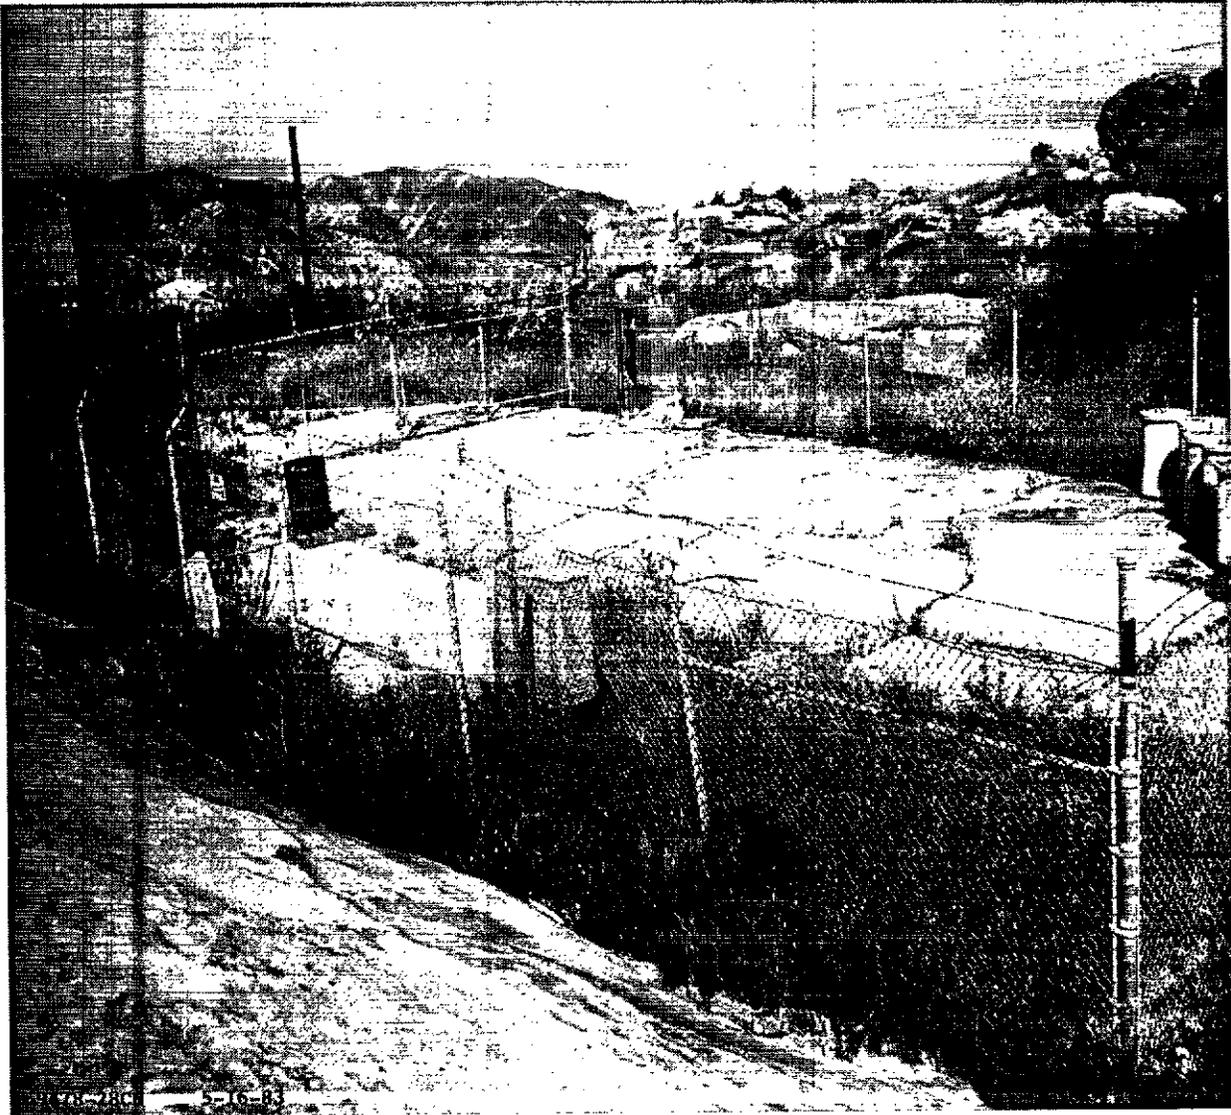
Figure 2-5. Interim Storage Facility (4654)

The Interim Storage Facility (4654) (Figure 2-5) included eight 20-inch diameter galvanized steel tubes, extending 25 feet into 32-inch diameter bore holes drilled into rock strata. The top portions of the storage tubes were encased in a common concrete trench and berm structure, and the bottom ends were seal-welded closed. See Figure 4-1 on page 15. The remainder of the ISF fenced-in area measured 65 feet by 40 feet and was paved with approximately 2-inch thick asphalt.

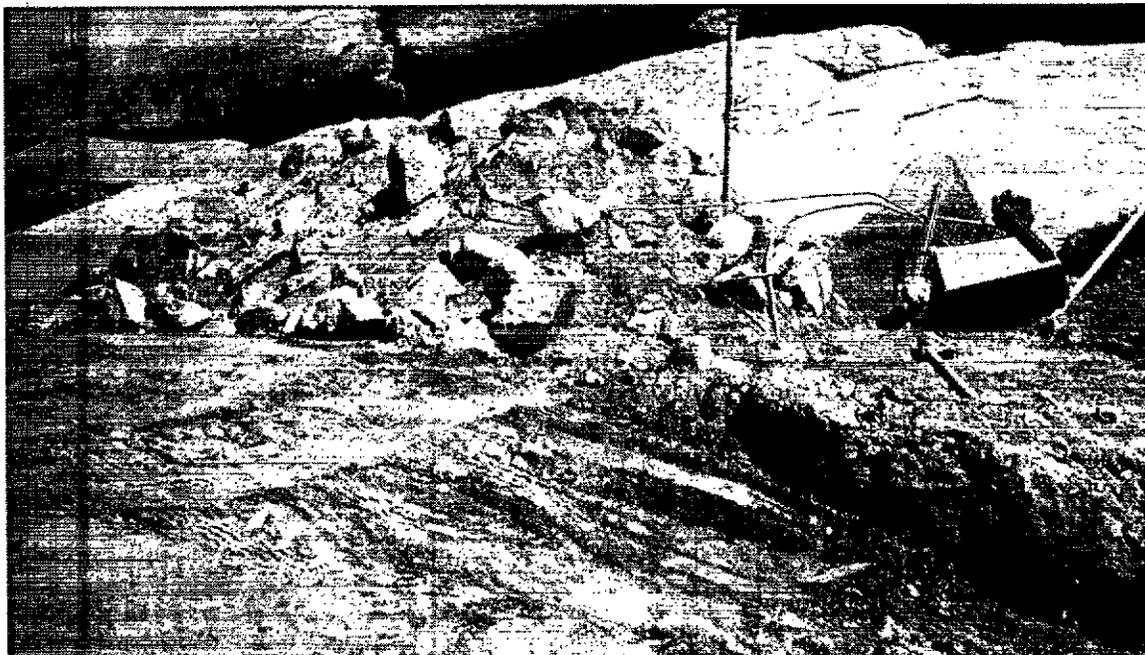
Figure 4-3. Broken Concrete Retention Area

The first excavation operation required removing the concrete that contained the upper portion of the storage tubes. This clean material was temporarily stored (after survey) in a retention area (Figure 4-3), then later used for backfill material.

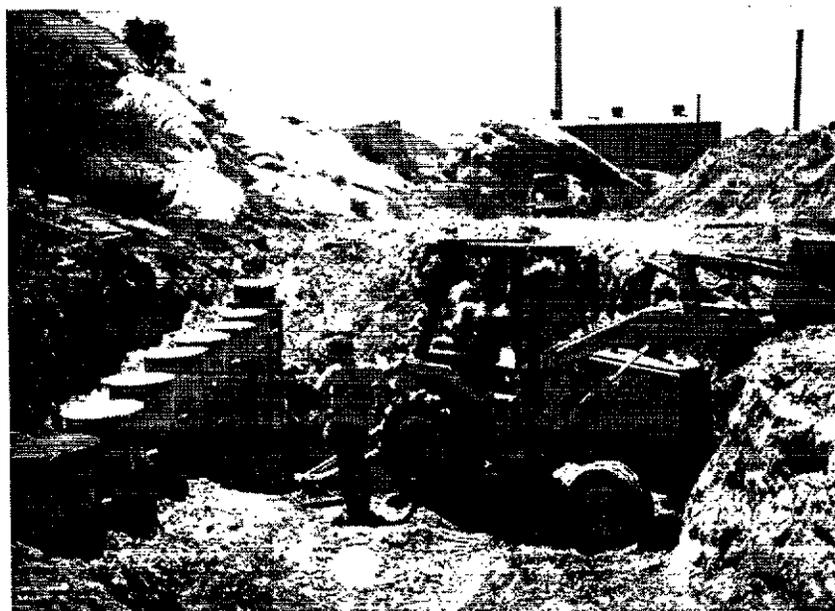
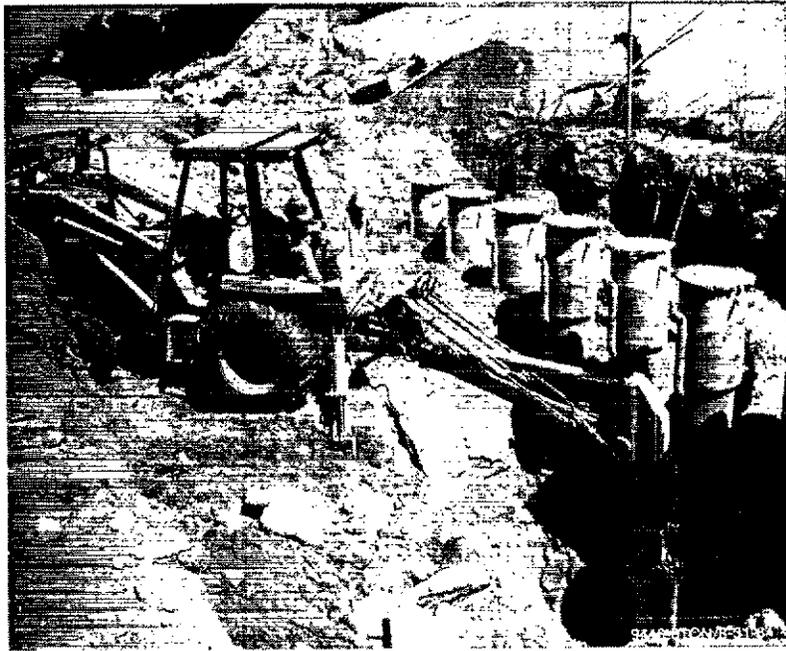
The excavation of soil and rock from the north side of the storage tubes exposed the tubes for removal (Figures 4-4 and 4-5) to a depth of 23 feet. During the excavation operation, at approximately 15 feet, the hydraulic hammer mounted on the end of a backhoe being used to excavate the area punctured storage tube 7 (see Figure 4-6). The storage tube and the surrounding area were surveyed and verified to be free of contamination. All the dirt and rock removed during this operation were found to be free of contamination and were stored and later used as backfill material. Samples were analyzed for Co-60, Cs-137, and other gamma emitters (Ref. 1).

Figure 4-4. Soil and Rock Retention Area

Figure 4-5. ISF Excavation Staging Trench

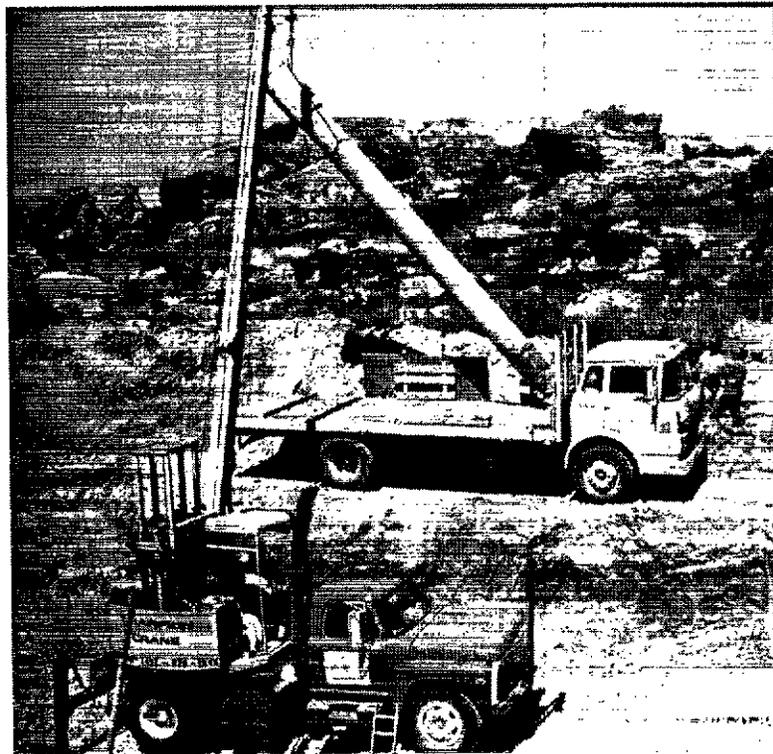
A mobile crane was used to transfer each storage tube to a flatbed truck for transport to the RMHF (Figures 4-7 and 4-8). As each storage tube was removed, it was surveyed, and verified to be externally free of contamination. As an extra precaution, a plastic bag was placed around the lower section to prevent the potential spread of contamination during transit. A soil sample was taken from each of the emptied boreholes as the tube was removed. These samples were analyzed for Co-60, Cs-137, and other gamma emitters. Results were found to be less than the then release criterion of 100 pCi/g gross detectable activity (Ref. 1, section 4.7).

Figure 4-7. ISF Storage Tube Removal

Figure 4-8. ISF Storage Tube Transfer

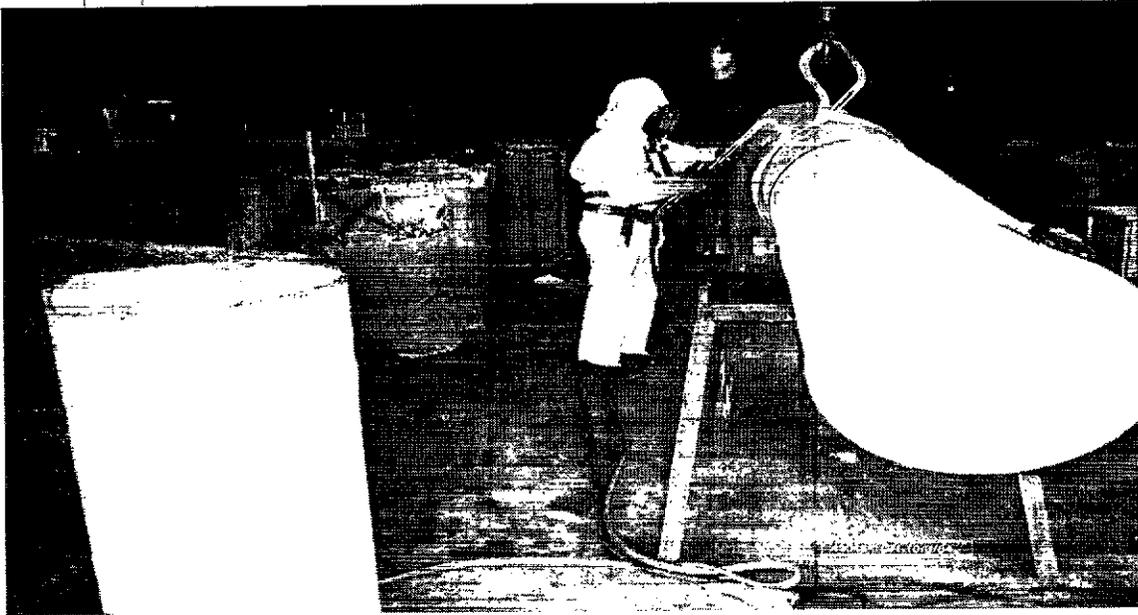
The 25-foot-long fuel element baskets and storage tubes were transferred to the RMHF for size reduction and packaging. Both the storage tubes and baskets were sectioned into approximately 4-foot lengths using an oxygen acetylene cutting torch in Building 021. Figures 5-1 and 5-2 show the cutting operation. A special prefilter smoke retention housing was fabricated to prevent the facility's absolute filters from plugging with the large amount of particulate matter generated during the cutting activity. The tube and basket sections were packaged in 12 wooden containers and also shipped as LSA waste to the DOE-Hanford site for disposal.

Figure 5-1. ISF Storage Tube Cutting

Figure 5-2. ISF Storage Tube Cutting
