**NUCLEAR MATERIALS
DEVELOPMENT FACILITY
DECOMMISSIONING
FINAL REPORT**

DOE Research and Development Report

Rockwell International

**CONTRACT: DE-AC03-81SF11565
ISSUED: 31 MARCH 1987**

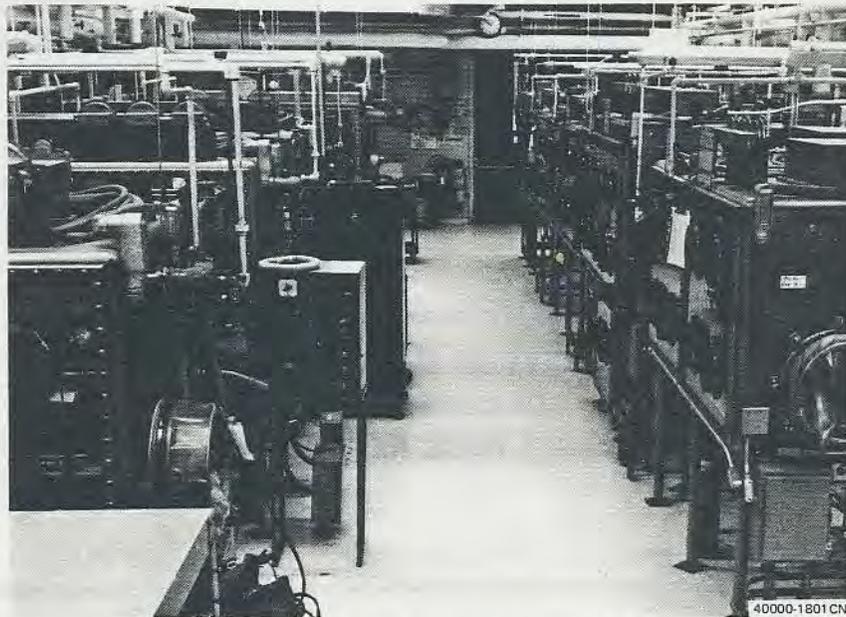
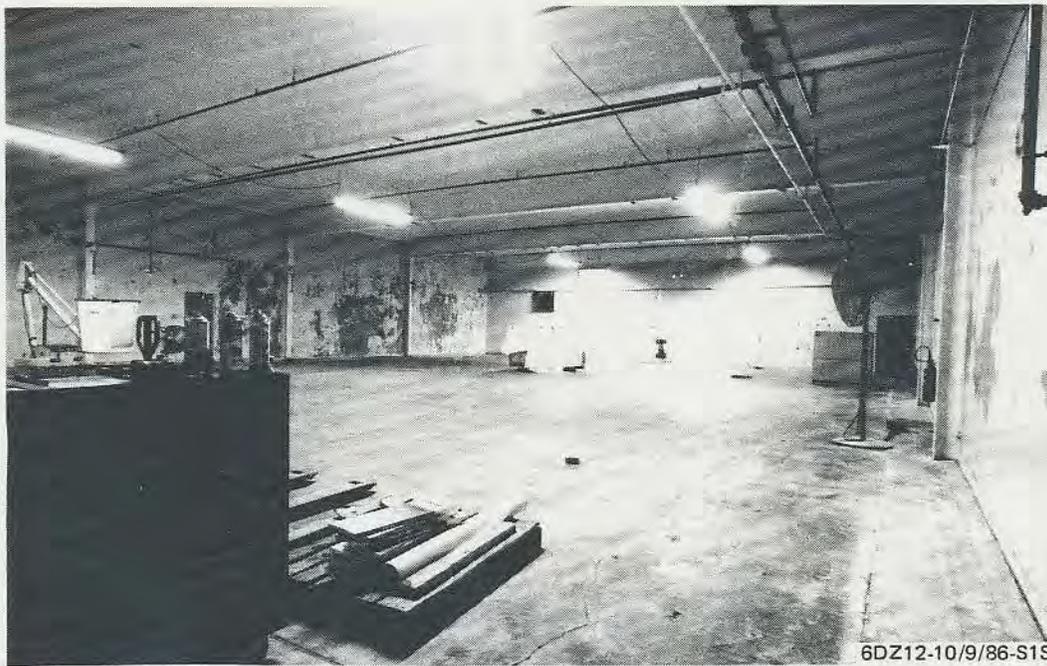
Frontispiece. Glove Box Room

(a) Prior to Decommissioning

(b) After Final Decontamination and Decommissioning

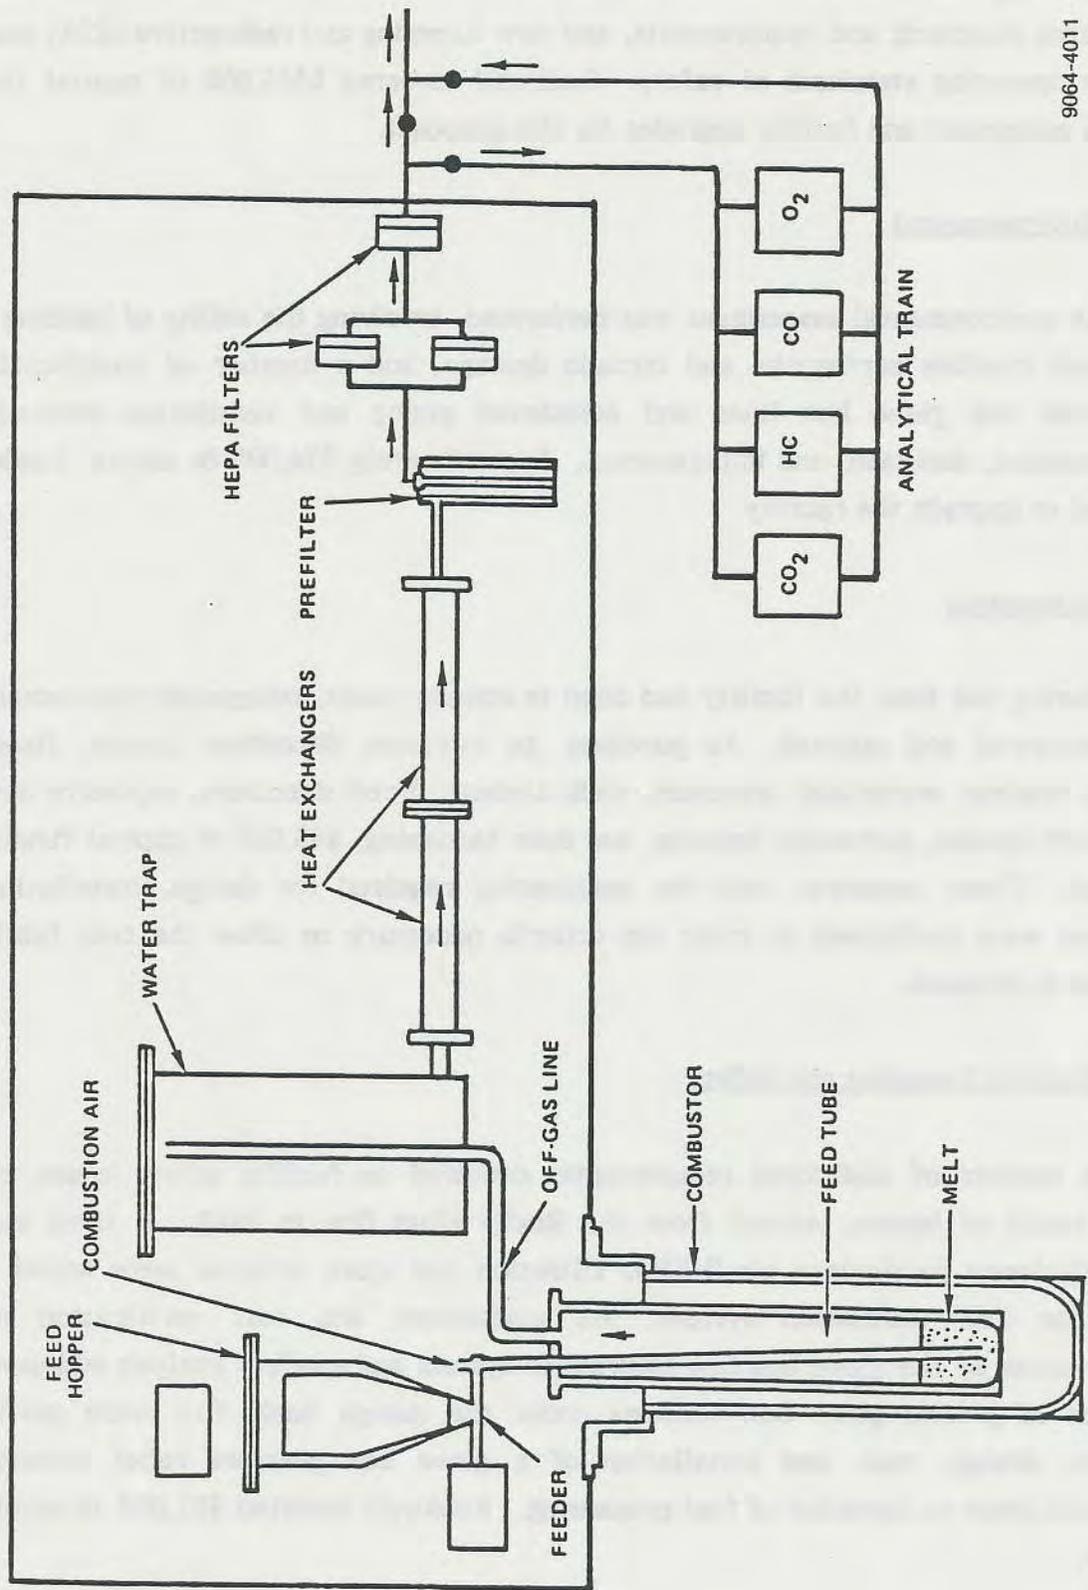
Figure 1. Bench-Scale Radwaste Combustor Flow Diagram

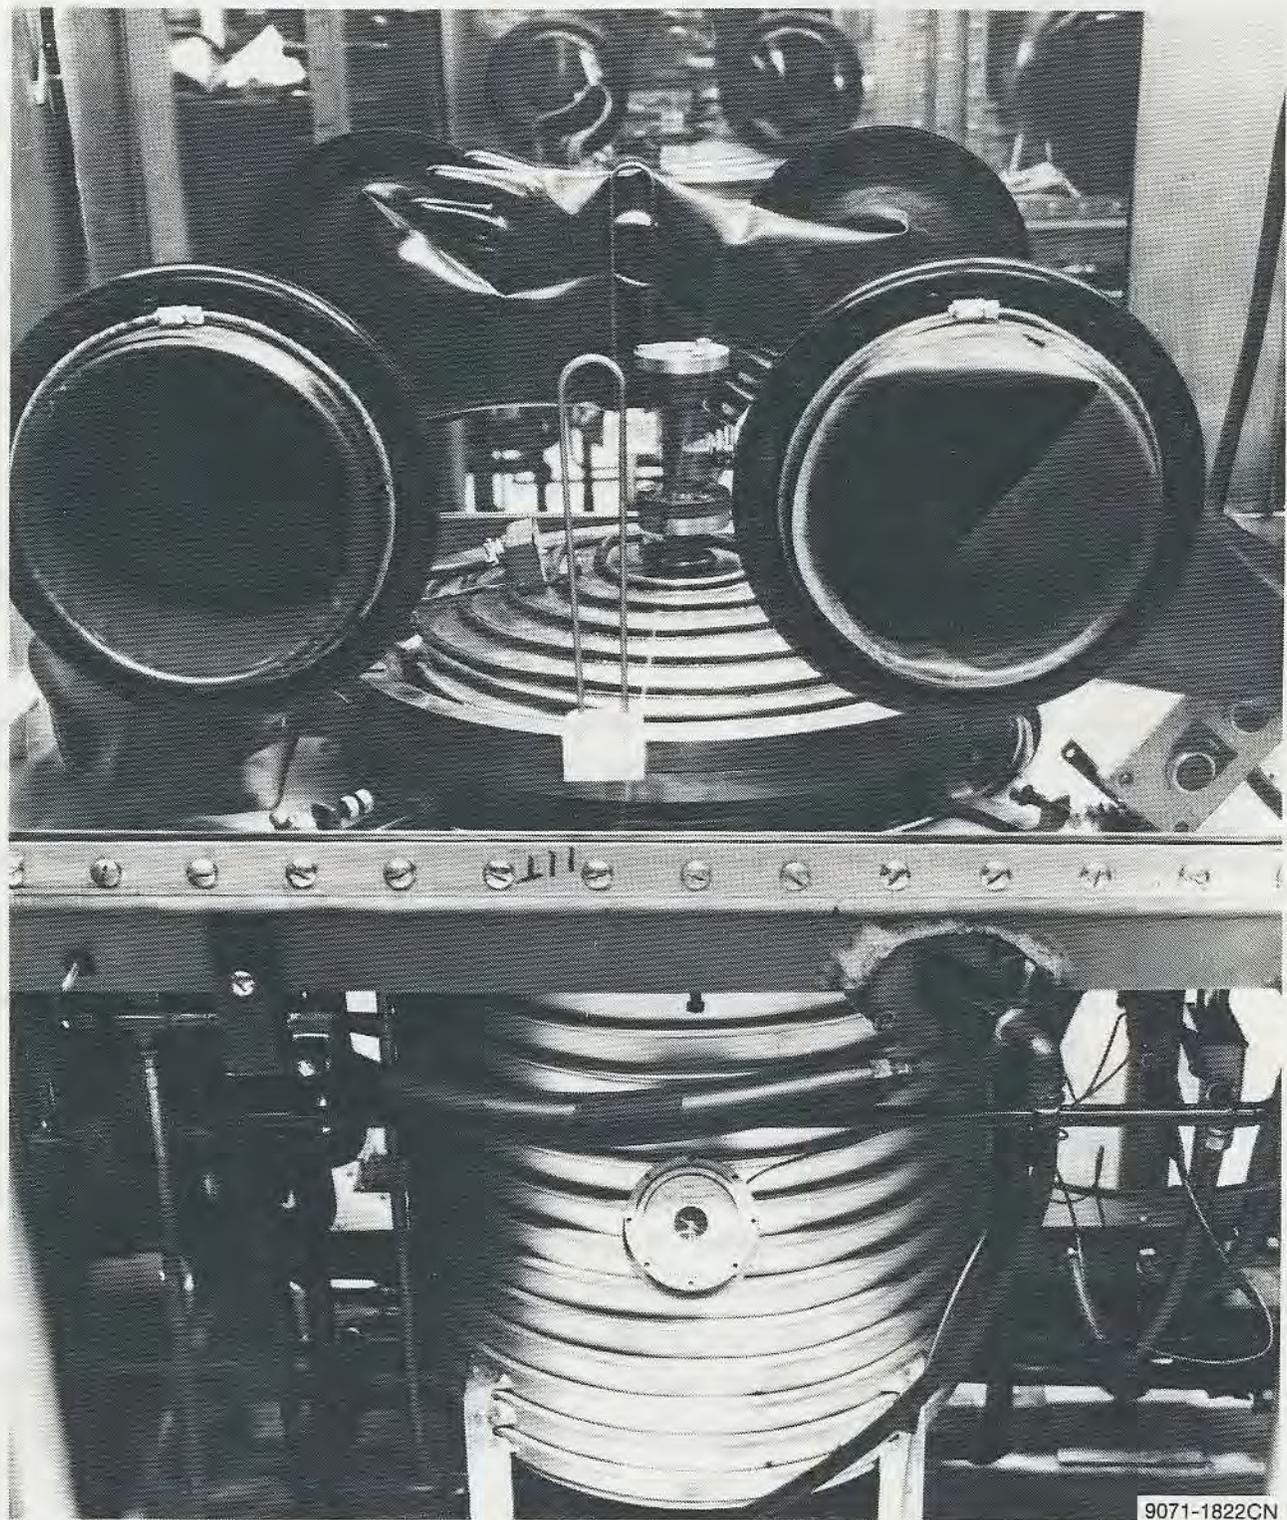
Figure 2. Fuel Pellet Sintering Furnace

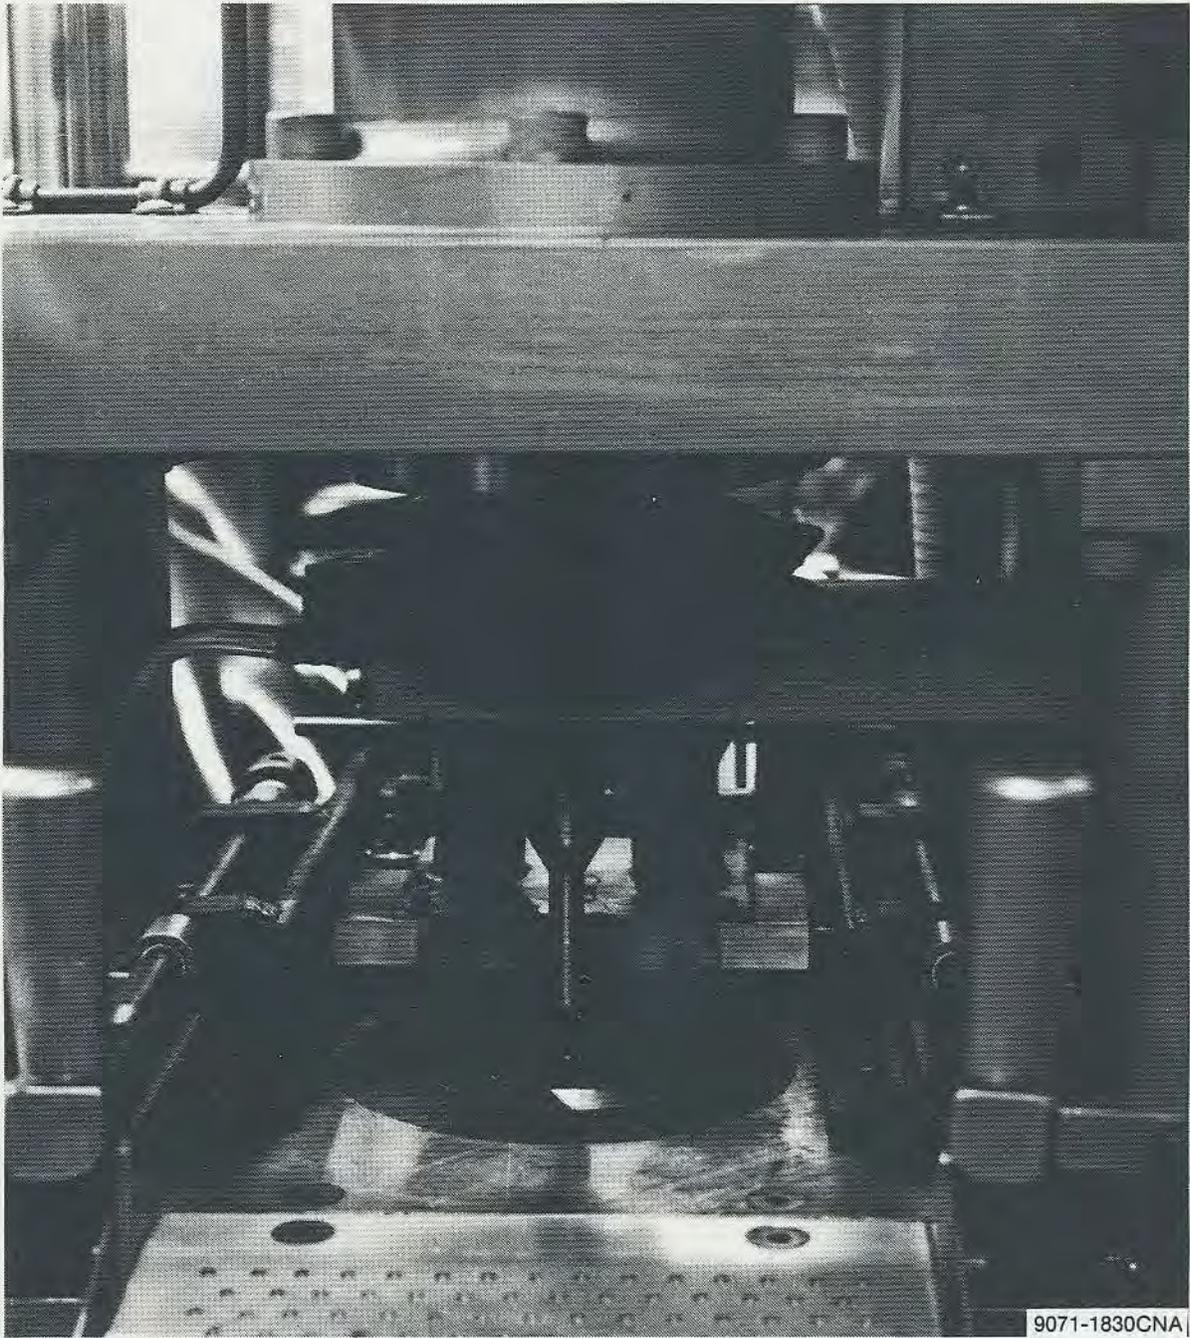
Figure 3. Automatic Pellet Press

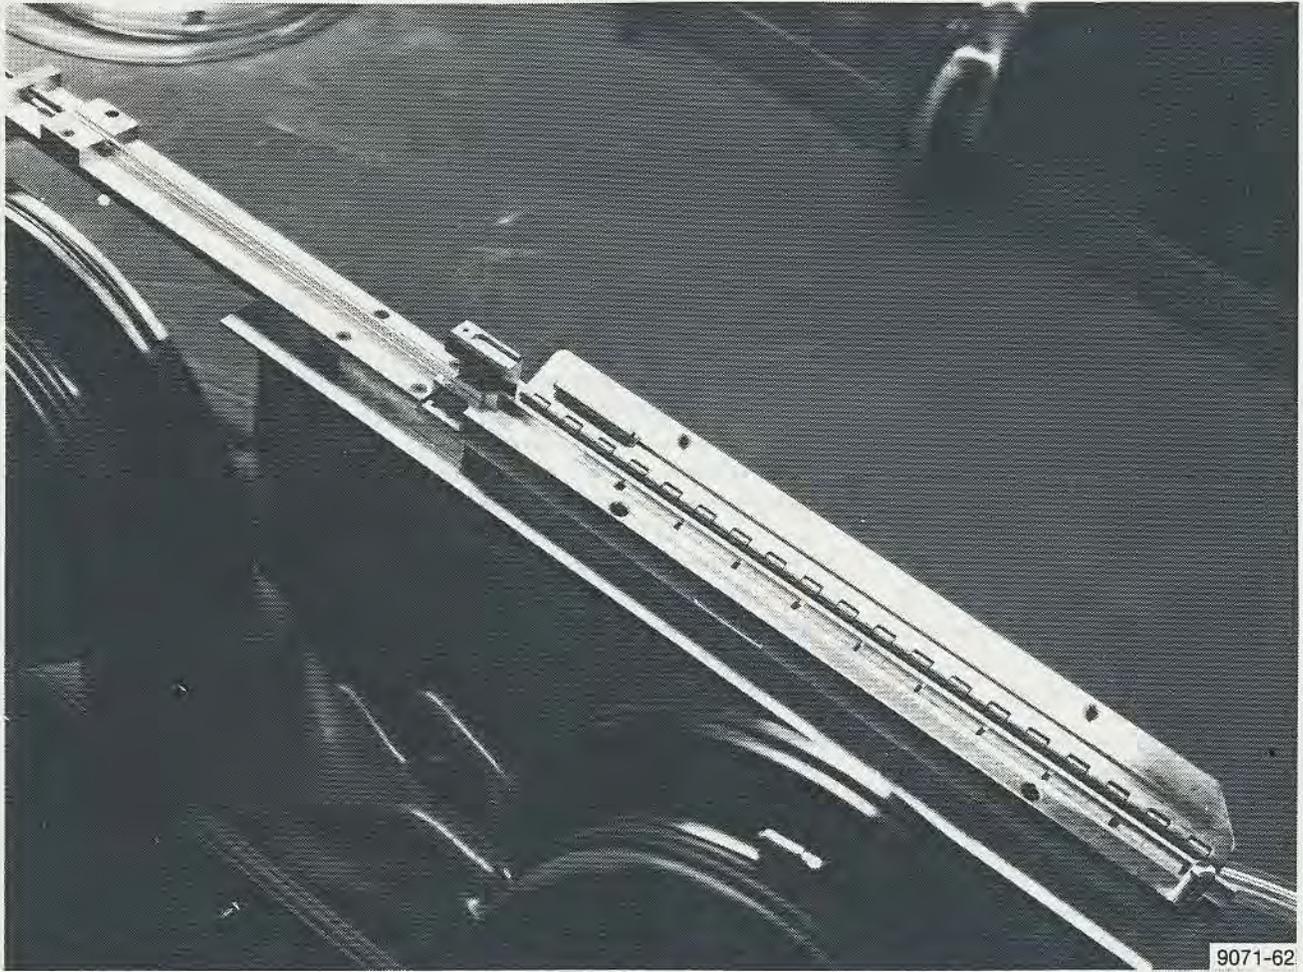
Figure 4. Loading of (U, Pu) Cx Pellets Into the Shroud

Atomics International was the responsible contractor for the AIR-1 experiment designed X276 when irradiated in the Experimental Breeder Reactor-II (EBR-II). The mixed carbide fuel had the composition shown in Table 1. The 316 stainless steel-clad fuel pins were sodium bonded and had both shrouded and unshrouded pins. Figure 4 shows the pellet loading station and Figure 5 the component parts of the fuel pin.

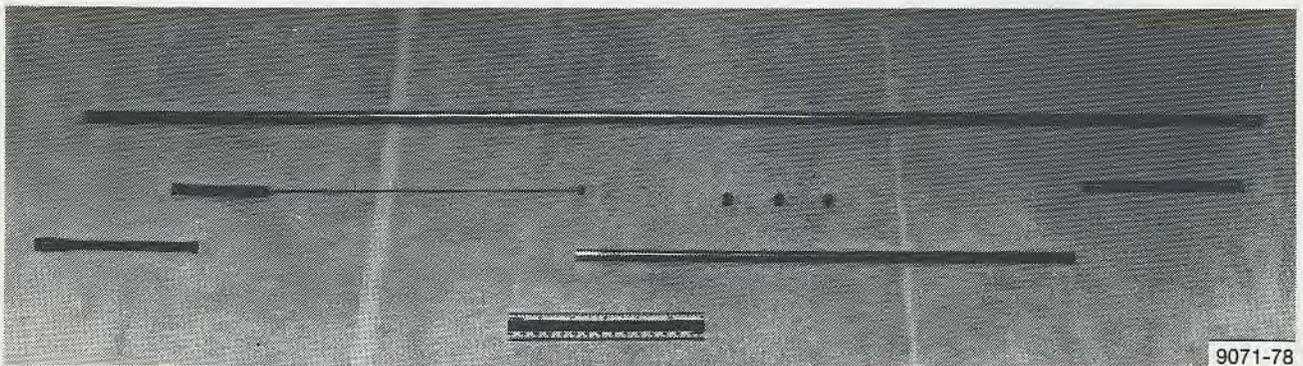
Figure 5. Advanced Fuel Systems Component Parts and Subassemblies

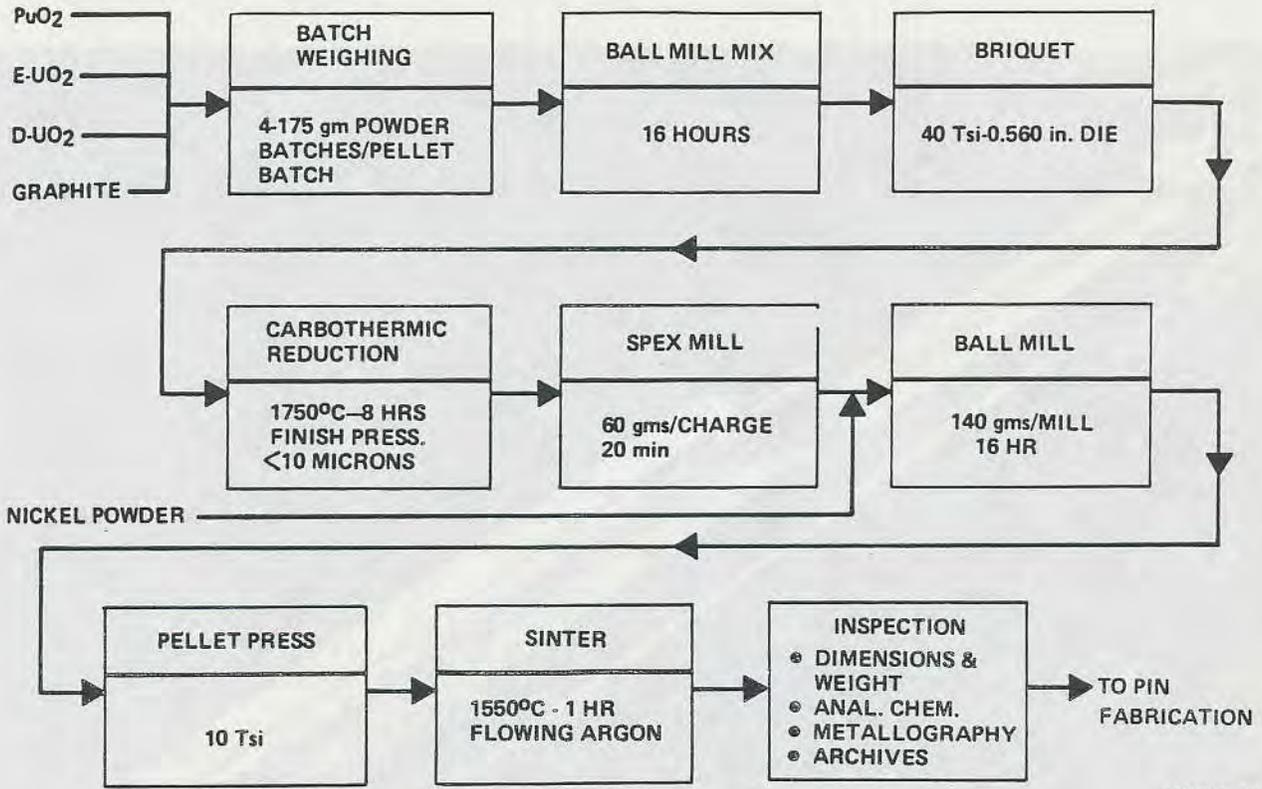
Figure 6. Advanced Fuel Systems Mixed Carbide Pellet Production, Process Flow

Flow diagrams for the fuel pellet fabrication and fuel element fabrication are shown in Figures 6 through 9.

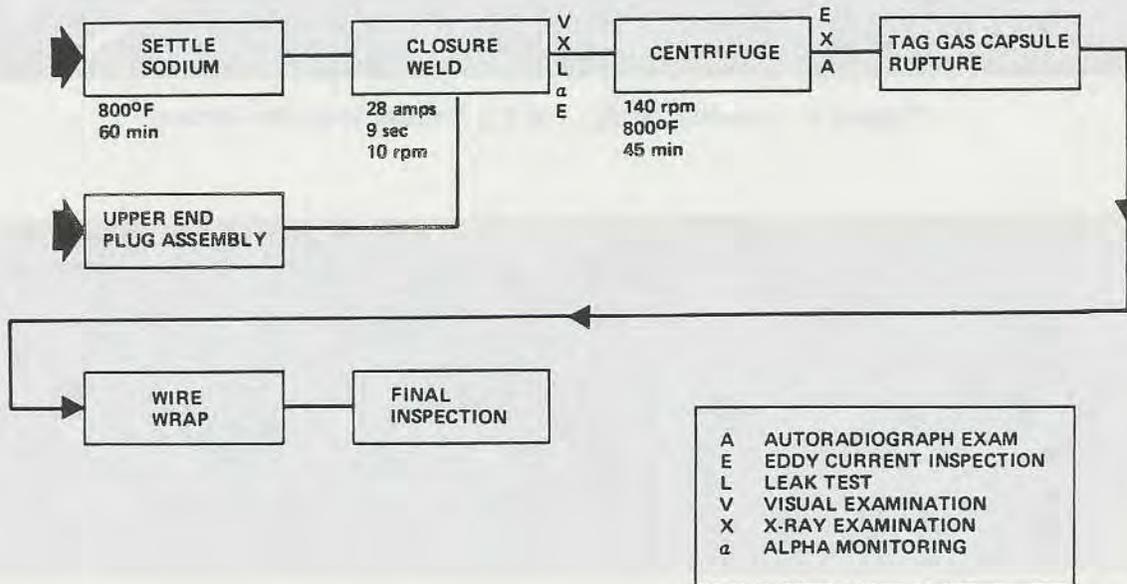
Figure 7. Advanced Fuel Systems Fuel Element Fabrication Flow Diagram

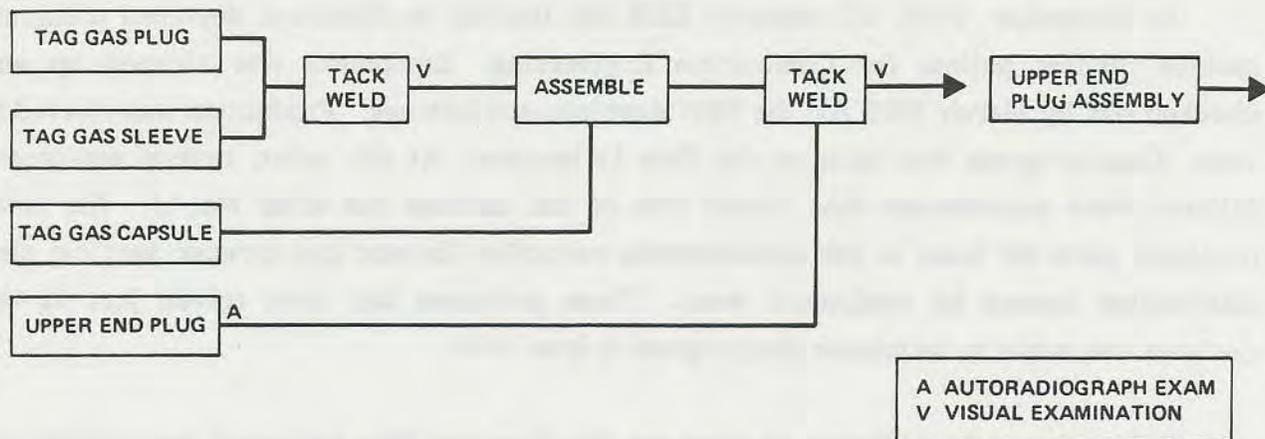
Figure 8. Fuel Element Fabrication Flow Diagram

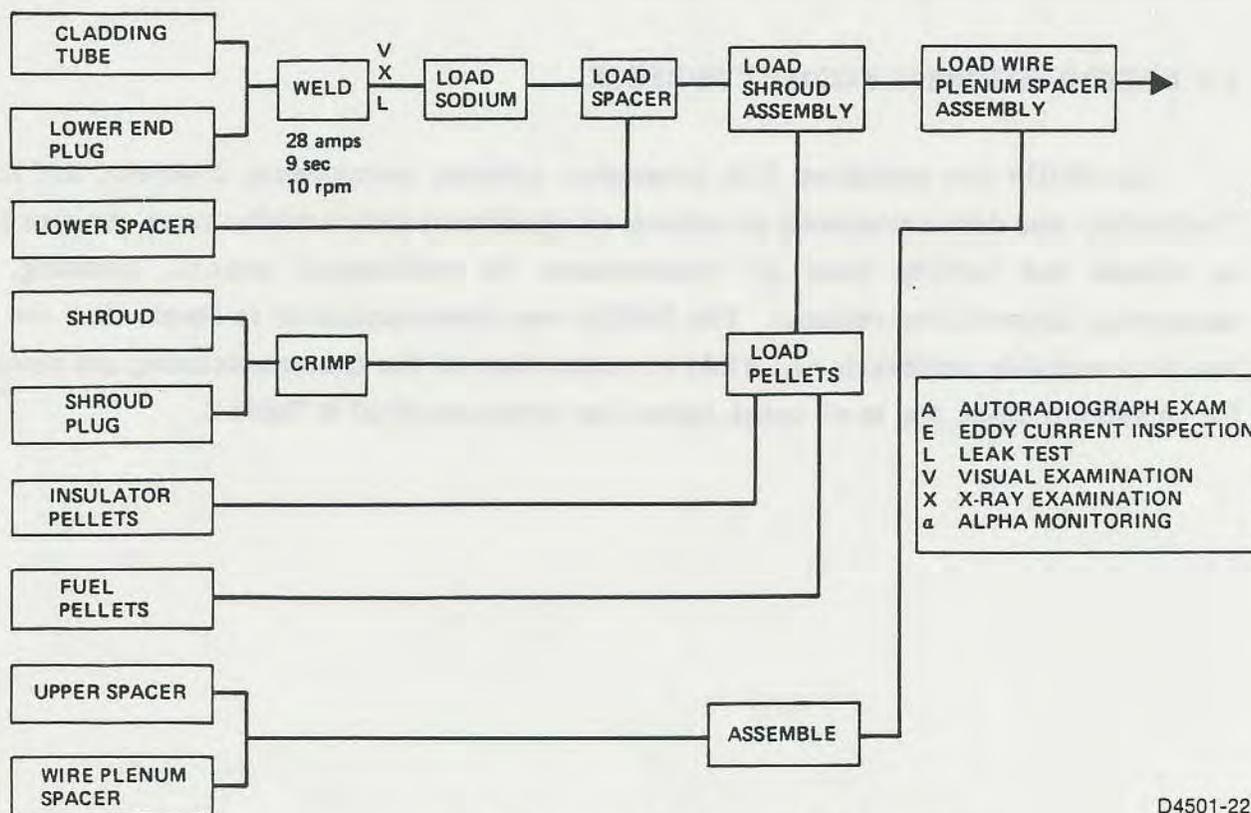
Figure 9. Fuel Element Fabrication Flow Diagram

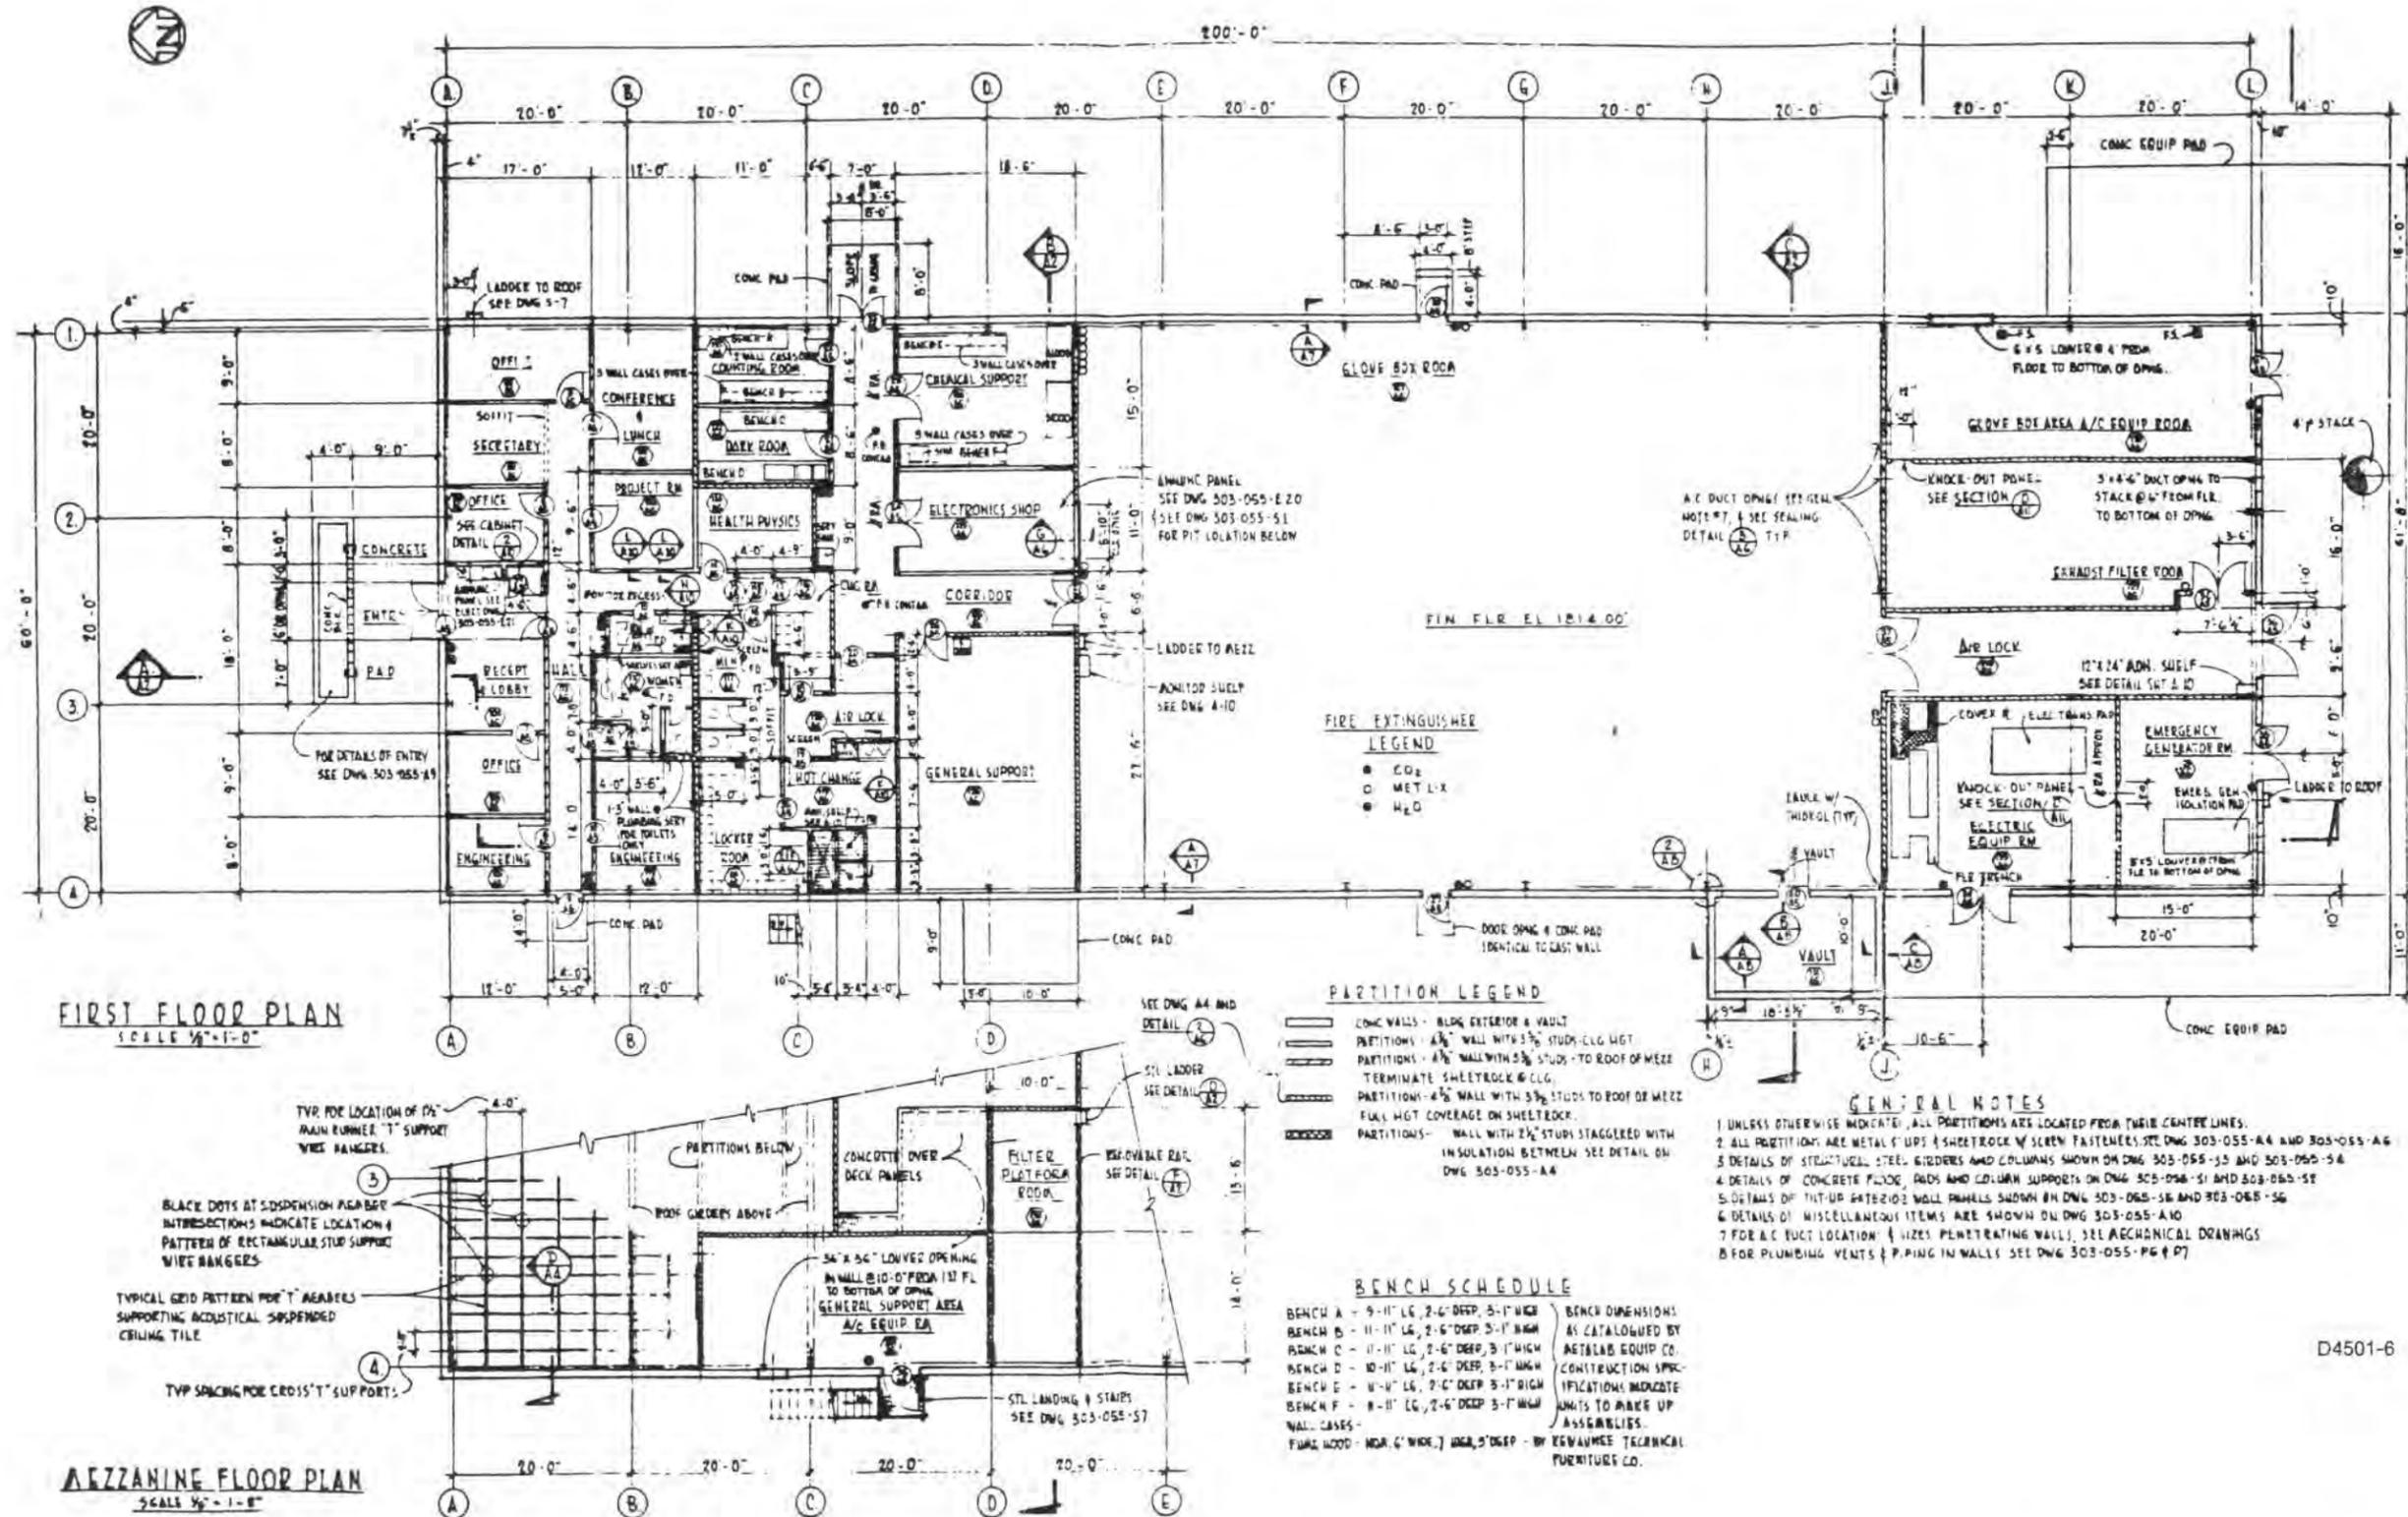
Figure 10. Architectural Plan, NMDP

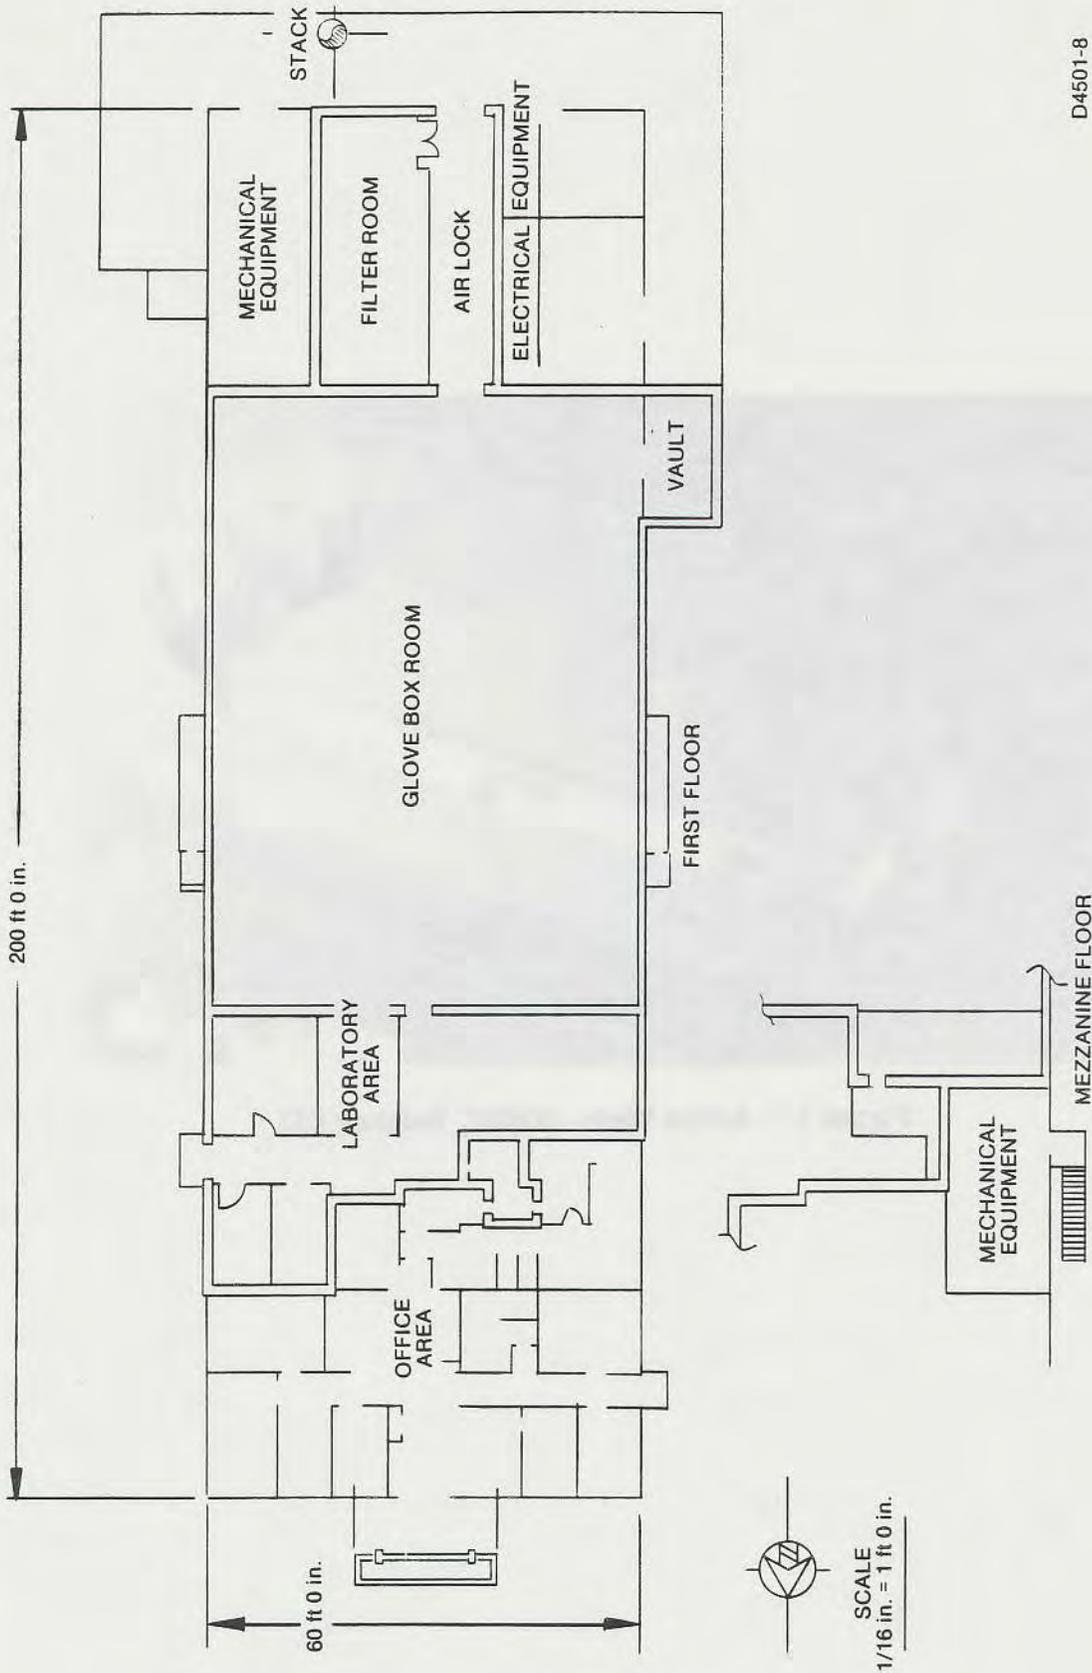
Figure 12. Building Enclosure—NMDF, Building 055

All air being exhausted from the building had to pass through the main bank of high-efficiency filters, which were located in the R/A exhaust filter room (Figure 12). Twenty-seven filters were arranged in nine isolatable units of three filters each (Figure 17). Filters could be replaced by isolating one unit at a time, changing the filters, and putting the unit back in service.

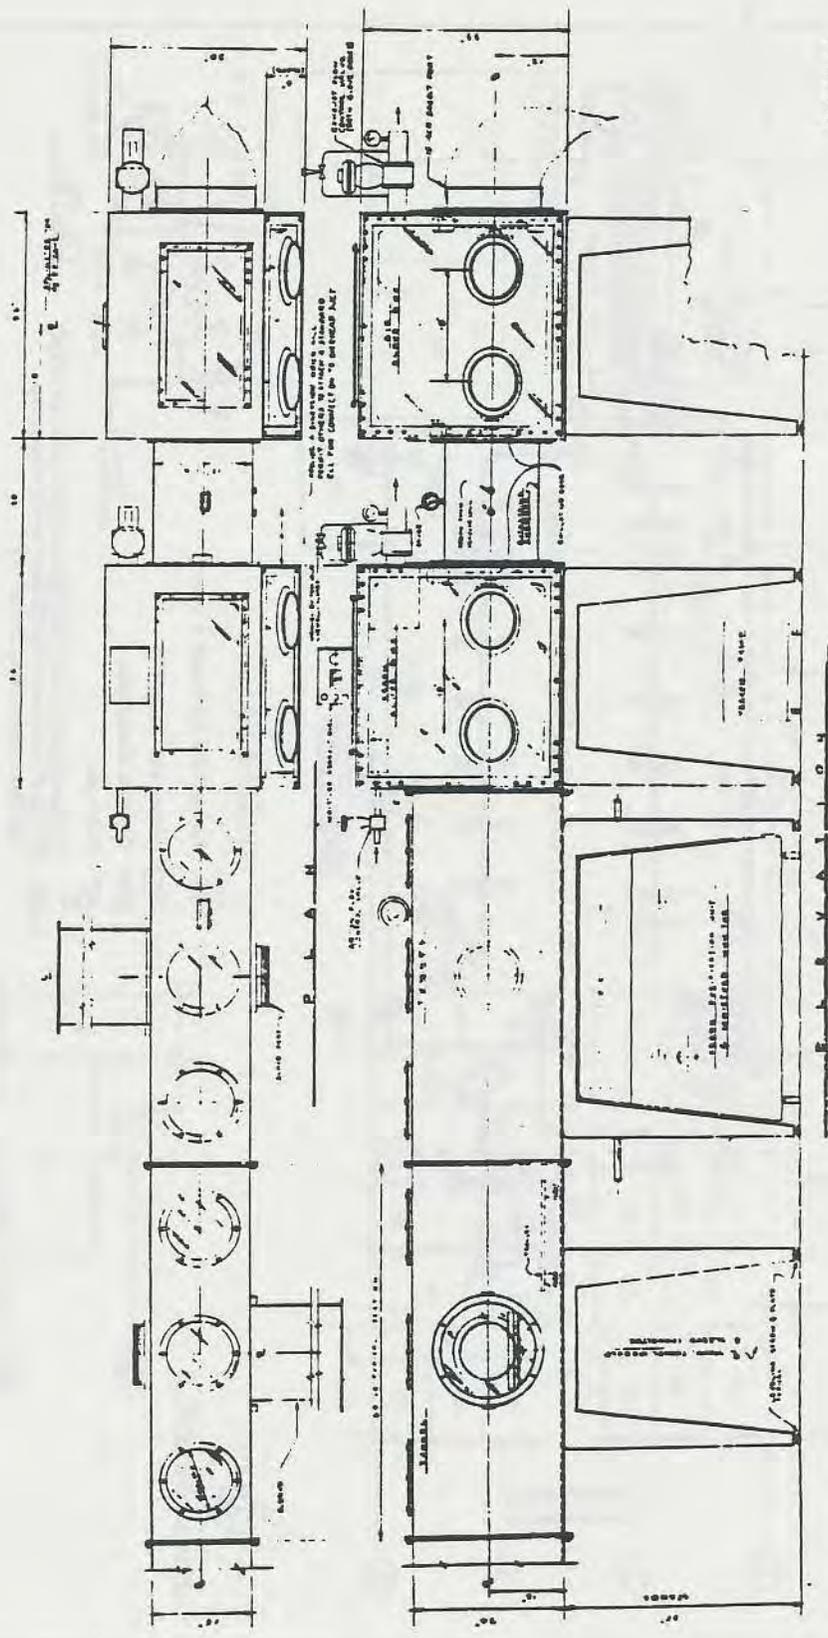
Figure 16. Glove Box Transfer Tunnel Design Detail, NMDf

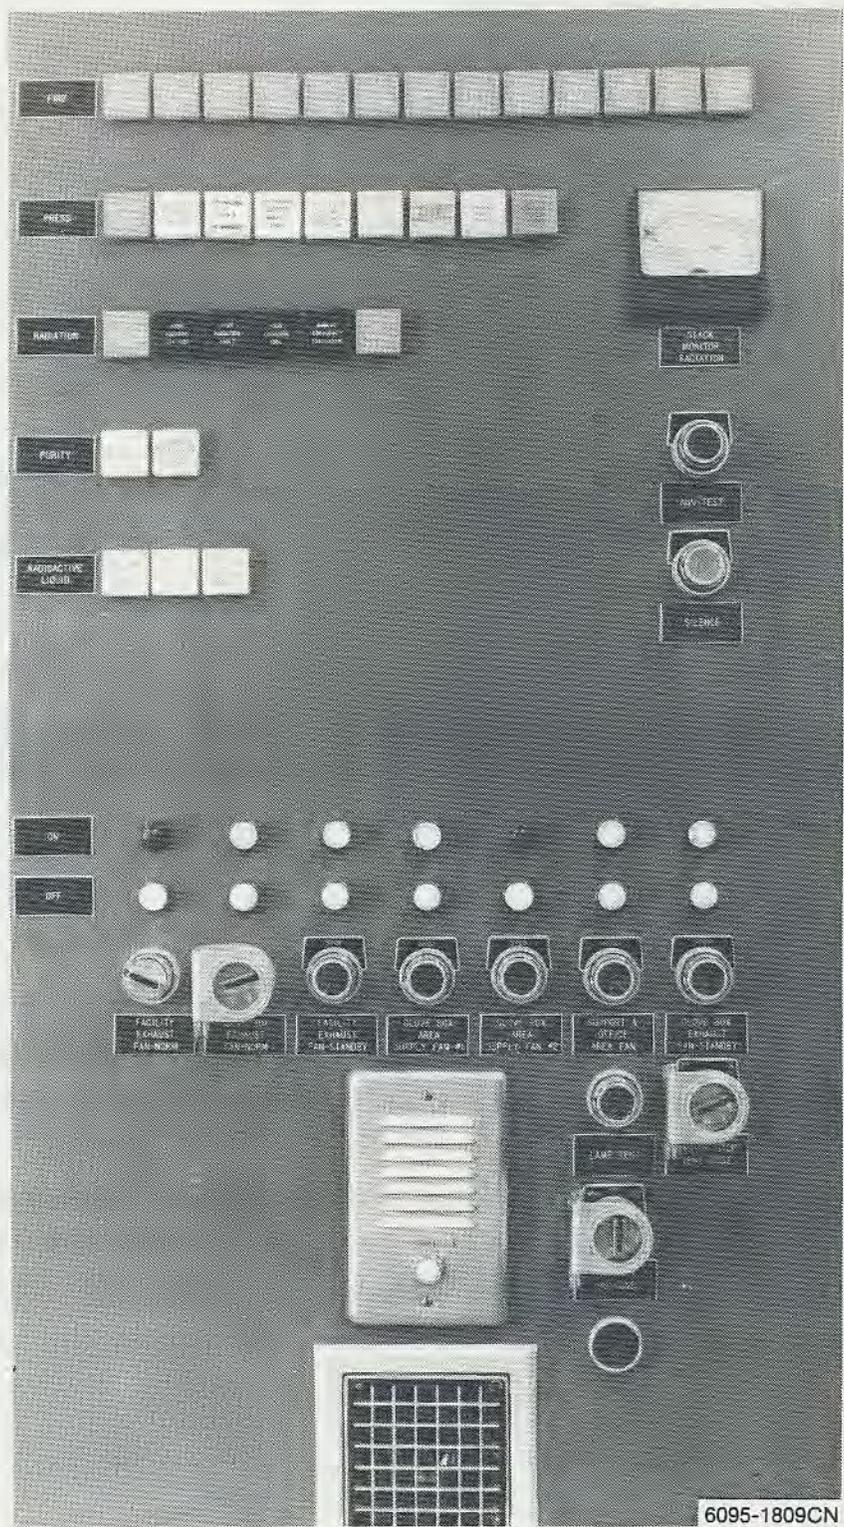
Figure 20. Administrative Area Annunciator Panel

The administrative area annunciator panel (Figure 20) lamps, pushbutton controls, and audible signals were operated with the main annunciator chassis and relays in the glove box room annunciator panel. In essence, the administrative annunciator was a remote station—although it had more alarm points, which enabled it to monitor the entire facility.

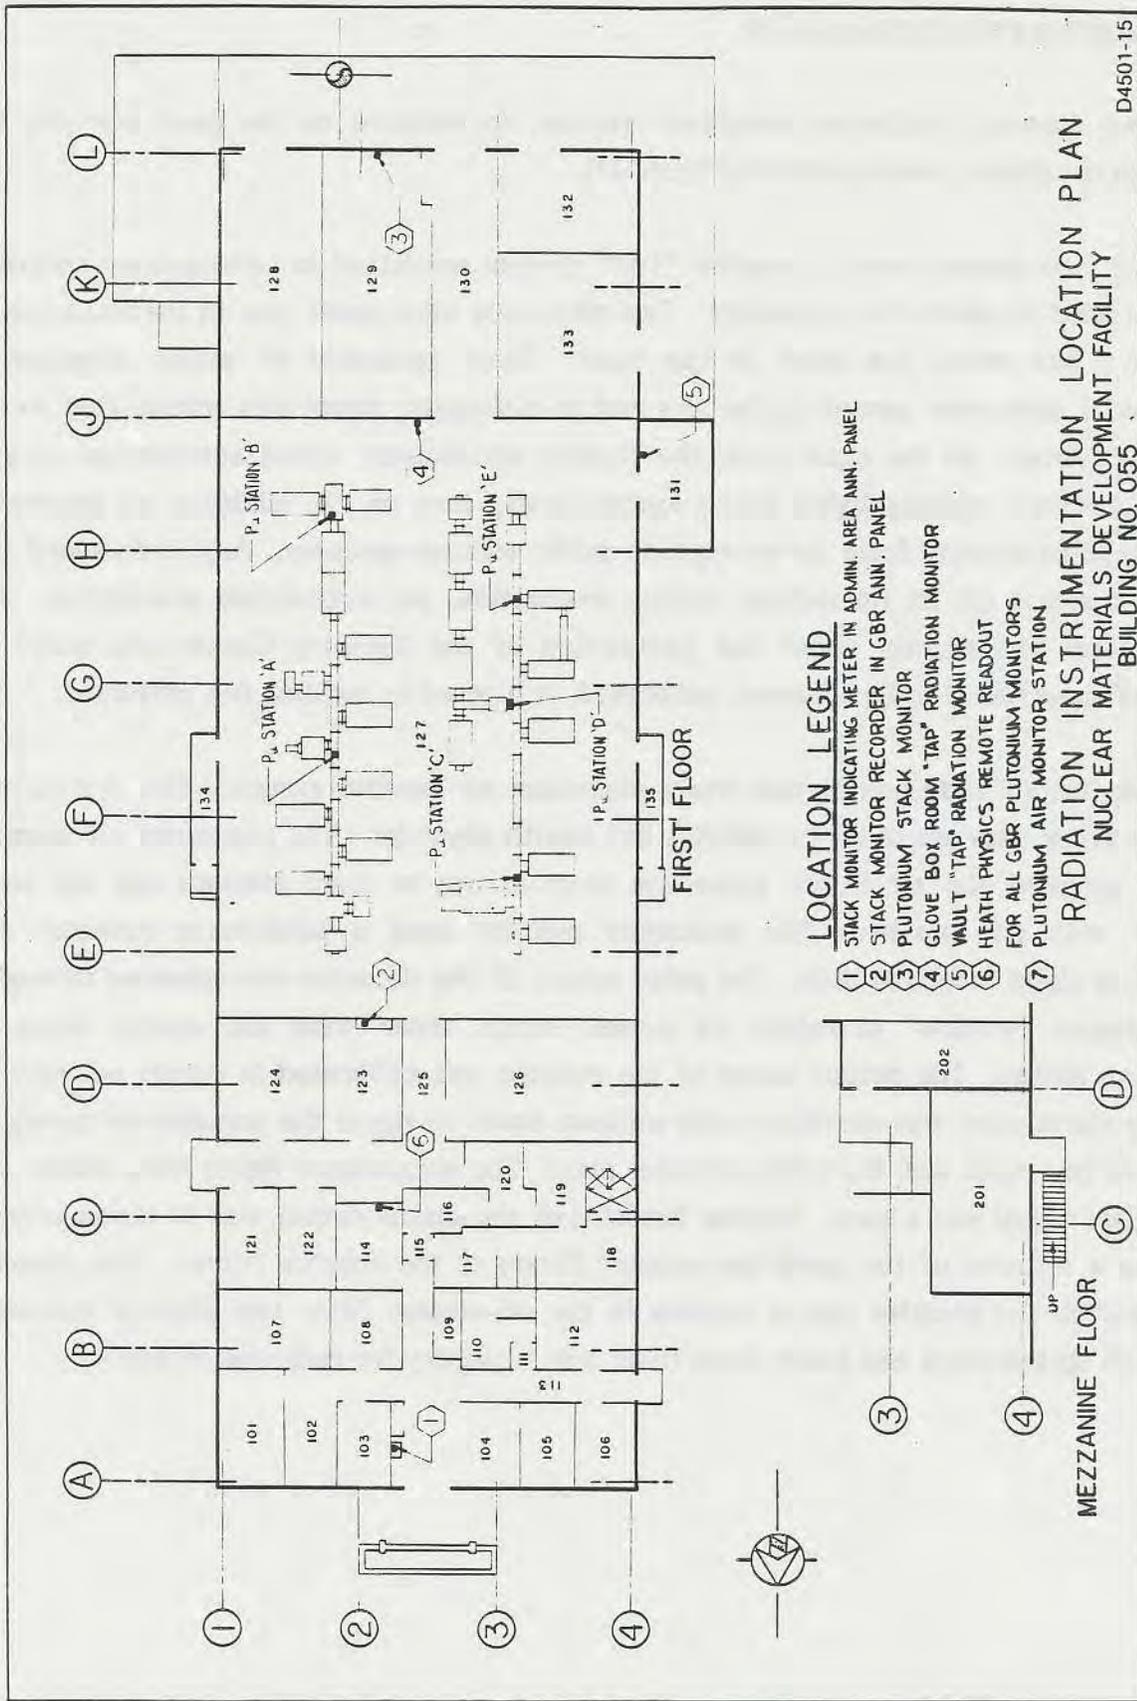
Figure 21. Radiation Instrumentation Location Plan

The first system was a Tracerlab "TAP" system sensitized to beta-gamma radiation and was used to alarm for criticality. Two detectors were used: one at the south end of the glove box room, the other in the vault. Upon actuation of either detector, a mechanical siren was turned on for 15 s and an automatic signal was transmitted to the Security Center. At the same time, the facility annunciator would actuate the outside beacon and red warning lights would automatically turn on. In addition, an electronic siren would be sounded from the emergency public address speakers. Any siren sound was always a signal for an immediate facility evacuation, per established procedures. The TAP system was strictly under the jurisdiction of the Security Center and under no circumstances was it to be adjusted, calibrated, or altered by building 055 personnel.

The second radiation system was a plutonium air monitor system. This system was directly under the control of the building 055 health physicist. The plutonium air monitor system sampled the air in the glove box room at one or more stations and the stack exhaust with one station. The plutonium monitor used a solid-state detector and monitored alpha radiation only. The pulse output of the detector was screened through a discriminator "window" to reject all pulses except those with the energy value of plutonium alphas. The output meter of the monitor was calibrated in counts per minute. A single alarm point was provided in the exhaust stack to signal the annunciator panels in the glove box room and the administrative area. The annunciator lights were amber and the audible signal was a horn. Another function of the alarm circuit was to automatically instigate a transfer of the glove box exhaust filters to the standby filters. This transfer was based on the premise that a rupture in the on-stream filter had allowed excessive plutonium up the stack and a new fresh filter was necessary for radiation safety.
