**NUCLEAR MATERIALS
DEVELOPMENT FACILITY
DECOMMISSIONING
FINAL REPORT**

DOE Research and Development Report

Rockwell International

**CONTRACT: DE-AC03-81SF11565
ISSUED: 31 MARCH 1987**

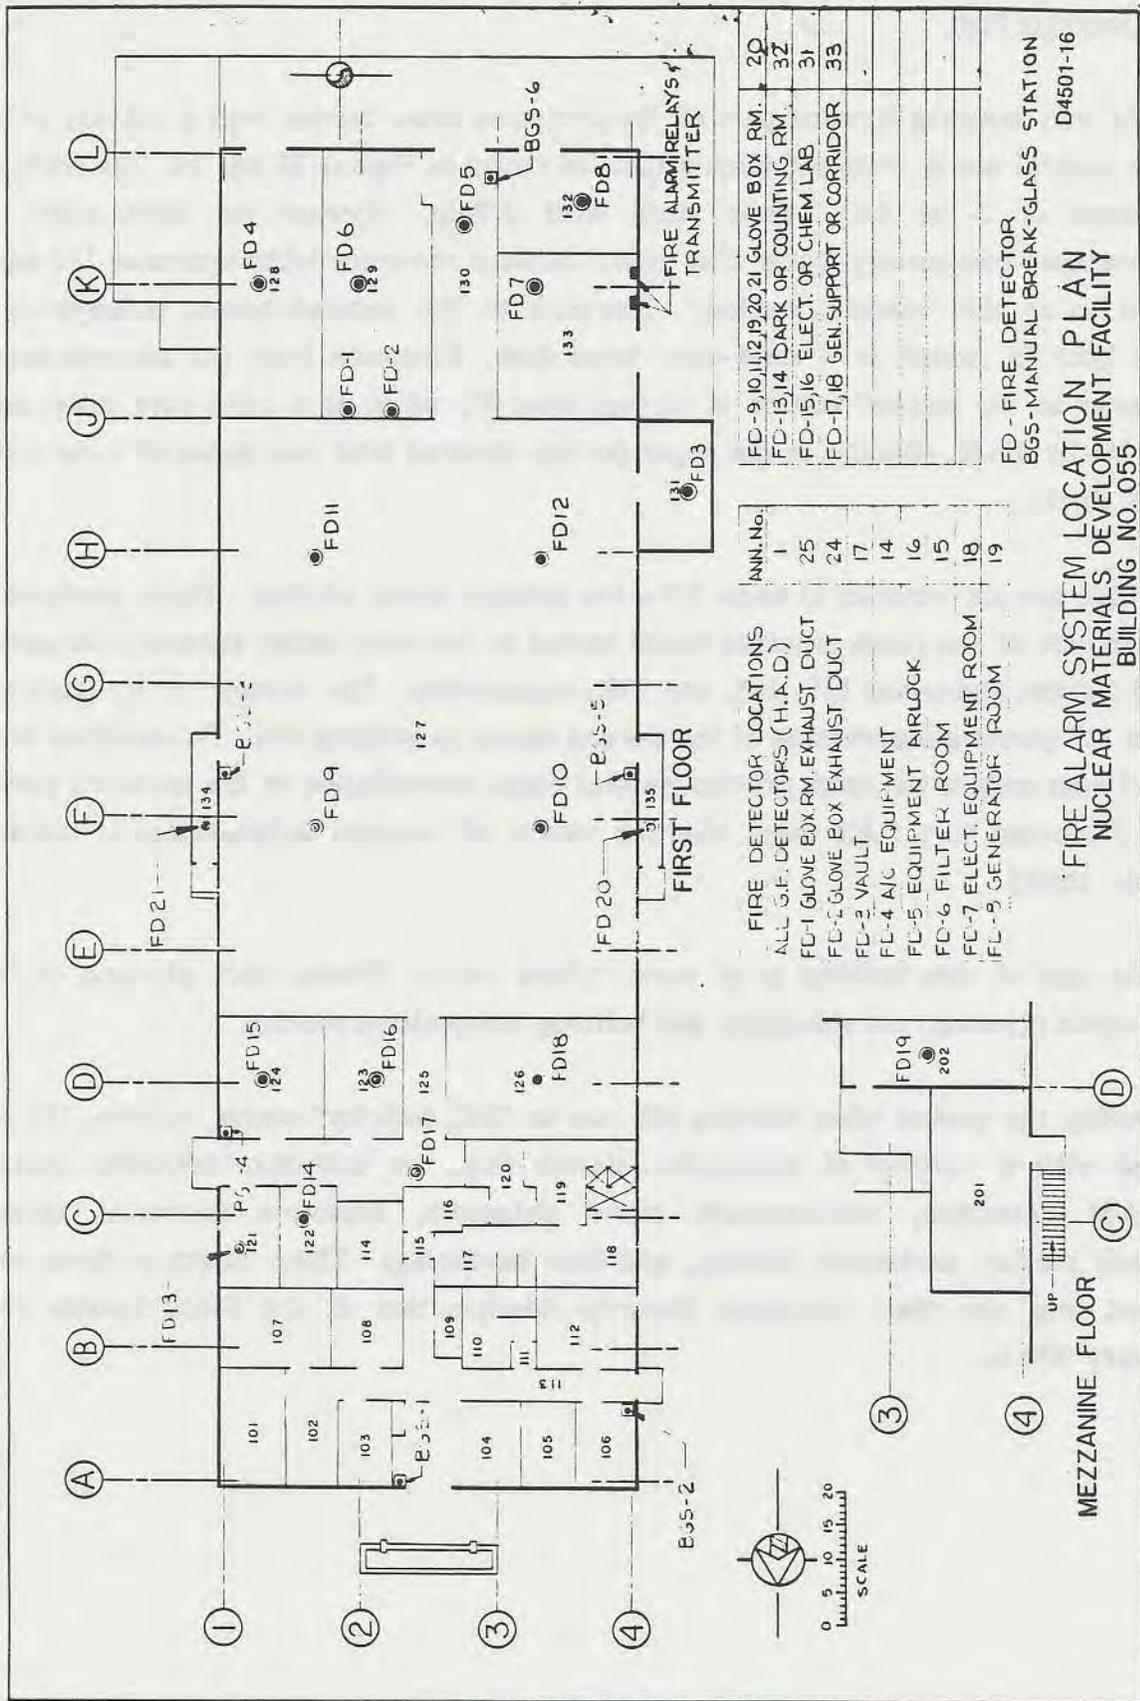
Figure 22. Fire Alarm System Location Plan

Each glove box tunnel had a HAD set to trip at ~150 to 160°F. Electrical contacts were normally open, closing to alarm. The device was bimetallic operated and was of rugged industrial construction. The detector was connected by a cord and could be located anywhere within the glove box. Preferred location was in the center of the glove box near the top. The detectors operated at 115 V, 60 Hz, and normal electrical precautions were observed. Reset action was automatic after restoration from an alarm condition.

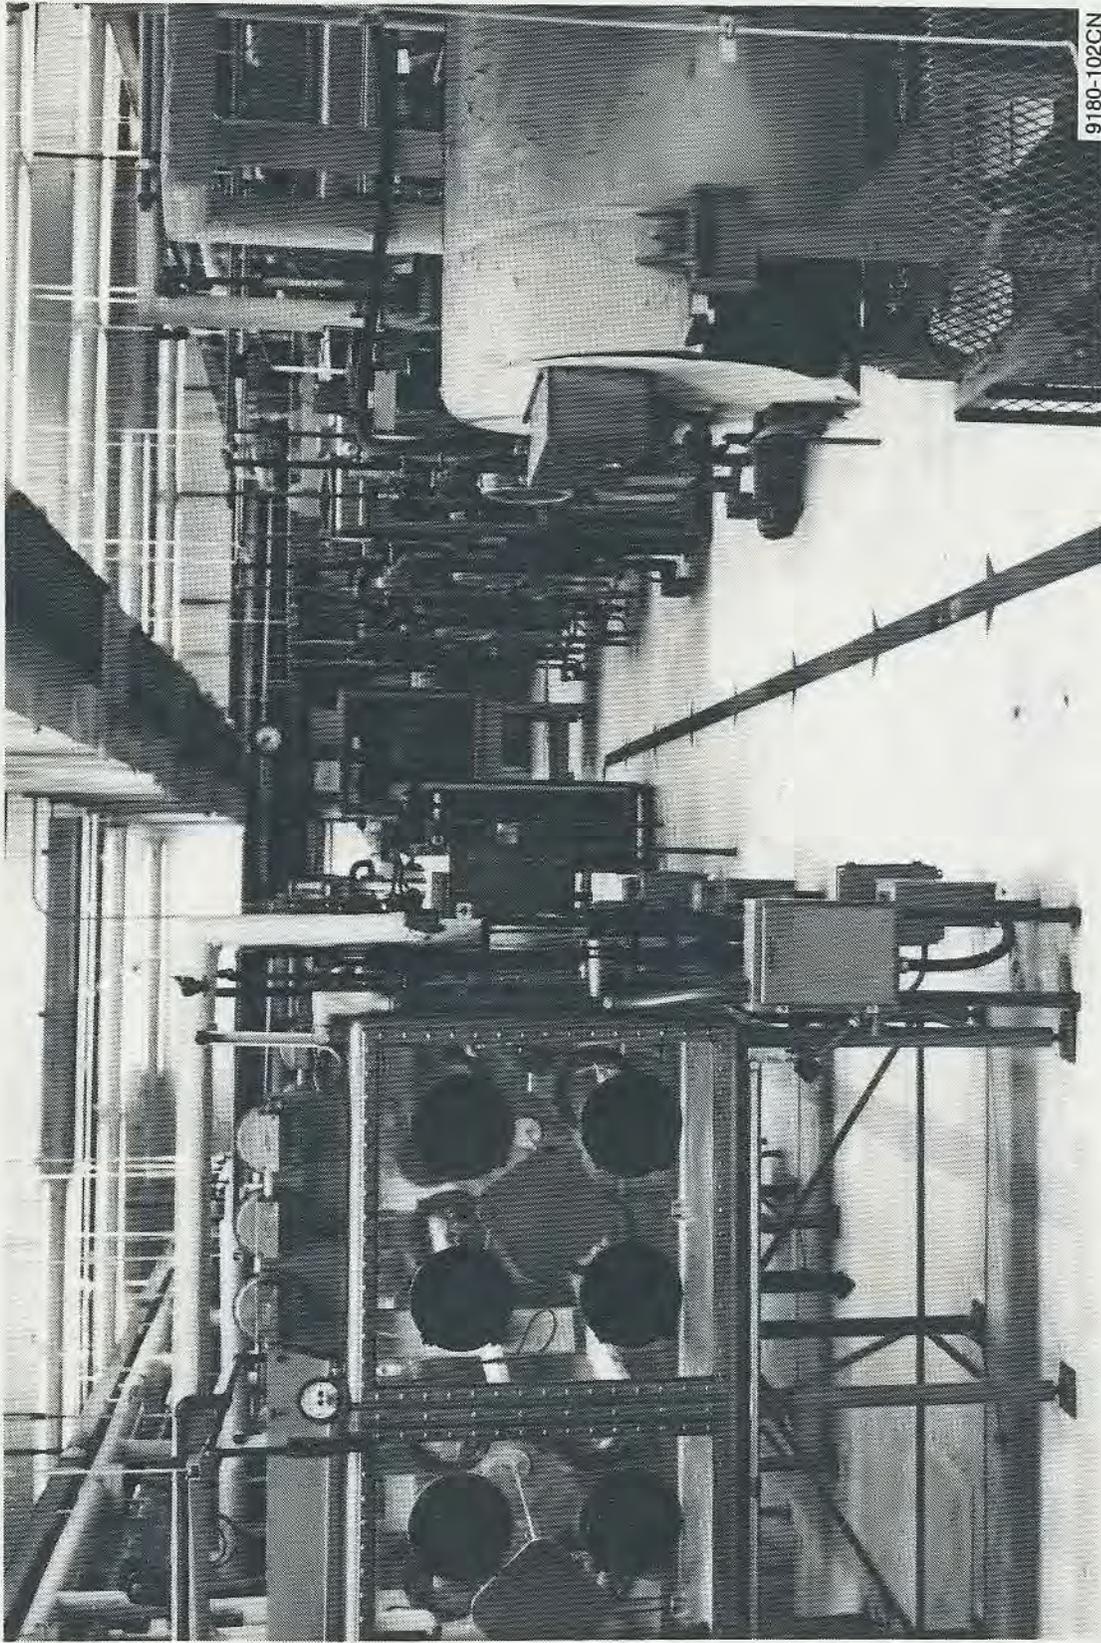
Figure 26. Glove Box Room

4.3.1.1 Glove Boxes and Tunnel Sections. The flow diagram used in cleaning the glove boxes is shown in Figure 25. Figure 26 shows the glove box room prior to decontamination operations. The equipment from all of the glove boxes was size reduced and removed. Figure 27 shows size-reduced equipment being packaged as TRU waste. The glove boxes were decontaminated, using the ALARA principle, to levels less than those required for classification as LSA waste. Decontaminating the boxes also made handling and packaging the boxes safer and less expensive. All boxes were decontaminated by hand scrubbing and coating with strippable paint. Figures 28 and 29 show the strippable paint being applied and then removed. When localized high-spot contamination collectively caused a glove box to be classified as TRU waste, a decontamination of those areas was always accomplished. Sanding, in addition to scrubbing and using strippable coatings, was used to eliminate these local spot contaminations. Once the glove box had been surveyed and determined to be LSA, the interior surfaces of the boxes were painted to cover open porosity and to fix the residual contamination. Based on a study performed by General Electric, Rustoleum was chosen as the most effective paint to use for fixing the contamination. The Rustoleum was chosen because it adhered well during bend tests of painted samples. Figure 30 shows the glove boxes being surveyed after decontamination. Figures 31 and 32 show a glove box being packaged as contaminated LSA waste. Figure 33 shows the glove box packaged and ready for shipment.

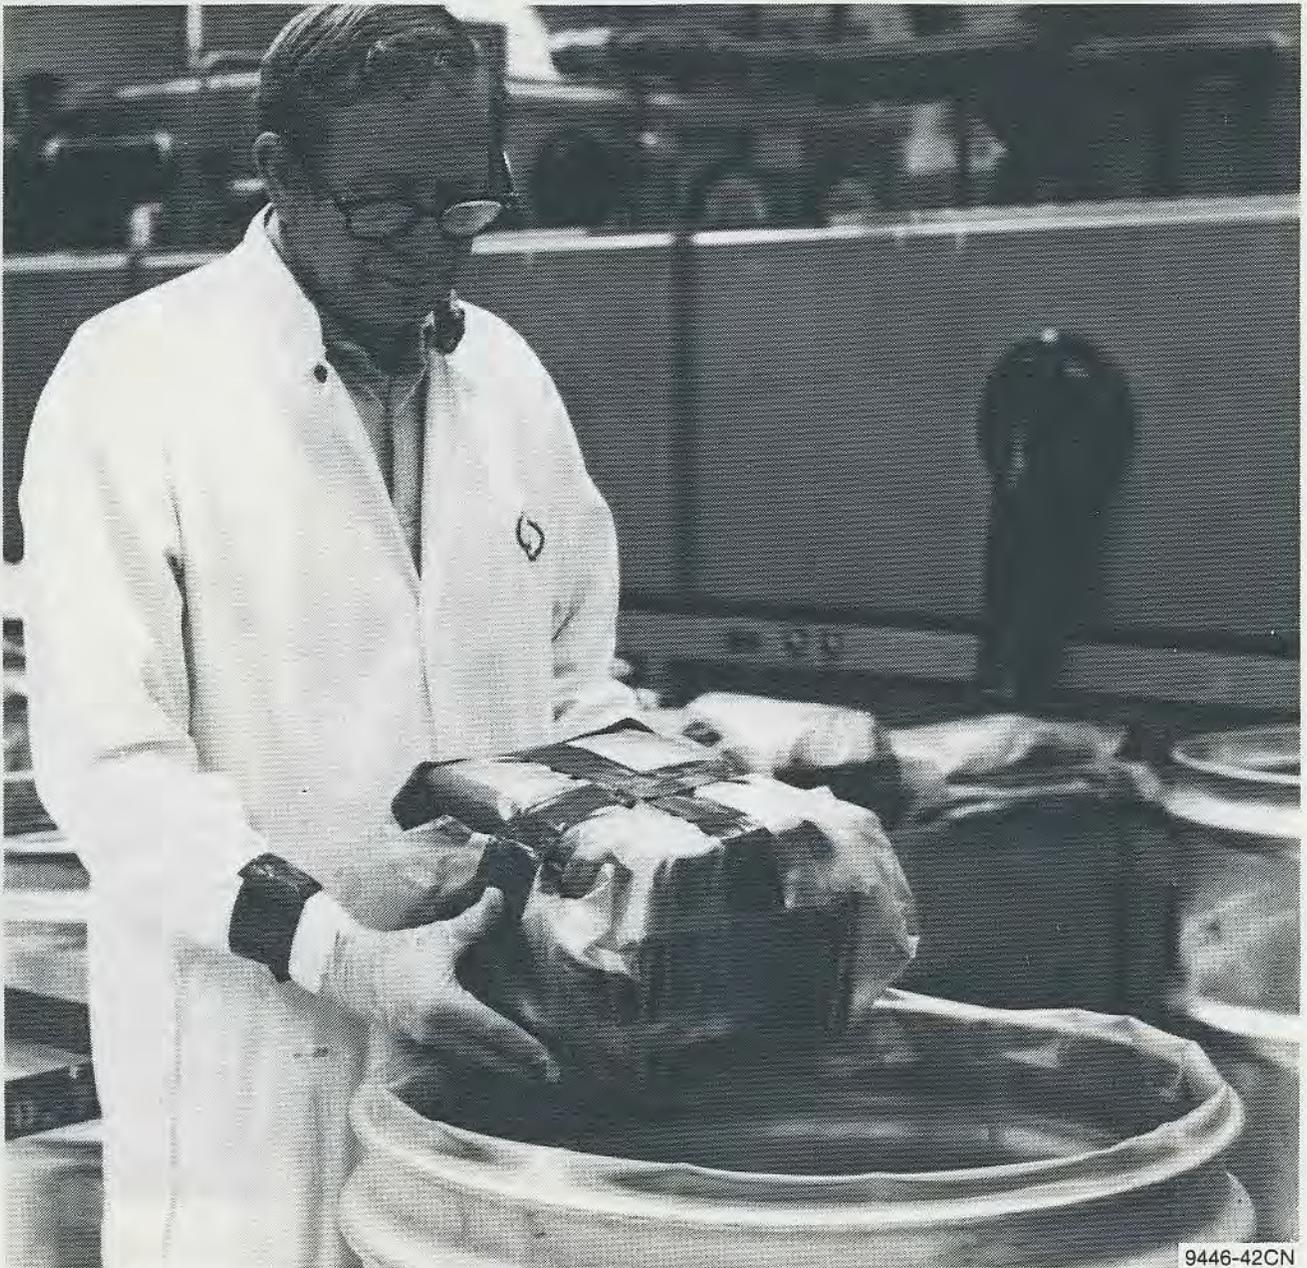
Figure 27. Packaging TRU Waste

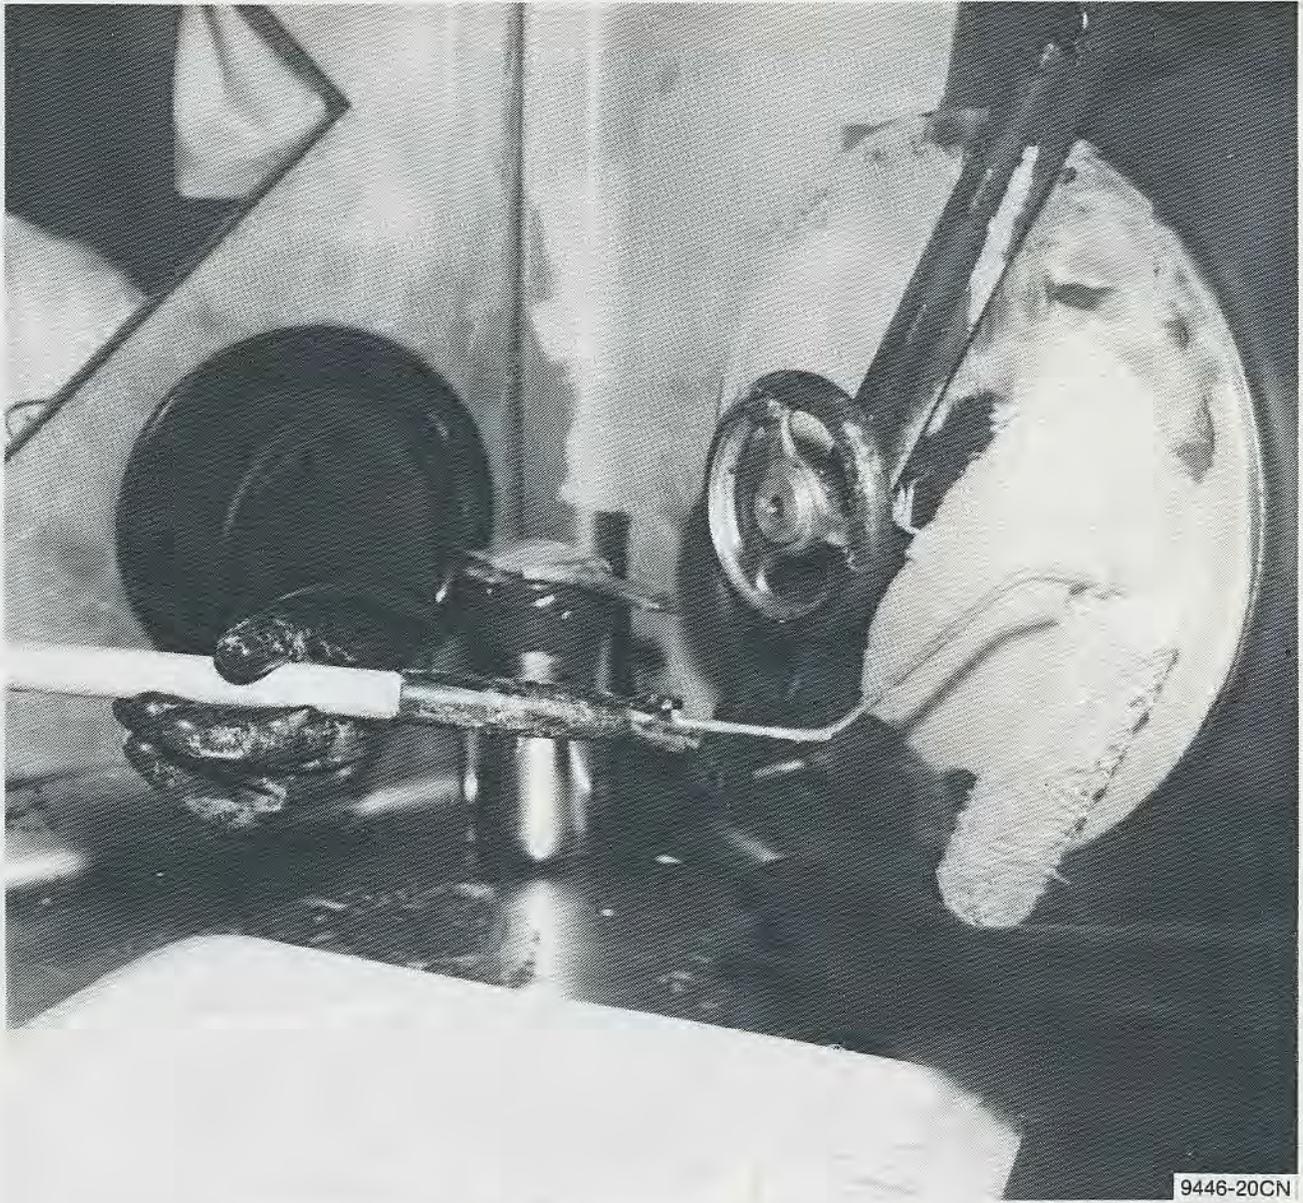
Figure 28. Strippable Paint Application

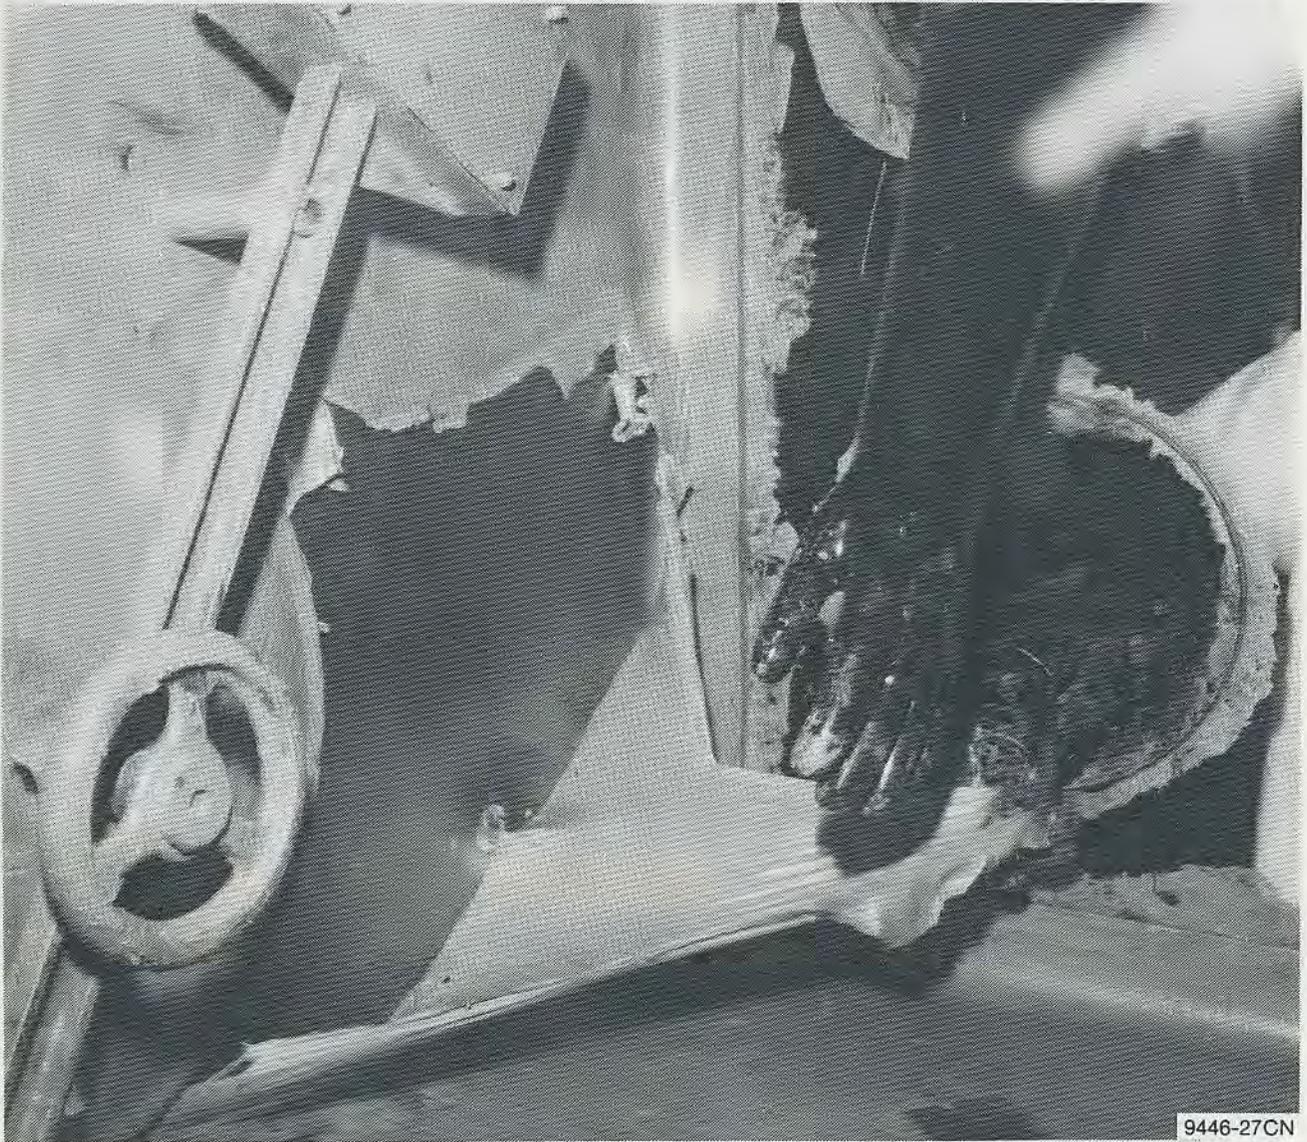
Figure 29. Strippable Paint Removal

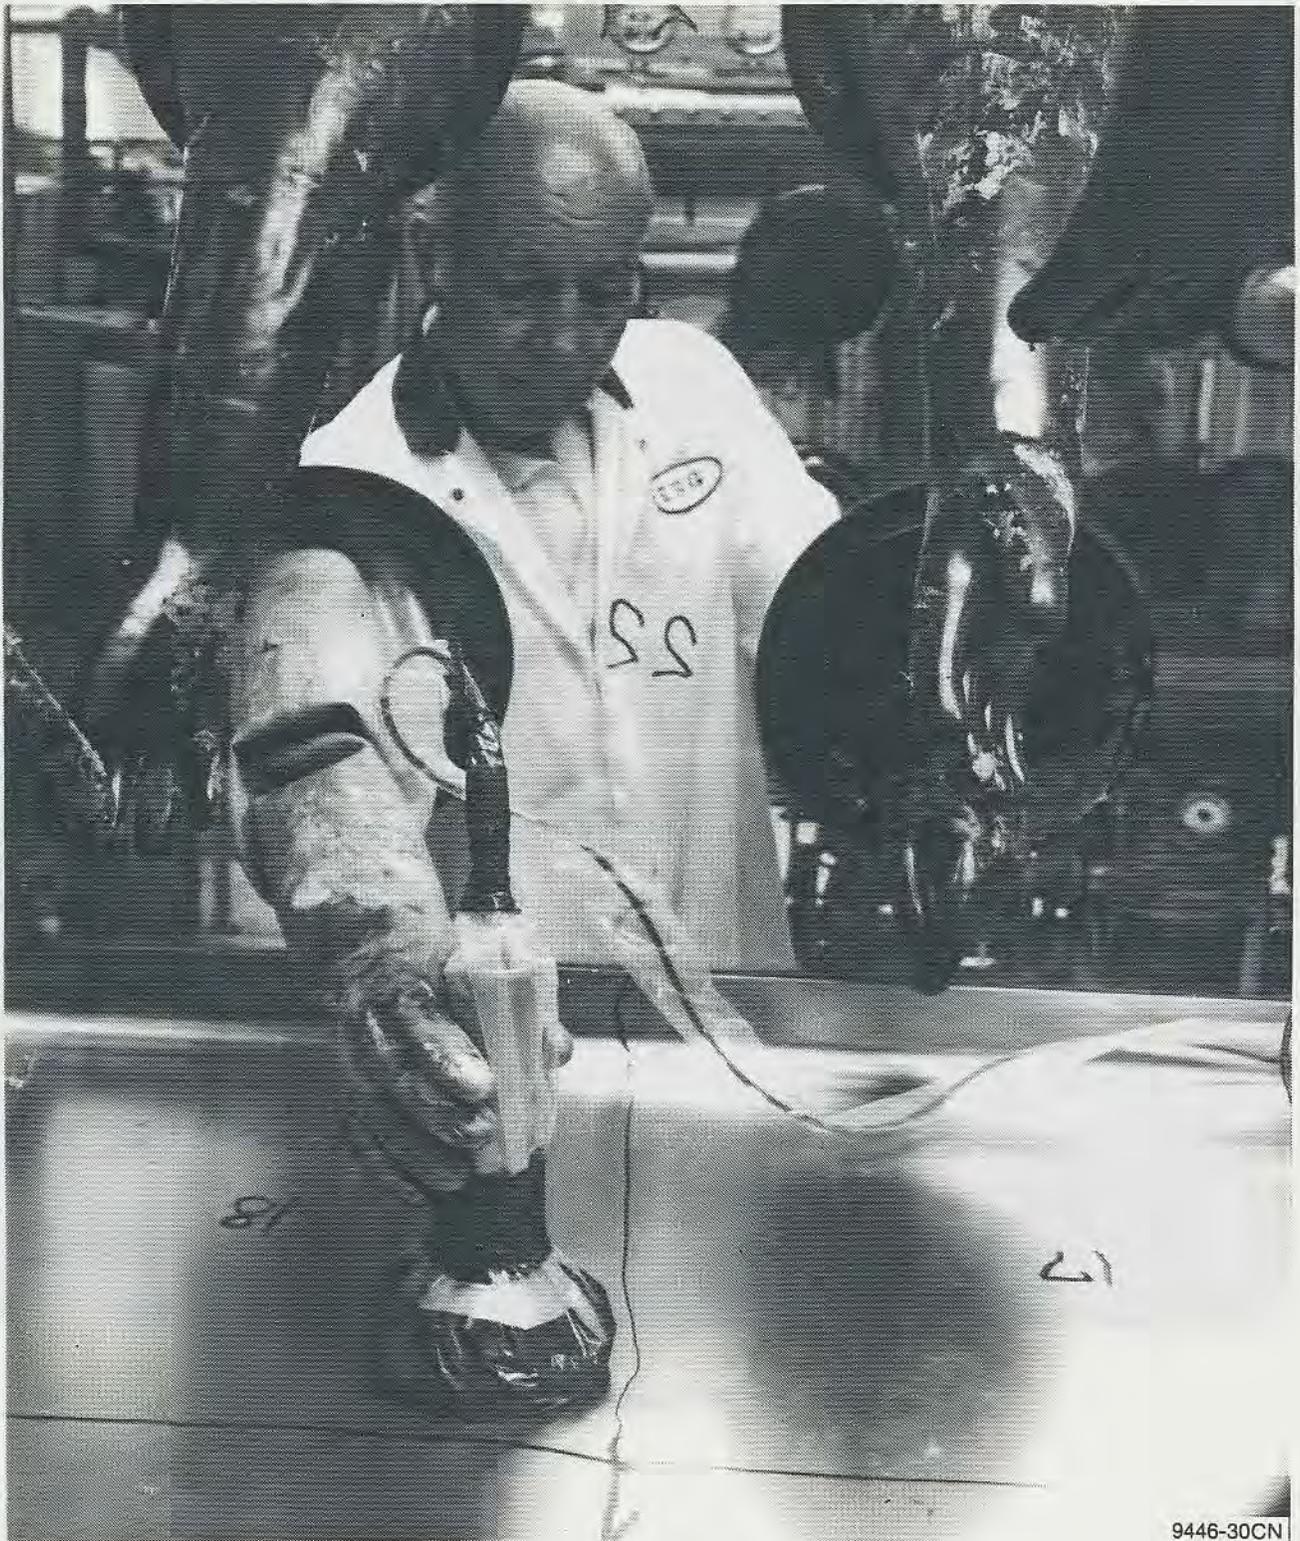
Figure 30. Glove Box Survey

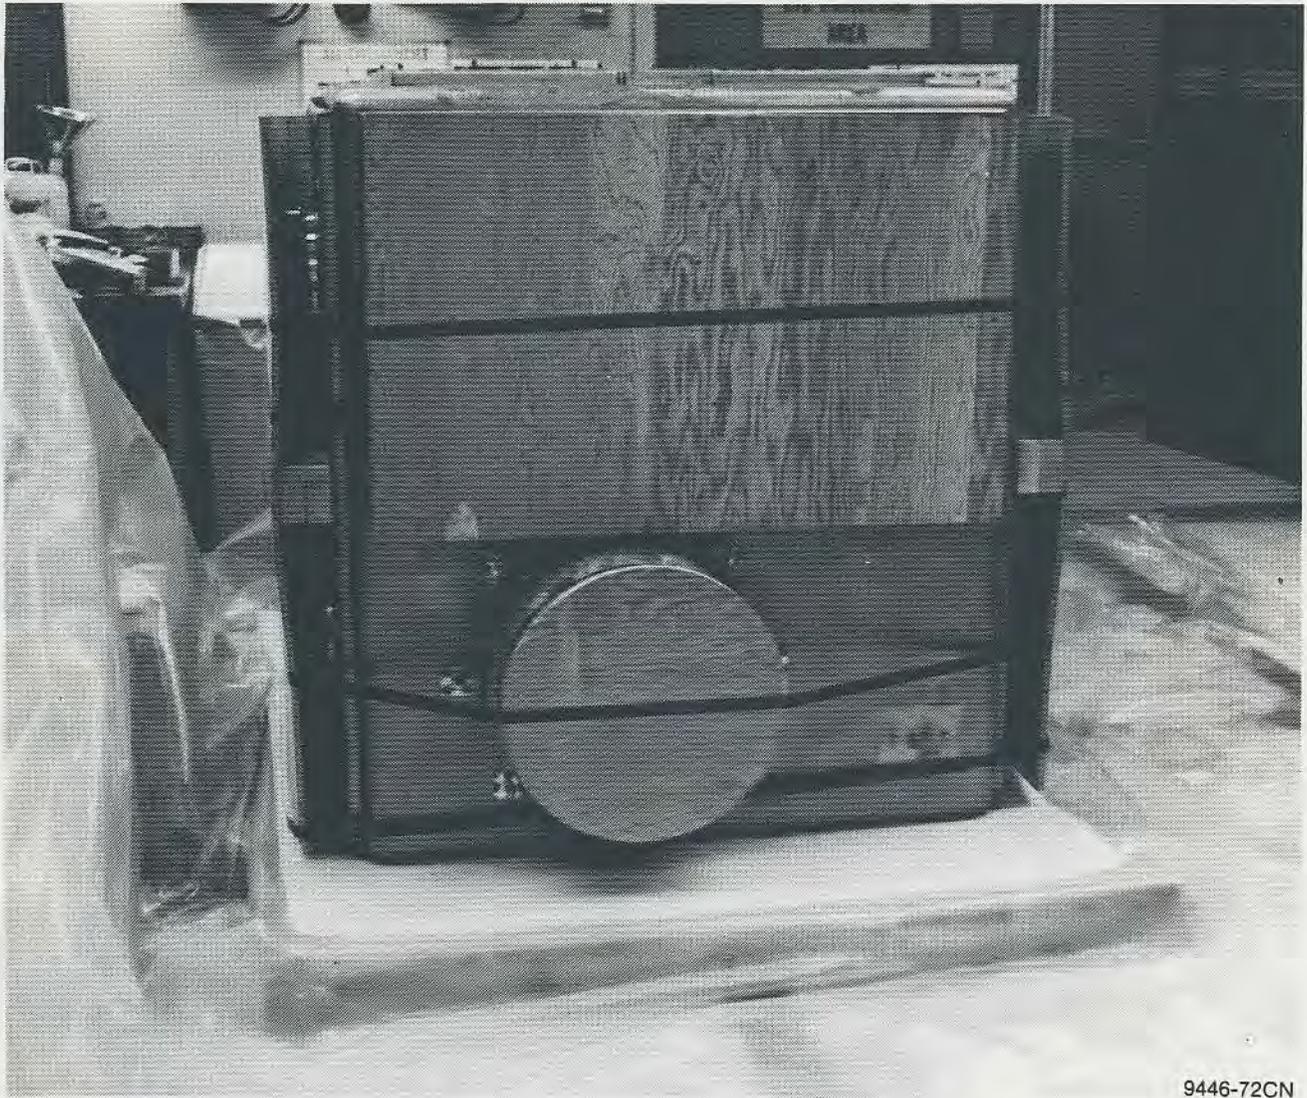
Figure 31. Glove Box Packaging, Structural Support

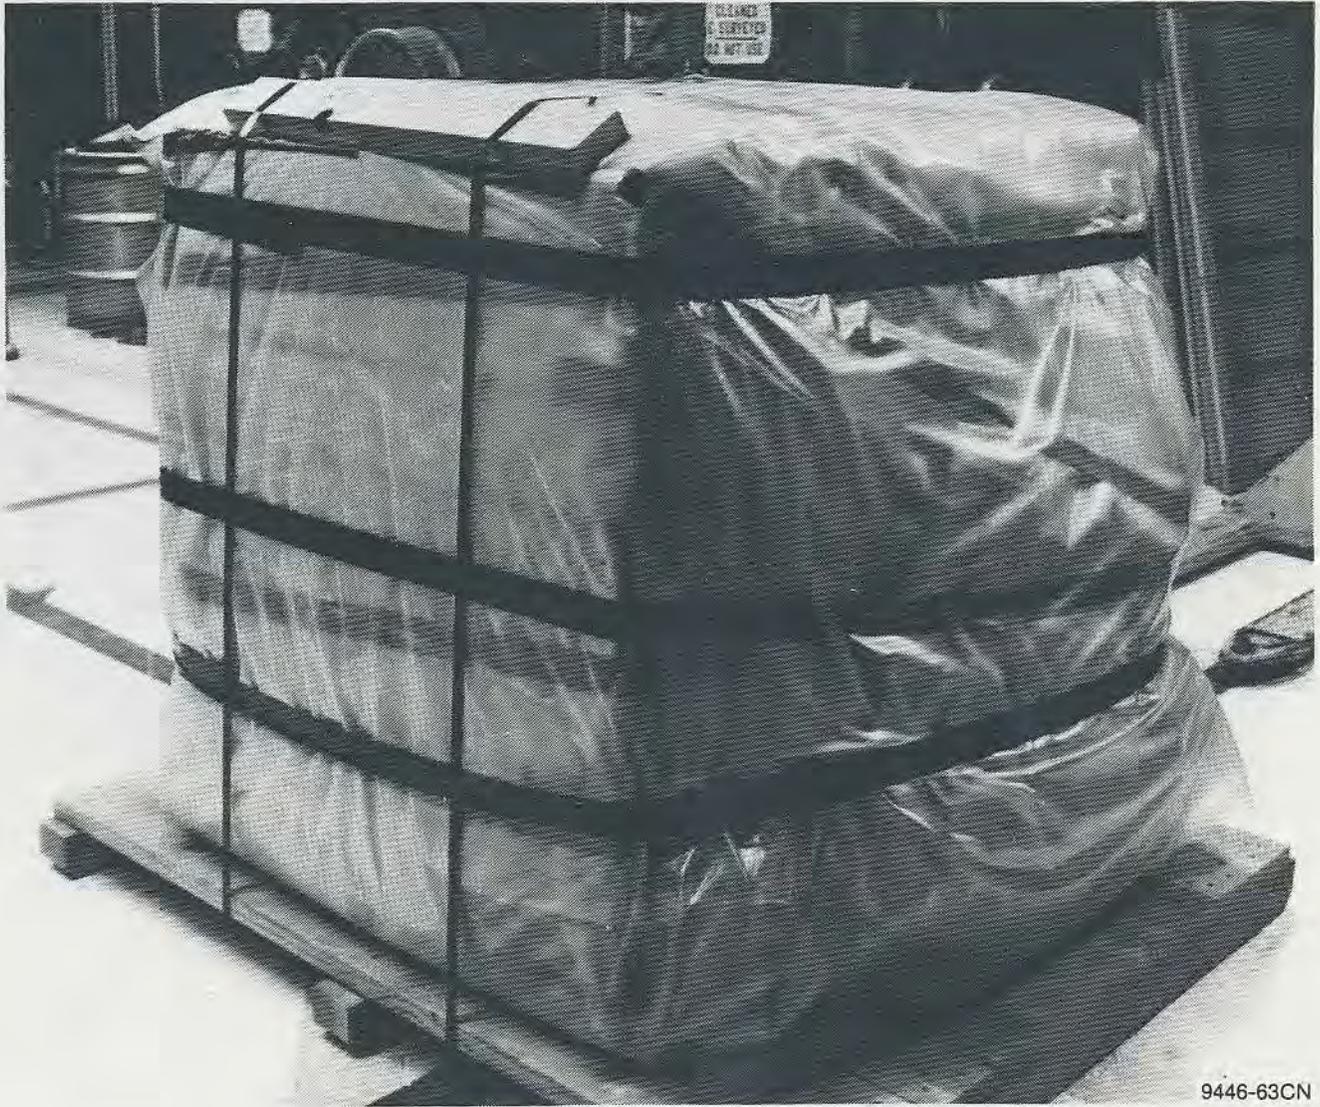
Figure 32. Glove Box Packaging, Plastic Wrap

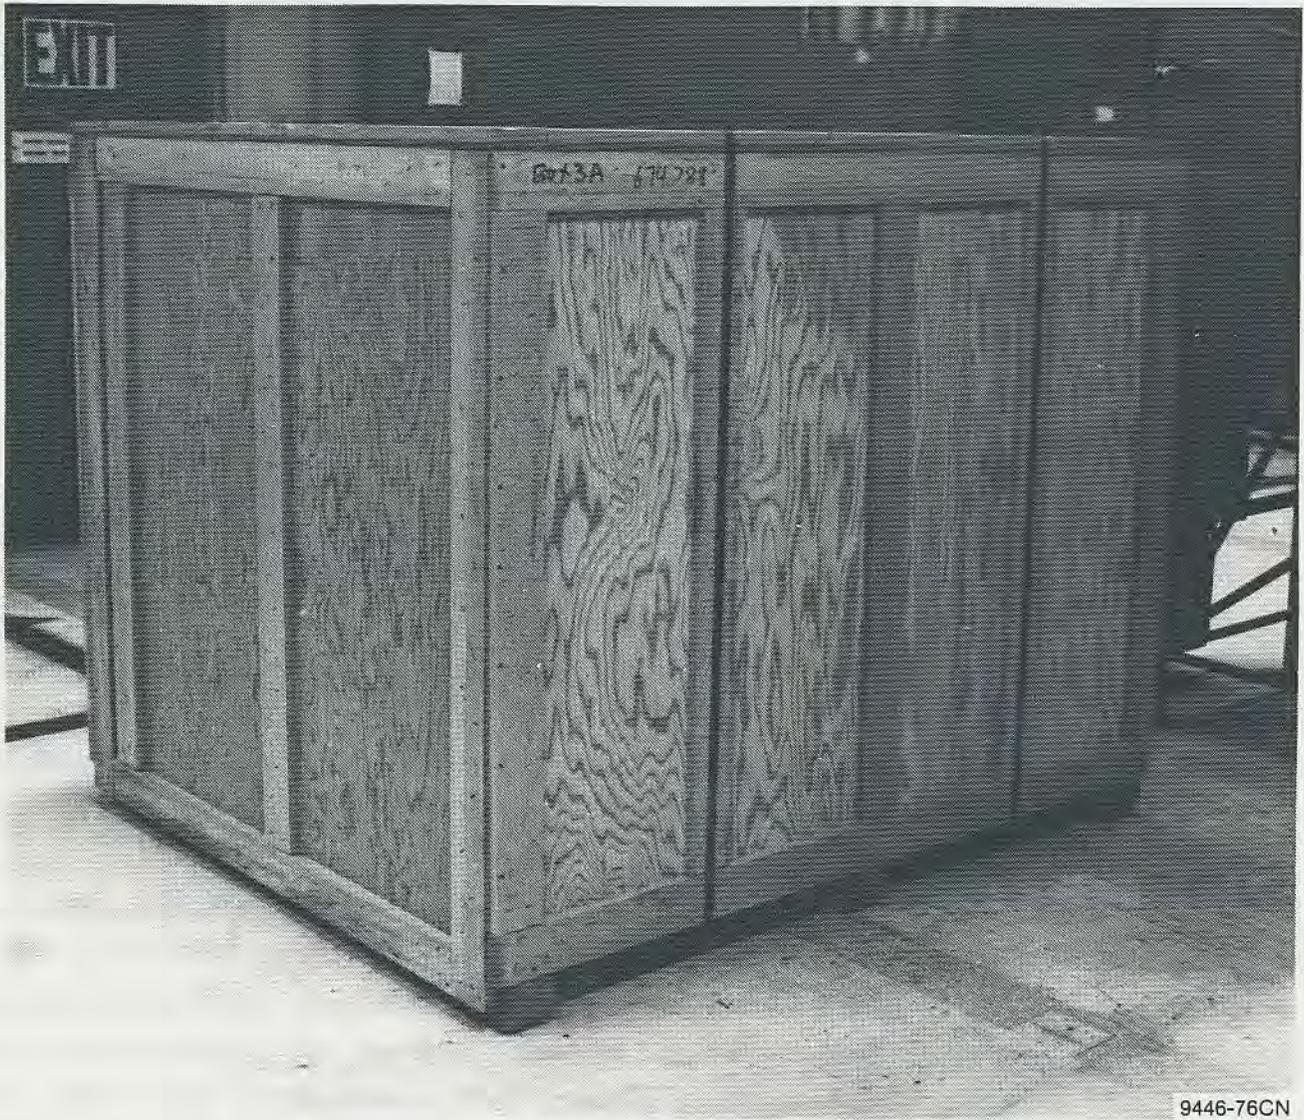
Figure 33. Glove Box Packaging, Complete

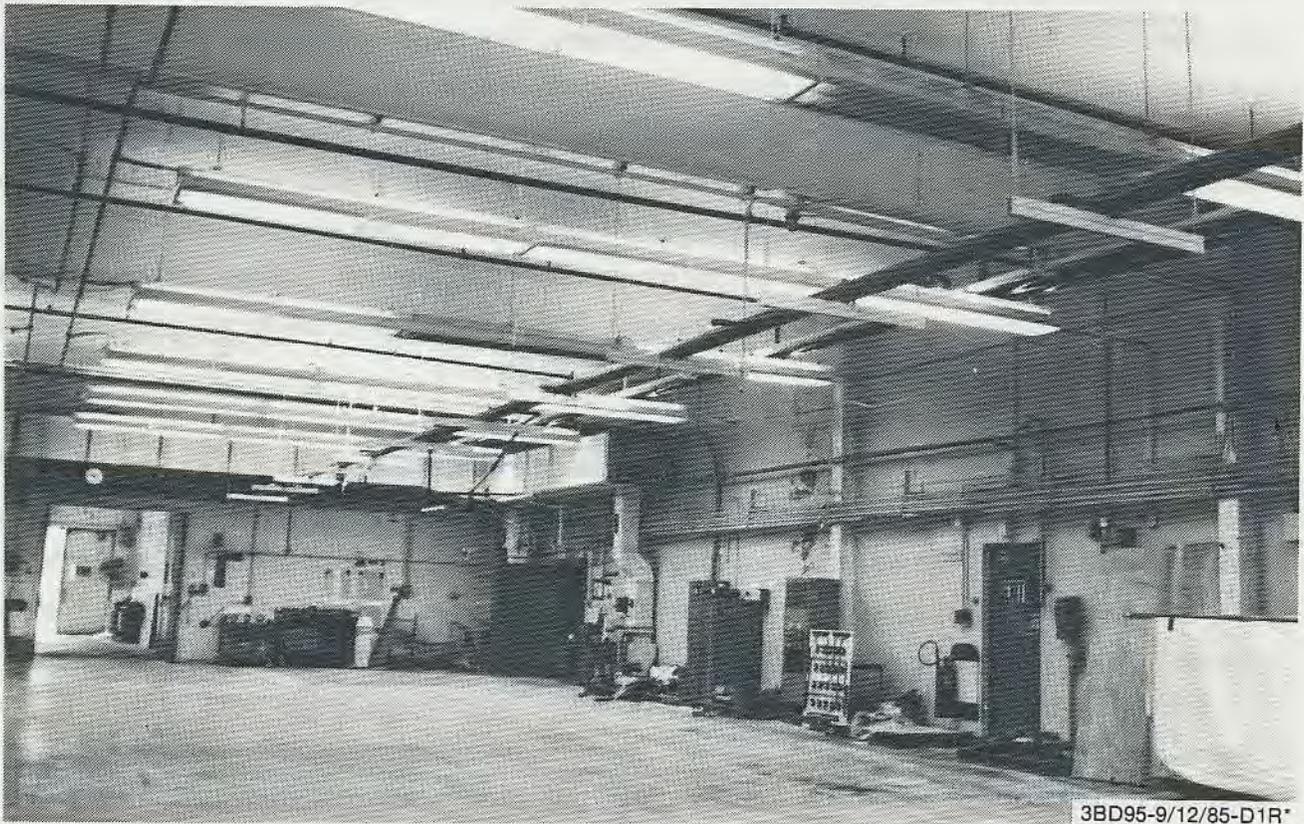
Figure 34. Glove Box Room, Interim D&D

4.3.1.3 Glove Box Room Structural Surfaces. Because of the nature of work conducted in the facility, all surfaces within the controlled area were considered to be potentially contaminated. The floor covering consisted of 6-ft-wide runs of linoleum. The linoleum was removed and packaged as LSA contaminated waste. The concrete floor, after removal of the linoleum, was radiologically surveyed over 100% of its surface, also due to the previous release of contaminated materials. No contamination was found in the controlled area except for one "hot" spot on the glove box room floor near the nuclear materials vault. The concrete surface at this spot was chipped to remove the contamination.

The ceiling support structure surfaces were found to have measurable fixed-spot contamination in the painted surface. Abrasive pads and detergent decontamination materials were used on the painted surfaces to remove the contamination.

Figures 34 and 35 show the glove box room in the final stages of D&D.

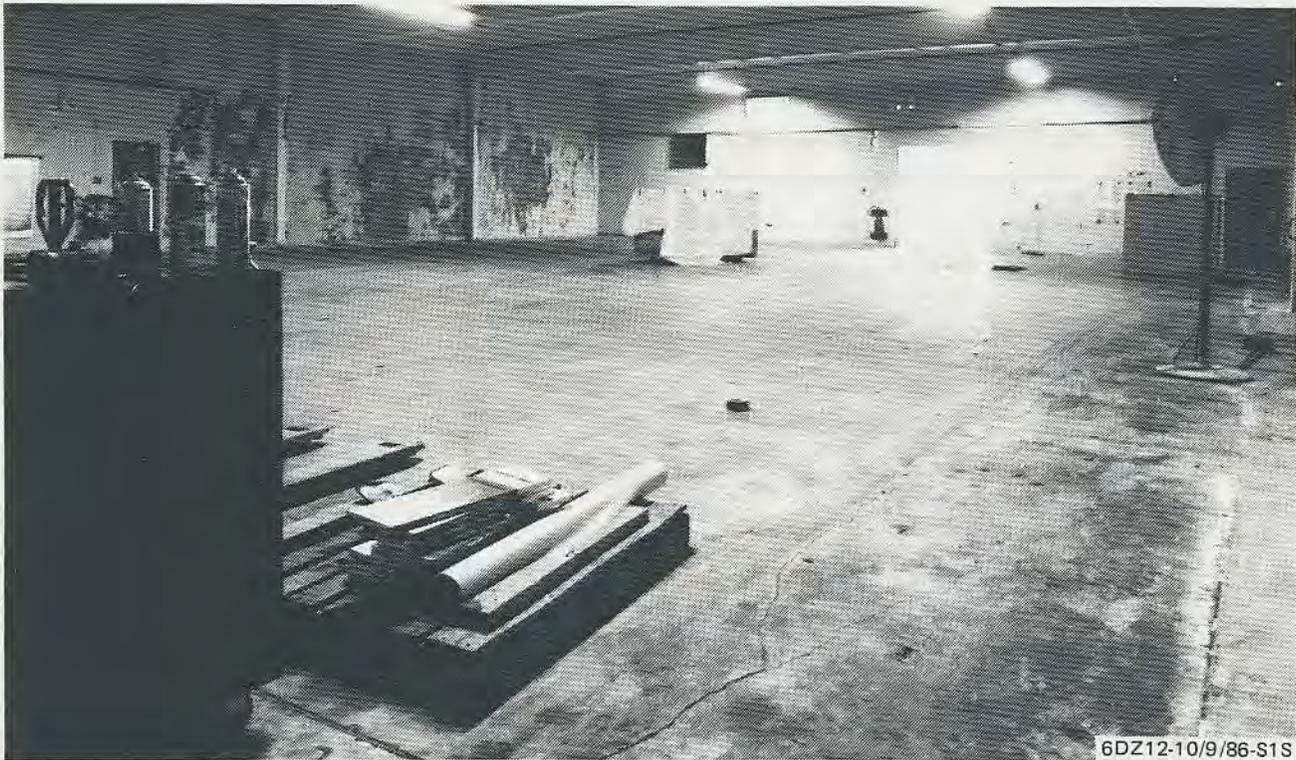
Figure 35. Glove Box Room, Final D&D

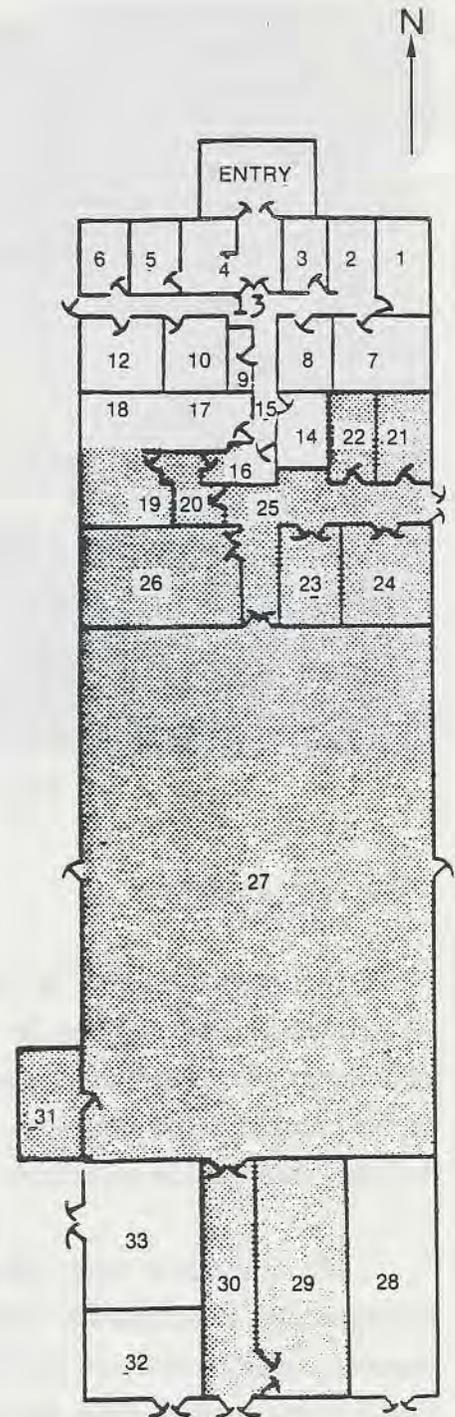
Figure 36. Access Areas, Building 055

The support areas in building 055 included all areas south of the change room entryways except for the air conditioning and heating equipment room, the electrical equipment room, and the emergency power room. Some of these areas were not expected to be contaminated but were surveyed for verification. The shaded areas in Figure 36 indicate those areas considered support areas.

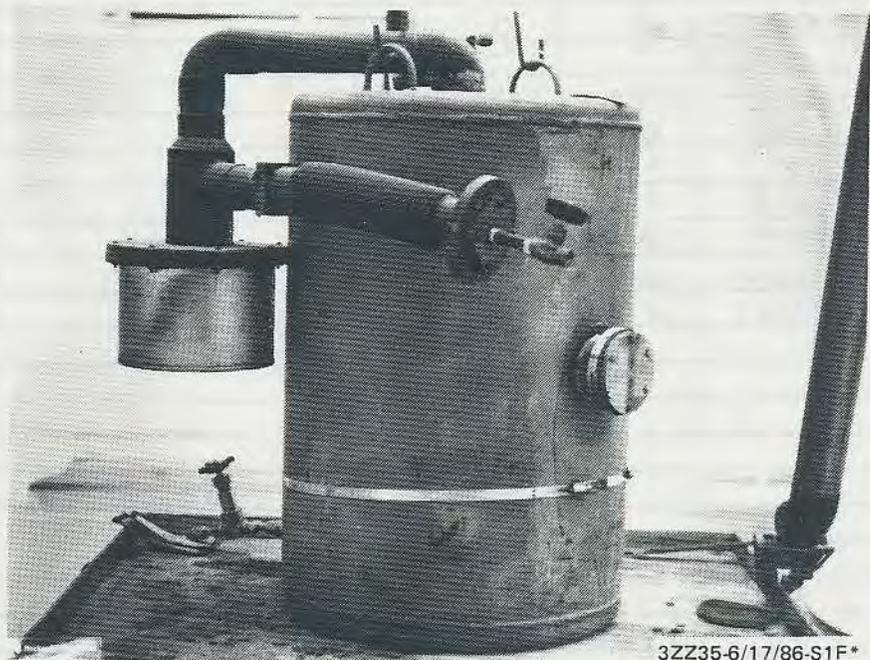
Each bubbler was a welded 300 series stainless-steel container with copper inlet and outlet pipes silver-brazed to the bubbler top (Figure 40). The outlet pipe included a filter canister (containing a phenolic-paper filter). The inlet and outlet pipe flanges were sealed with neoprene-gasketed cover plates. Seven of the ten bubblers had a 2-in.-diameter gasketed and sealed side port approximately half way up the side. The port was added when the bubblers were drained and recharged during their use period. All bubblers had a small-diameter drain line with a welded bellows valve and end cap at its base. The bubblers were internally baffled and included multiple layers of wire mesh to direct gas flow and maximize oxygen removal. Figure 41 illustrates a cross-sectional view of a typical NaK bubbler.

Figure 40. NaK Bubbler

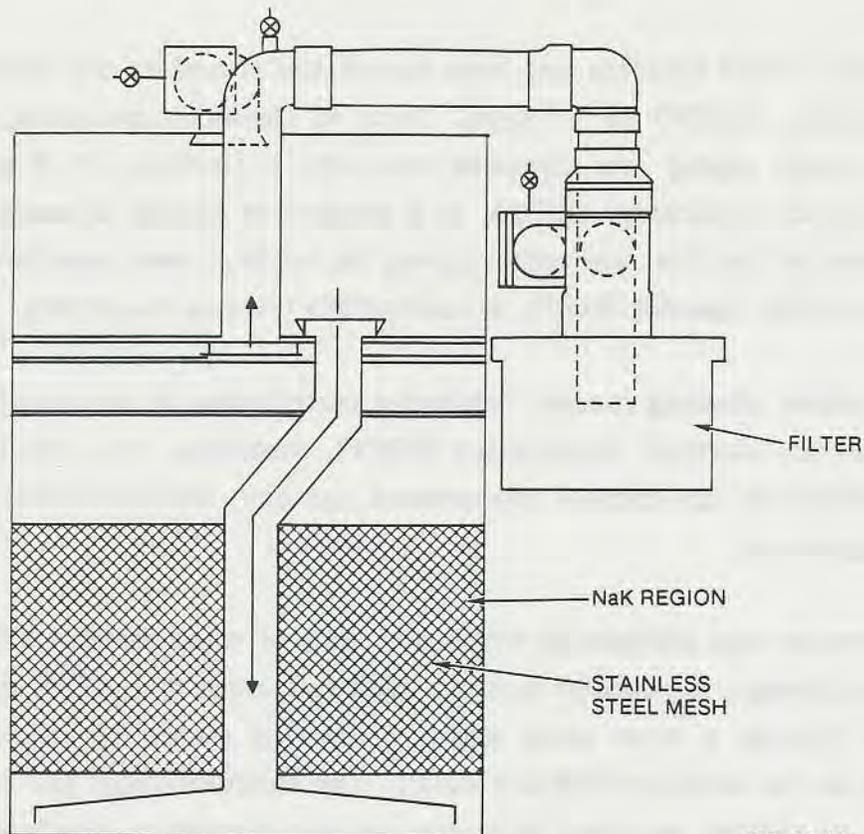
Figure 41. Cross-Sectional View of NaK Bubbler

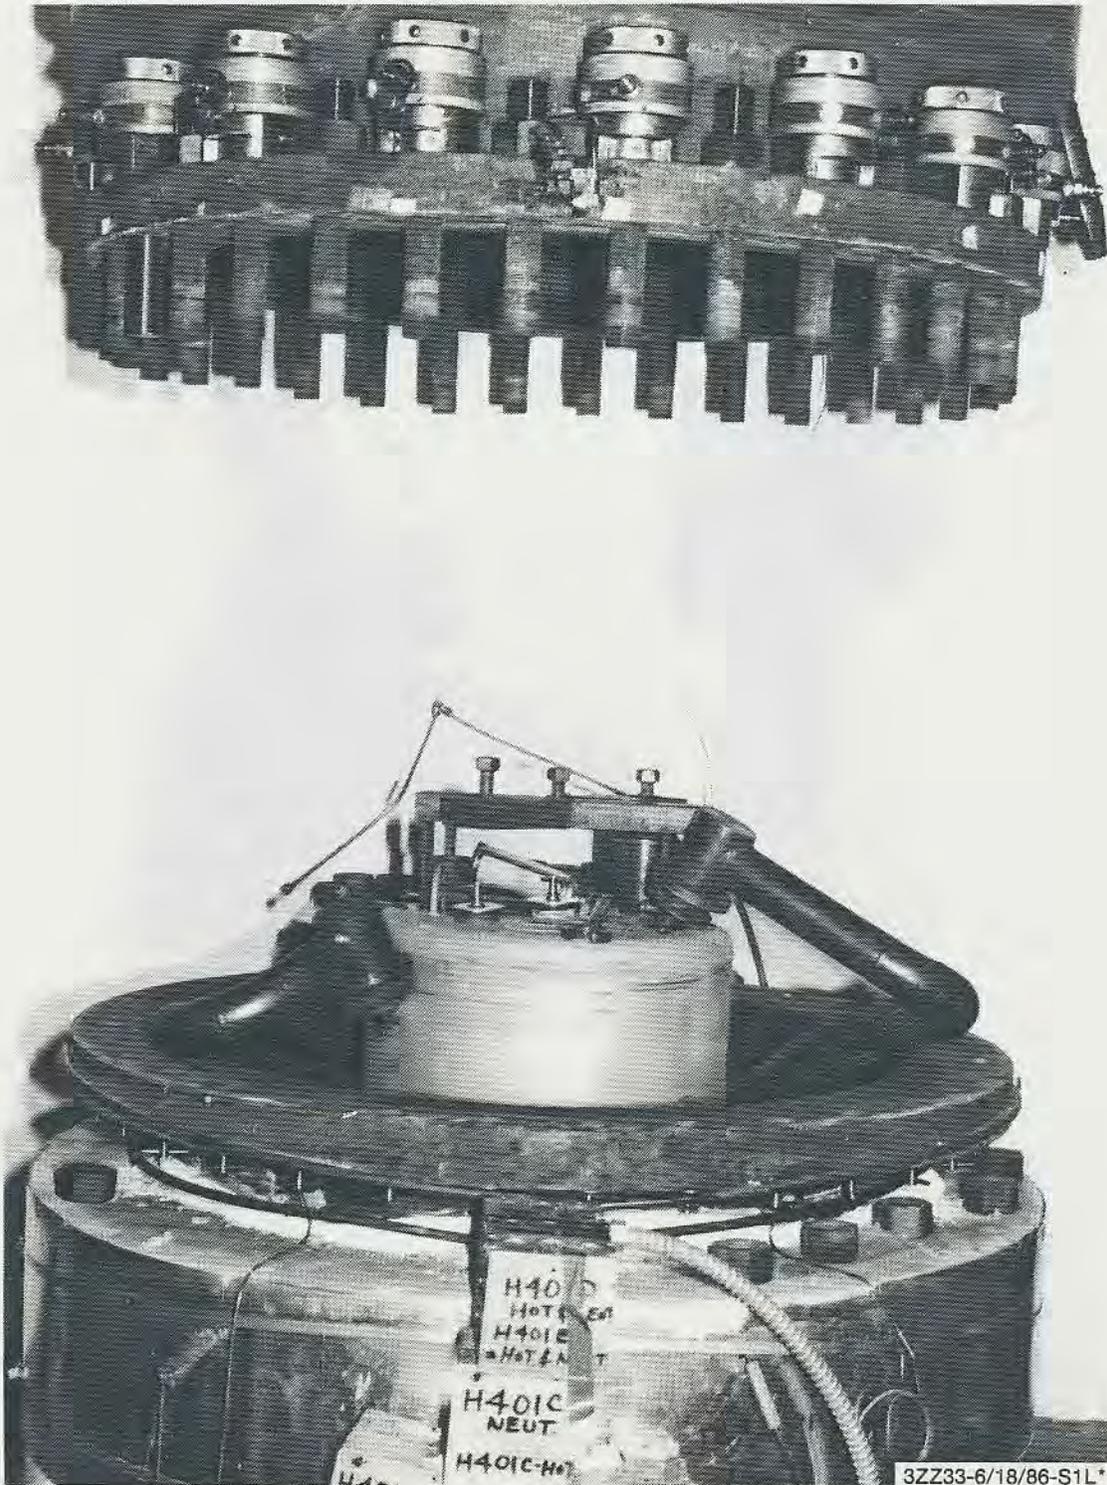
Figure 43. NaK Bubbler Cleaning Vessel

The process was designed to evaporate ~95% of the metallic NaK by passing 900°F nitrogen gas through the bubbler during a period of about 40 h. The vapor-laden N_2 gas was passed through a water spray and a single-tray absorption unit (mixing vessel) to precipitate out the metal as KOH and NaOH. The moisture-laden gas was passed through a demister to remove entrained moisture and then through an absolute filter to prevent any release of potential R/A material before being discharged into the atmosphere. The liquid was collected in the system reaction vessel and periodically transferred to holding tanks where it was neutralized by sparging with CO_2 .

Upon completion of the hot nitrogen evaporation phase, the bubbler containment vessel and N_2 gas temperature were decreased to <300°F. Dry steam was progressively introduced into the nitrogen stream and temperatures decreased until saturated conditions were achieved. The metals and oxides remaining were reacted in the bubbler and carried into the system reaction vessel. At the end of the steam phase, the vessel was cooled to 212°F and H_2O was added to the bubbler for a final rinse. Lastly, the vessel was flushed with hot gaseous nitrogen to evaporate the residual H_2O .
