**NUCLEAR MATERIALS
DEVELOPMENT FACILITY
DECOMMISSIONING
FINAL REPORT**

DOE Research and Development Report

Rockwell International

**CONTRACT: DE-AC03-81SF11565
ISSUED: 31 MARCH 1987**

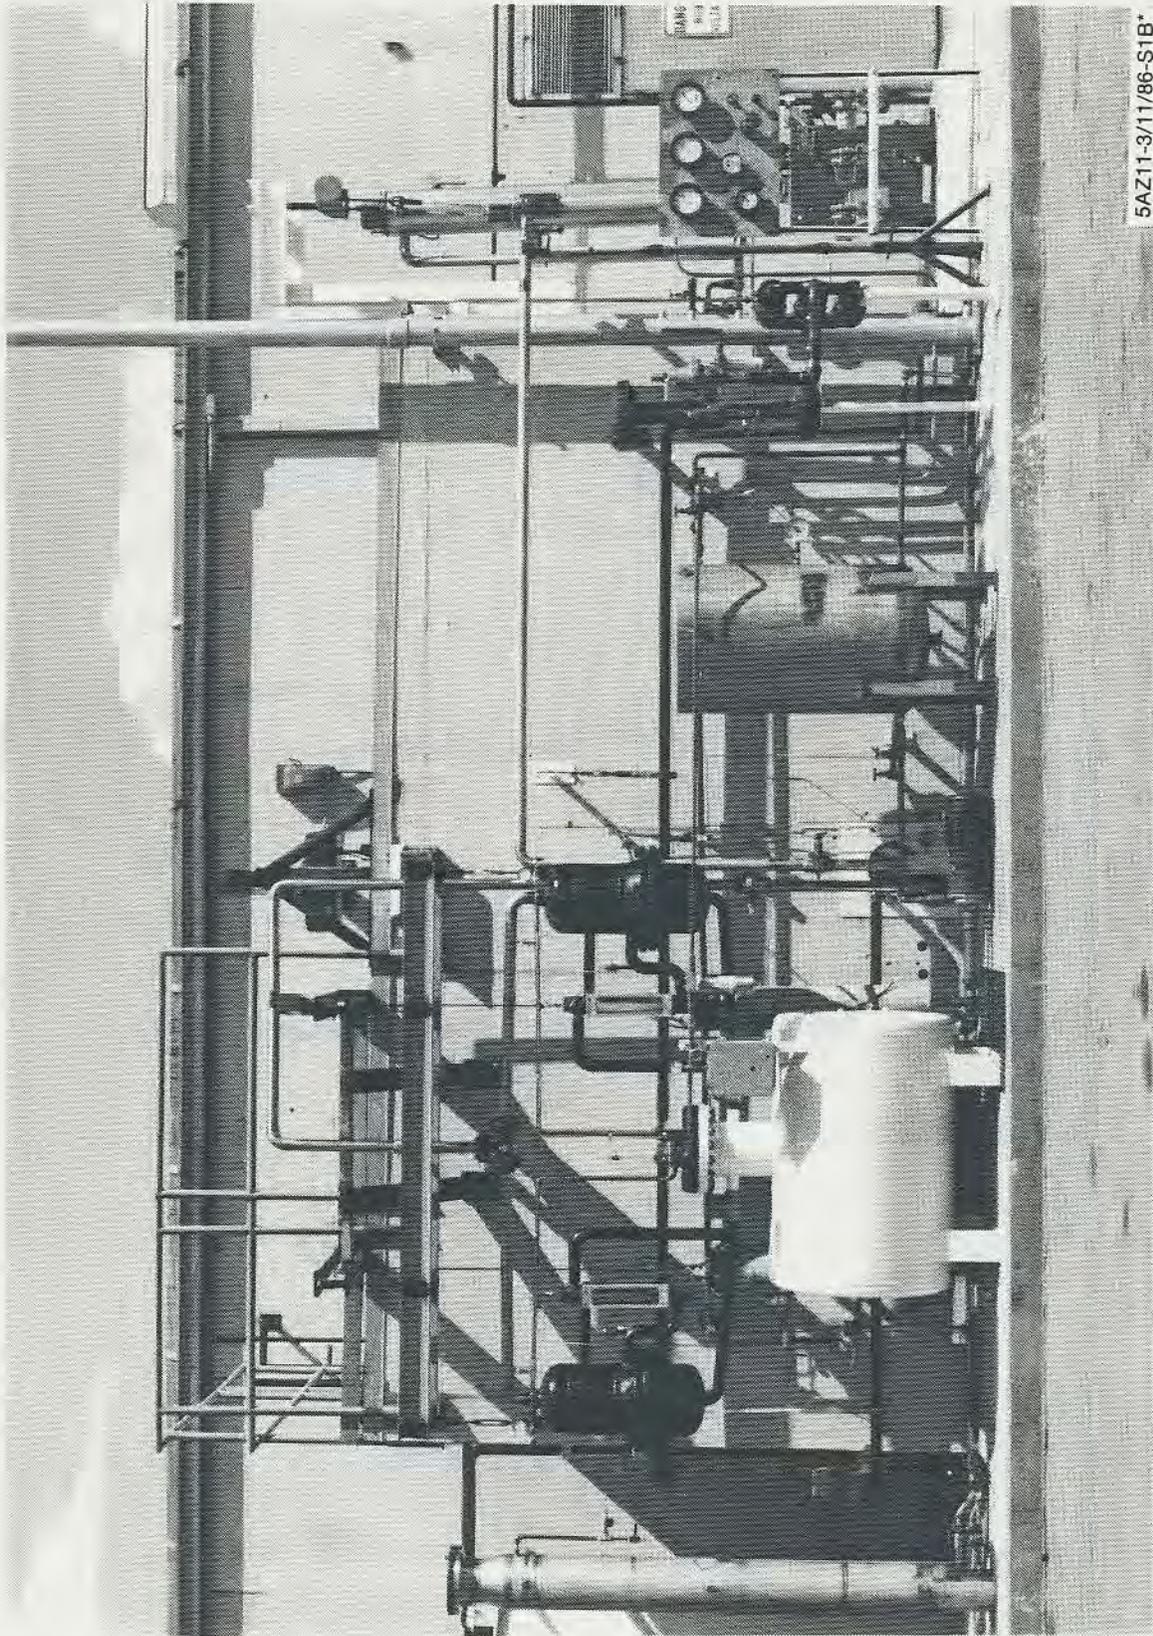
Figure 44. NaK Bubbler Cleaning Facility

The process was designed to evaporate ~95% of the metallic NaK by passing 900°F nitrogen gas through the bubbler during a period of about 40 h. The vapor-laden N_2 gas was passed through a water spray and a single-tray absorption unit (mixing vessel) to precipitate out the metal as KOH and NaOH. The moisture-laden gas was passed through a demister to remove entrained moisture and then through an absolute filter to prevent any release of potential R/A material before being discharged into the atmosphere. The liquid was collected in the system reaction vessel and periodically transferred to holding tanks where it was neutralized by sparging with CO_2 .

Upon completion of the hot nitrogen evaporation phase, the bubbler containment vessel and N_2 gas temperature were decreased to <300°F. Dry steam was progressively introduced into the nitrogen stream and temperatures decreased until saturated conditions were achieved. The metals and oxides remaining were reacted in the bubbler and carried into the system reaction vessel. At the end of the steam phase, the vessel was cooled to 212°F and H_2O was added to the bubbler for a final rinse. Lastly, the vessel was flushed with hot gaseous nitrogen to evaporate the residual H_2O .

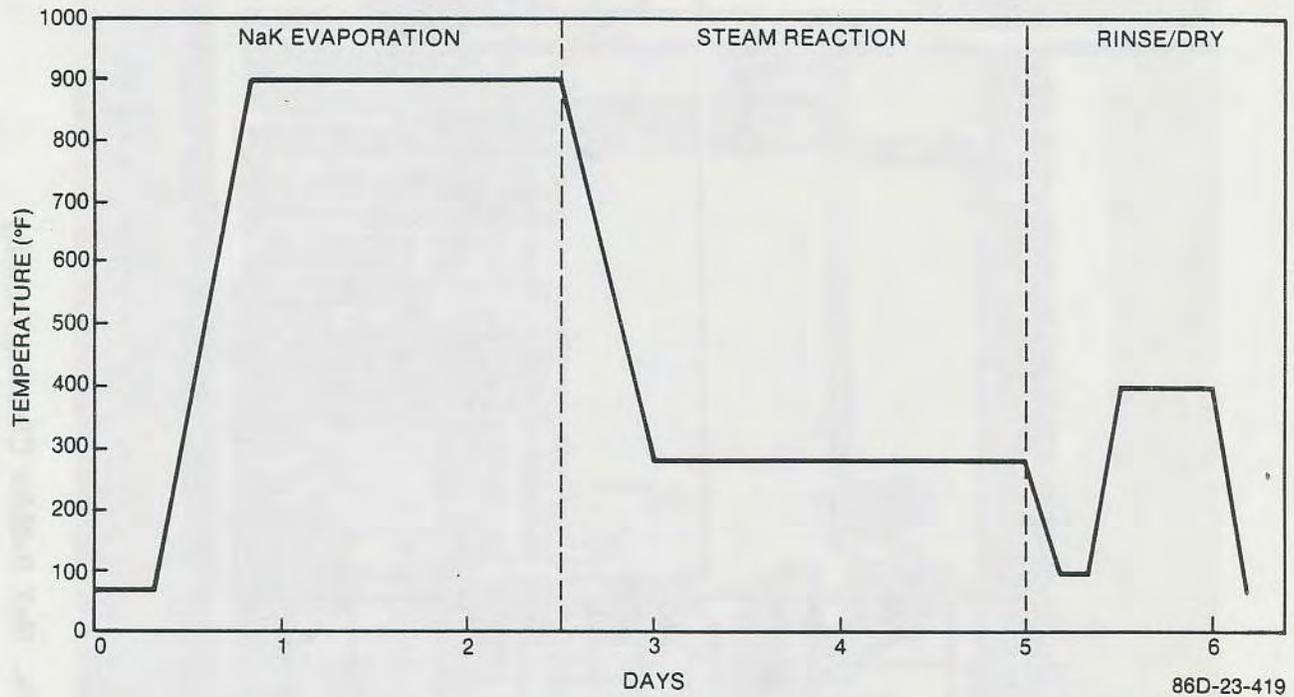
Figure 45. Bubbler Cleaning Process Time-Temperature Graph
