**S8ER FACILITIES DECOMMISSIONING
FINAL REPORT**

DOE Research and Development Report

S8ER FACILITIES DECOMMISSIONING

FINAL REPORT

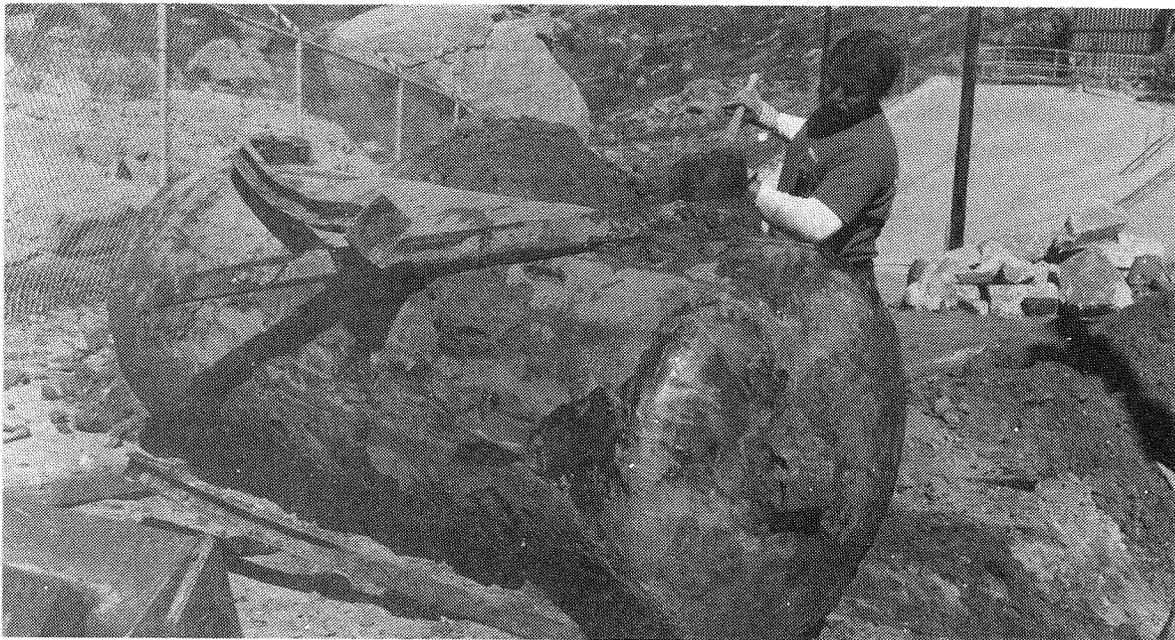
Figure 15. Radioactive Gas Holdup Tank Being Prepared for Burial

The razing techniques for the nonradioactive or decontaminated structure were conventional disassembly and salvage of the main members. Minor noncontaminated components were sold for scrap. Contaminated material not found to be economical to decontaminate (for example the waste gas holdup tank shown in Figure 15) was boxed and shipped to the disposal site.

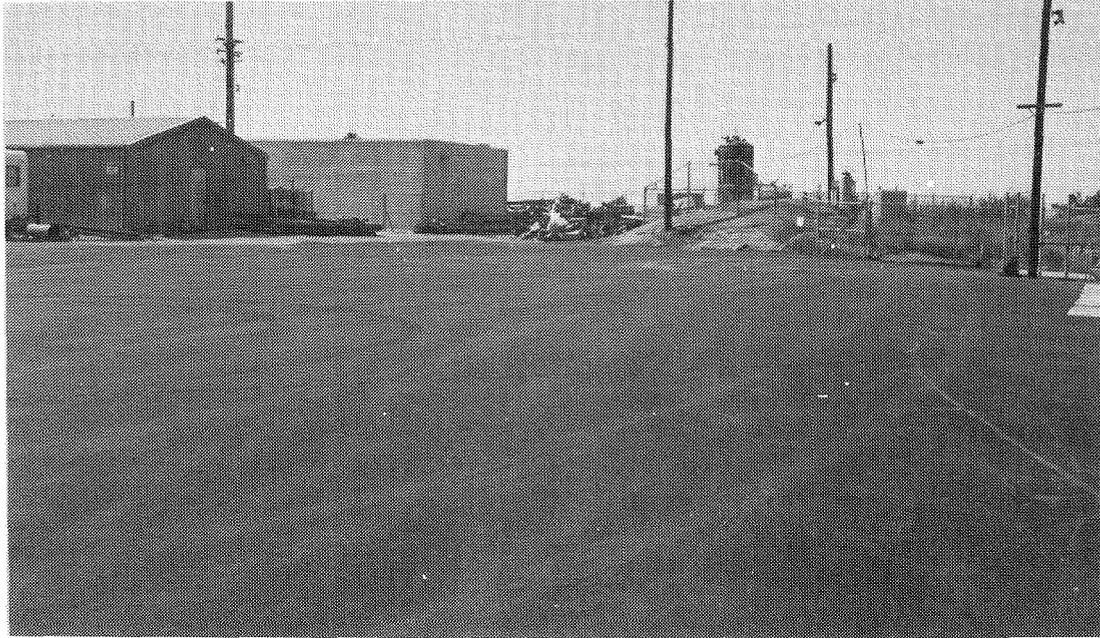
Figure 22. Completed Site Paving

The site was left radiologically noncontaminated and paved with new imported asphalt for use as a parking lot (Figure 22). No further radiation surveys are required.
