Group A

Site Summary – Building 4114

Site Summary – Parking Lot 4511

Site Summary – Old Conservation Yard

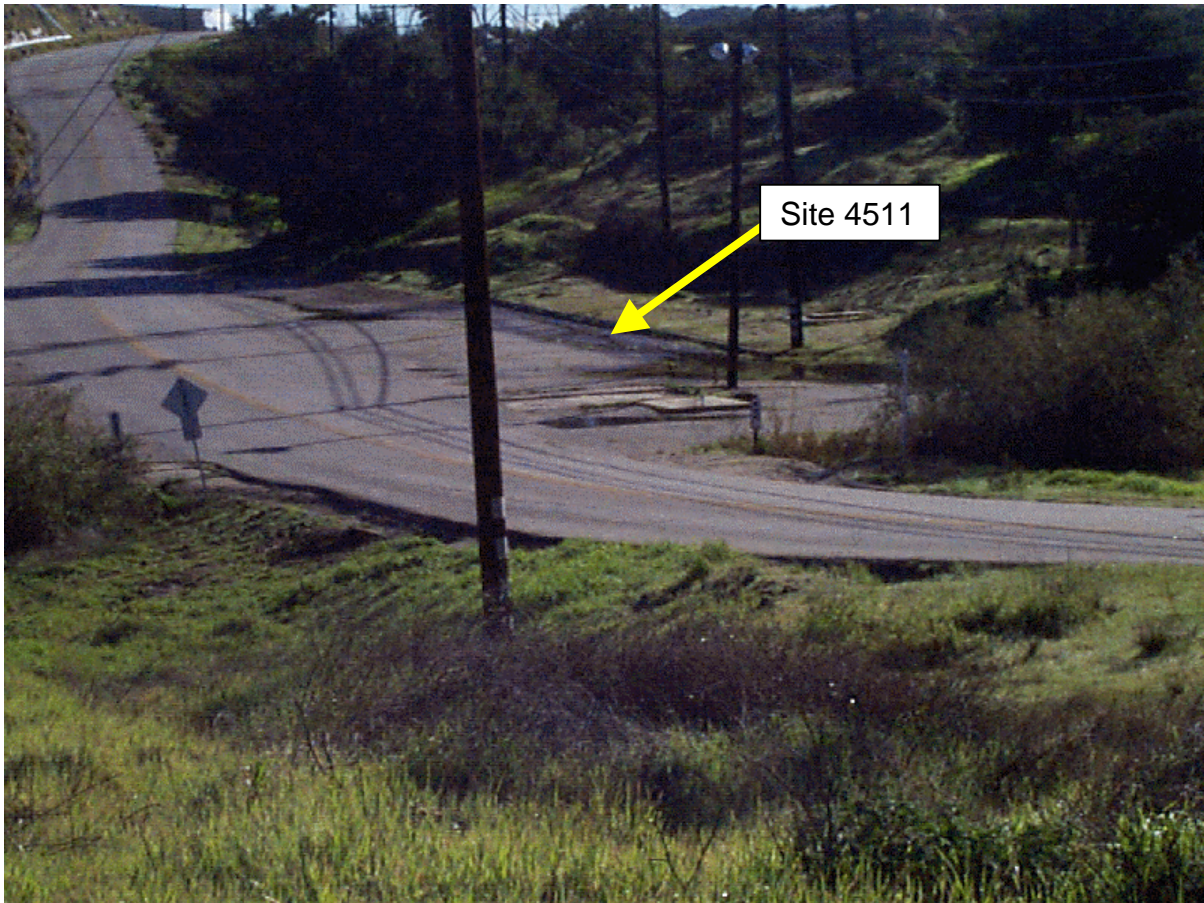
Photograph – Site 4511

- Parking Lot 4511 was an asphalt pad that was located between the OCY and Site 4583.
- Serviced by Guard Shack 4113.
- Serviced by Guard Shack 4623.

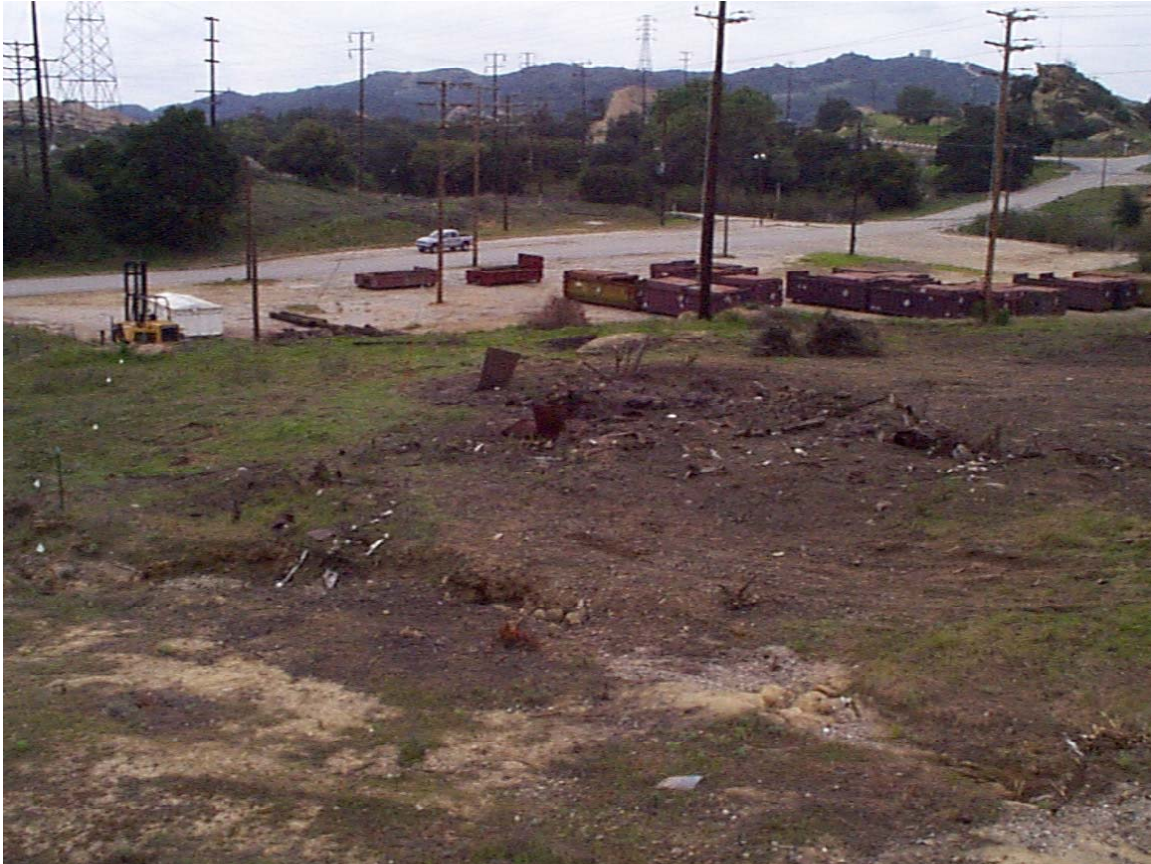
Photograph – Old Conservation Yard (OCY)

- The OCY is a natural terrain yard, and did not have a fenced boundary. It is located on an irregular plateau in a mountainous area and is approximately three acres.²
- The Barrel Storage Yard was partially paved, gravel and dirt and is approximately one acre.¹
- Serviced by Conservation Shack 4313.

- During this survey, ambient gamma exposure measurements within the fenced storage yard indicated a contaminated mud puddle in the southwest corner of the Barrel Storage/Conservation Yard. The value was approximately three times ambient background, above the acceptable limits (5 µR/hr above ambient background). Additional soil samples were collected in this area.

- All other areas of the site were below Derived Concentration Guideline Levels for ambient gamma exposure rates.
 - Soil sampling in the area found the average Cs-137 concentration at 81 pCi/g, which was above the DCGL of 60.4 pCi/g.

- The site was remediated in 1989 to remove contamination found during the 1988 radiological survey. The top four inches of soil were removed from a 20-foot by 20-foot area in the Barrel Storage/Conservation Yard. Confirmation samples were collected.²
