Site Summary Group J
AREA IV
Santa Susana Field Laboratory, CA

Site Summary – Building 4023

Building 4023
Liquid Metals Component Test Building
Corrosion Test Loop
Includes Building 4742, Substation

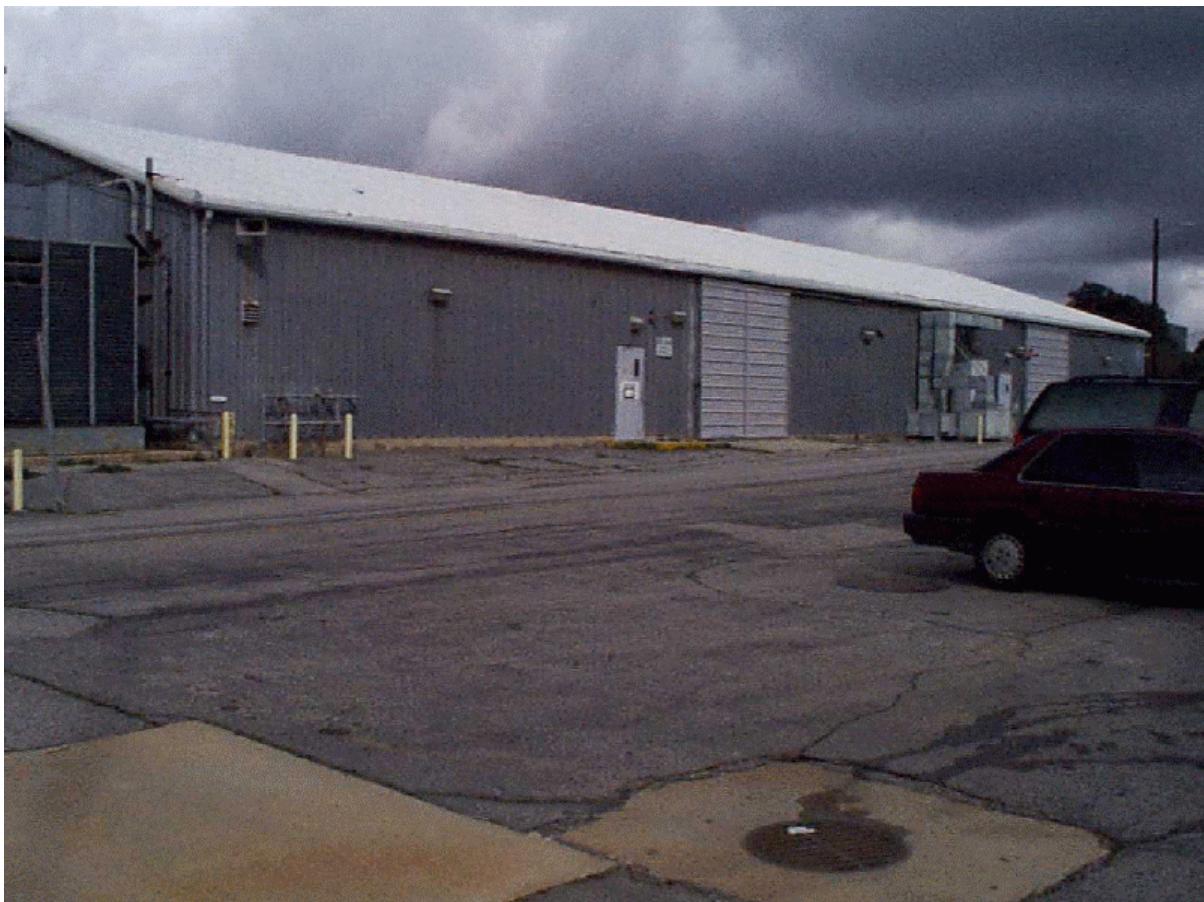
Photograph – Building 4023

- Building 4023 was a single story structure with galvanized steel walls and roof and a concrete slab floor. The sodium test loop was located in the western, or “old,” portion of the building. The “new” building section held an analytical chemistry laboratory and a storage set-up room.³
- The facility was approximately 20 feet below the general grade of the adjacent 12th Street.¹
- The waste holdup tank was located in an exterior sub-grade open-top concrete vault (7.5 feet x 10 feet x 6 feet) at the east end of Building 4023.²
- Serviced by Substation 4742.

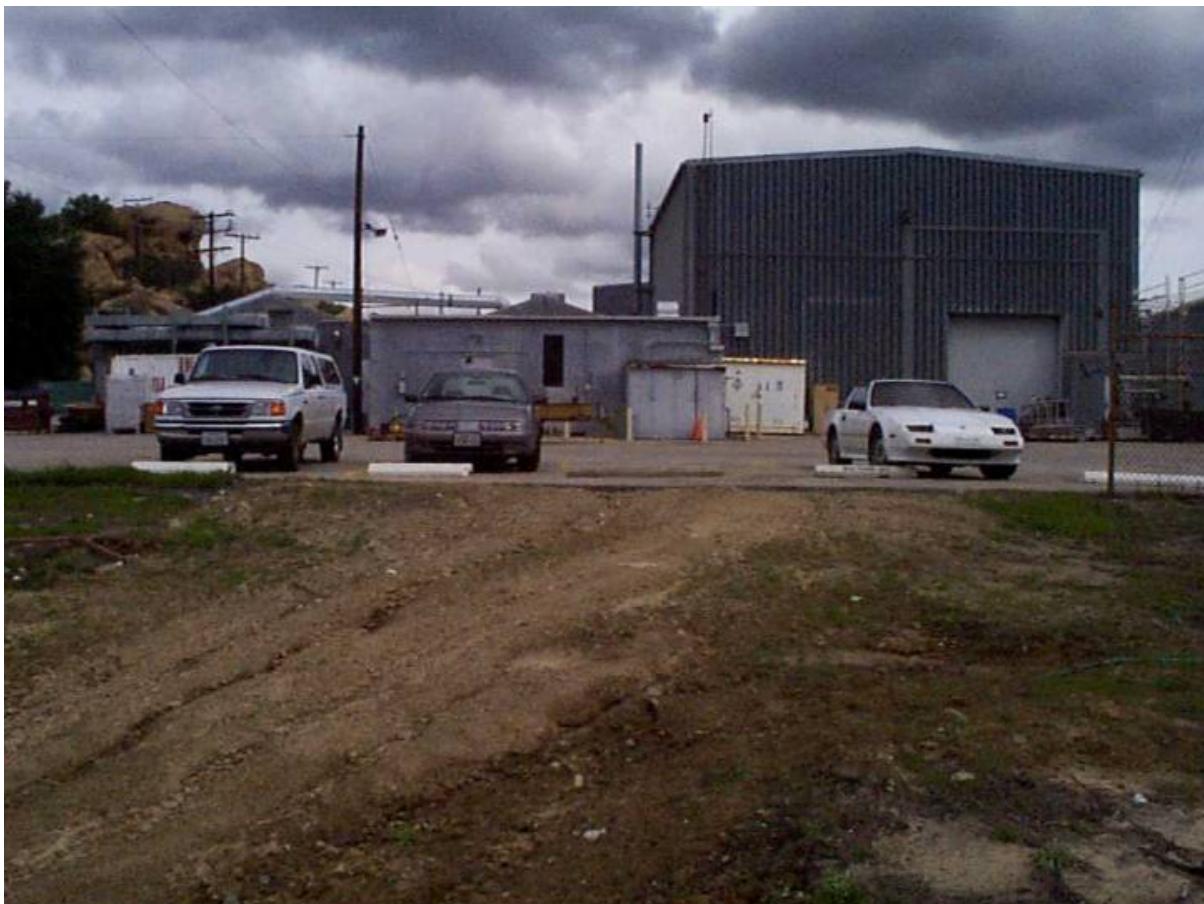
Photograph – Building 4024

- Building 4024 is constructed of aluminum siding, steel framing, some flooring and concrete.²
- The basement consists of a cell complex with two power test cells and a cell-transfer lock. This complex is constructed of shielded concrete walls ranging from two feet to nine feet thick, penetrated by various through-tubes, conduits and cooling pipes.¹

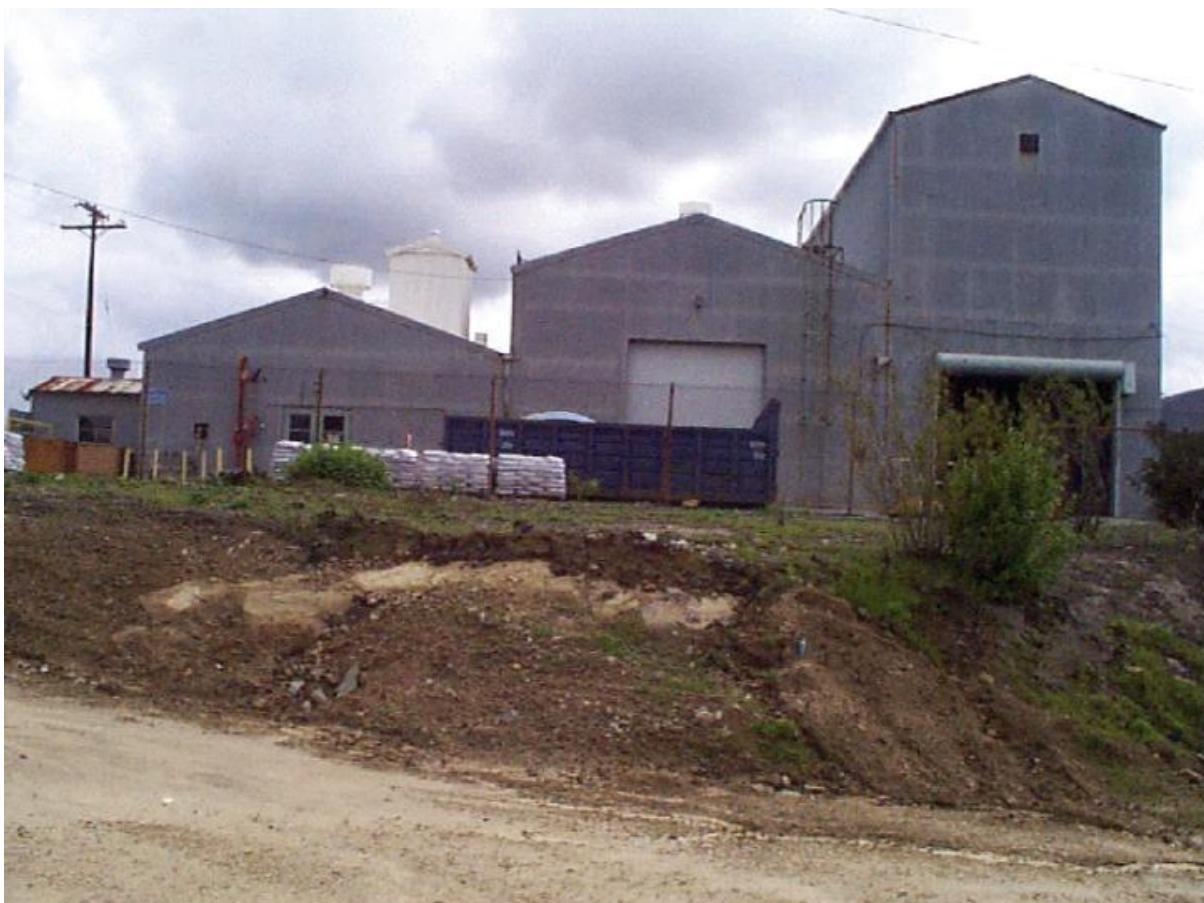
Photograph – Building 4025

- Building 4025 had a steel frame with steel sides and a steel roof and consisted of three bays. The low bay had a ceiling height of 9 feet, the middle bay had a ceiling height of 20 feet and the high bay had a ceiling height of 35.5 feet.¹
- On a 1962 Industrial Planning Map, Building 4925 Mechanical Equipment Slab and Building 4926 SRE Mock-up Equipment Area were identified as separate from but adjacent to Building 4025. In subsequent Industrial Planning Map, the outlines of Buildings 4925 and 4926 remain, but no longer have their own numbers. As such, it is assumed that both 4925 and 4926 are included in Building 4025, and that all three were treated as a single facility.^{1,2}
- Serviced by Substations 4725 and 4924.¹

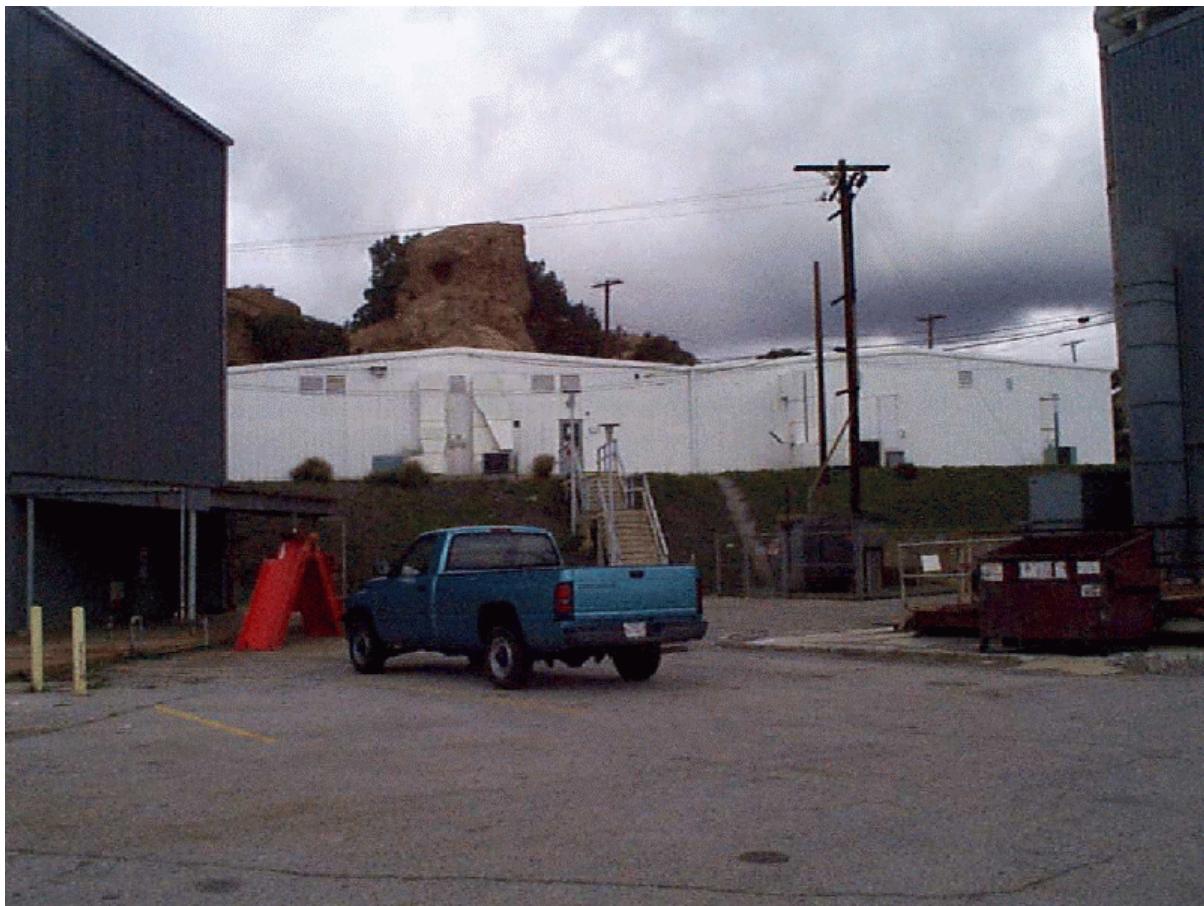
Photograph – Building 4036/4037

- Building 4036/4037 consisted of two one-story metal buildings joined together, each with a concrete slab floor and concrete foundation. The support structure consisted of steel beams with corrugated steel siding and roof. The buildings contain numerous internal partition walls with wood framing and drywall surfaces.²
- Serviced by Substation 4727.
