Group O

Group O Map

Site Summary Group O
 AREA IV
 Santa Susana Field Laboratory, CA

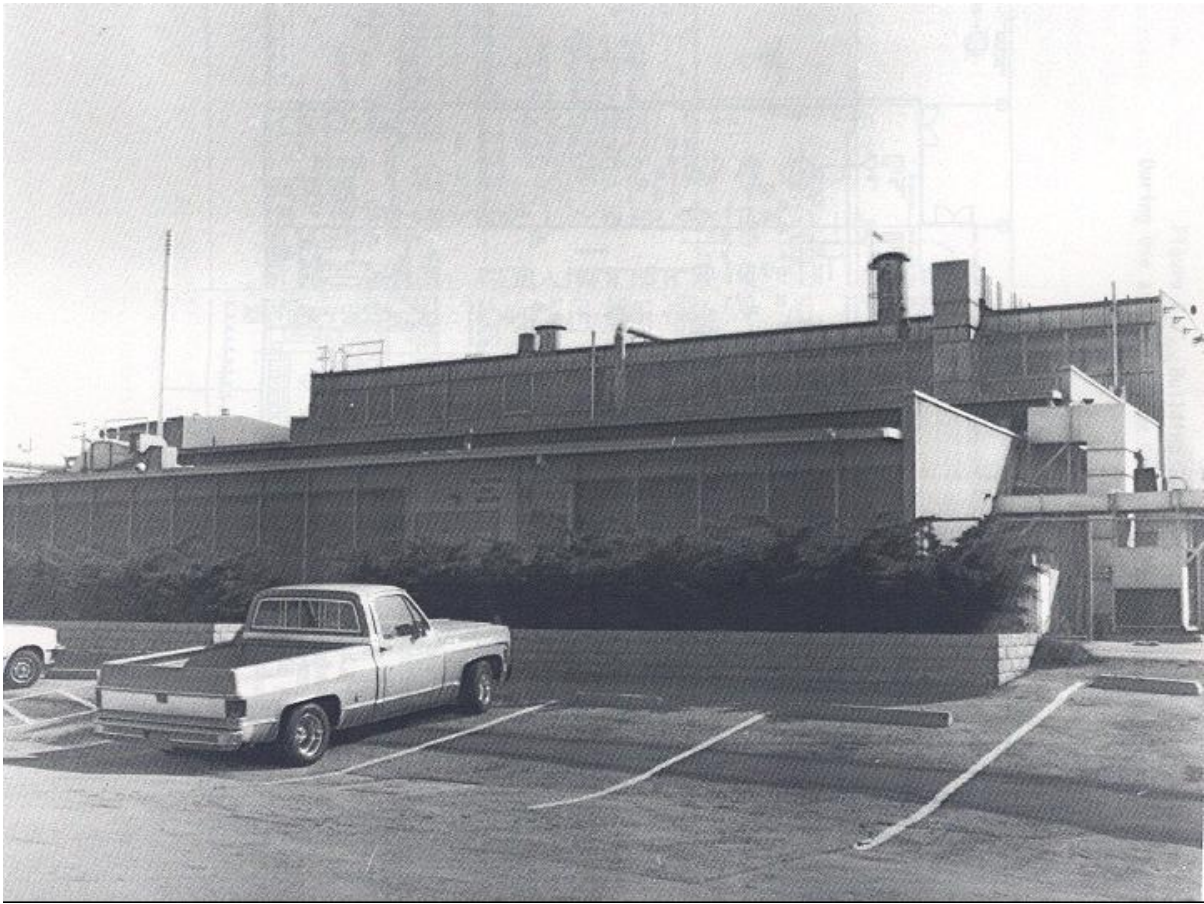
Photograph – Building 4005

- Building 4005 was a tilt-up concrete structure with Butler aluminum siding and several windows. The structure was 80 feet long (running north to south), and 60 feet wide.
- Building 4005 was divided into several portions, including a small administration area, change rooms, chemistry laboratories, storage rooms and a large high-bay area.²
- Several concrete pads sat east of the building and held various equipment from the Molten Salt Oxidation project and the radioactive filter plenums.
- Building 4005 was connected to a holding tank by drain lines.
- Serviced by Substation 4705.

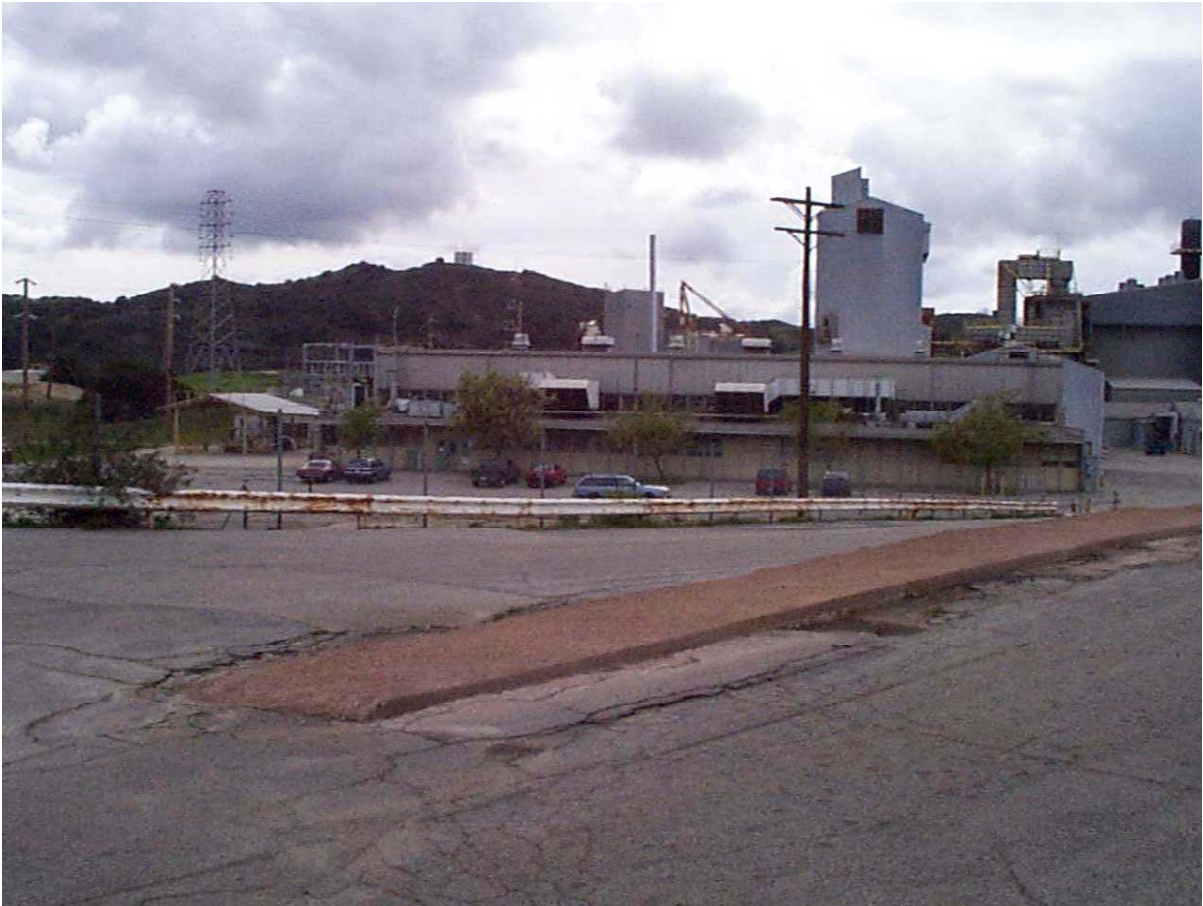
Photograph 1 – Building 4006

- Building 4006 was constructed with a steel frame and steel walls and measures 13,284 square feet, including 2,268 square feet of office space and 7,674 square feet of lab space.¹
- The building had an associated cooling tower that was removed in the early 1980s in order to make room for a Power Pak associated substation.³
- Serviced by Substation 4706.

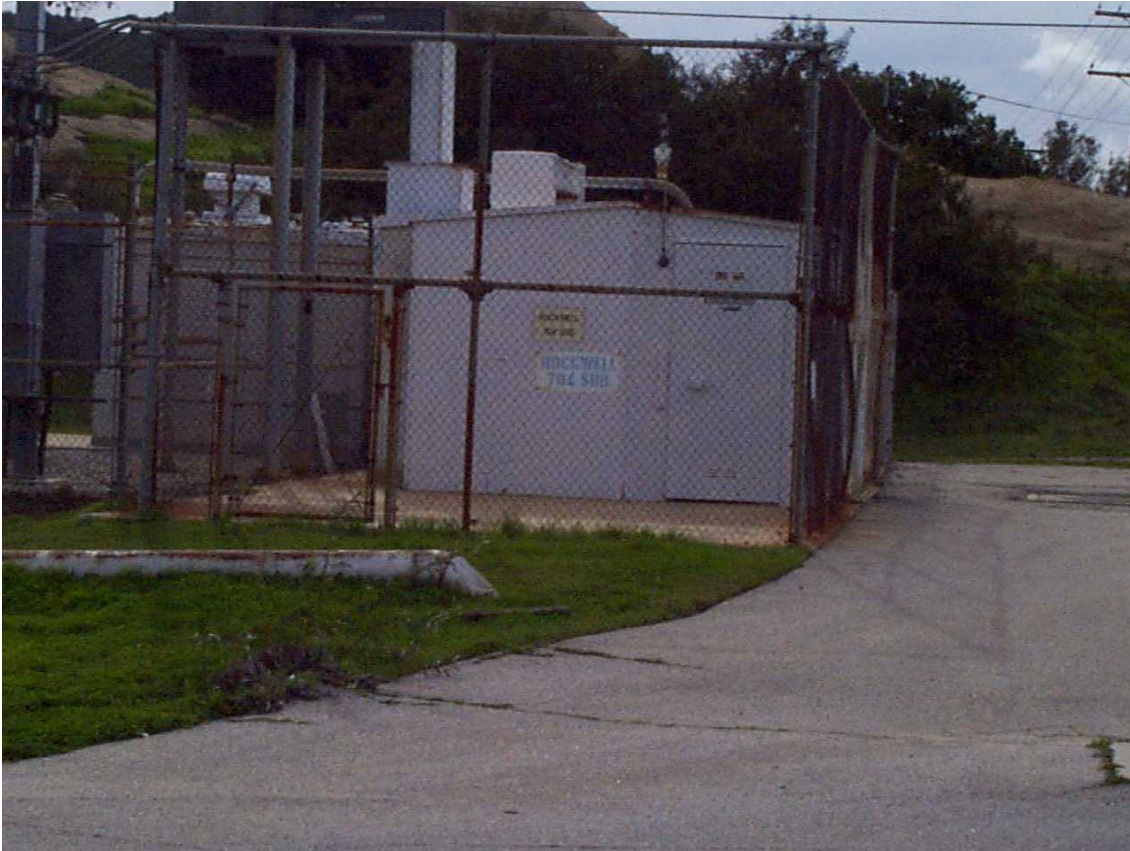
Photograph– Building 4704

- Constructed prior to 1962.
- Building 4704 is an inbound transformer adjacent to a station owned by Edison Power.¹
- Scheduled for demolition in 2004.

- Building 4704 was a small structure located at the corner of 17th and F Streets.
