Group Q

Site Summary Group Q
 AREA IV
 Santa Susana Field Laboratory, CA

Site Summary – Building 4007

Site Summary – 17th Street Drainage

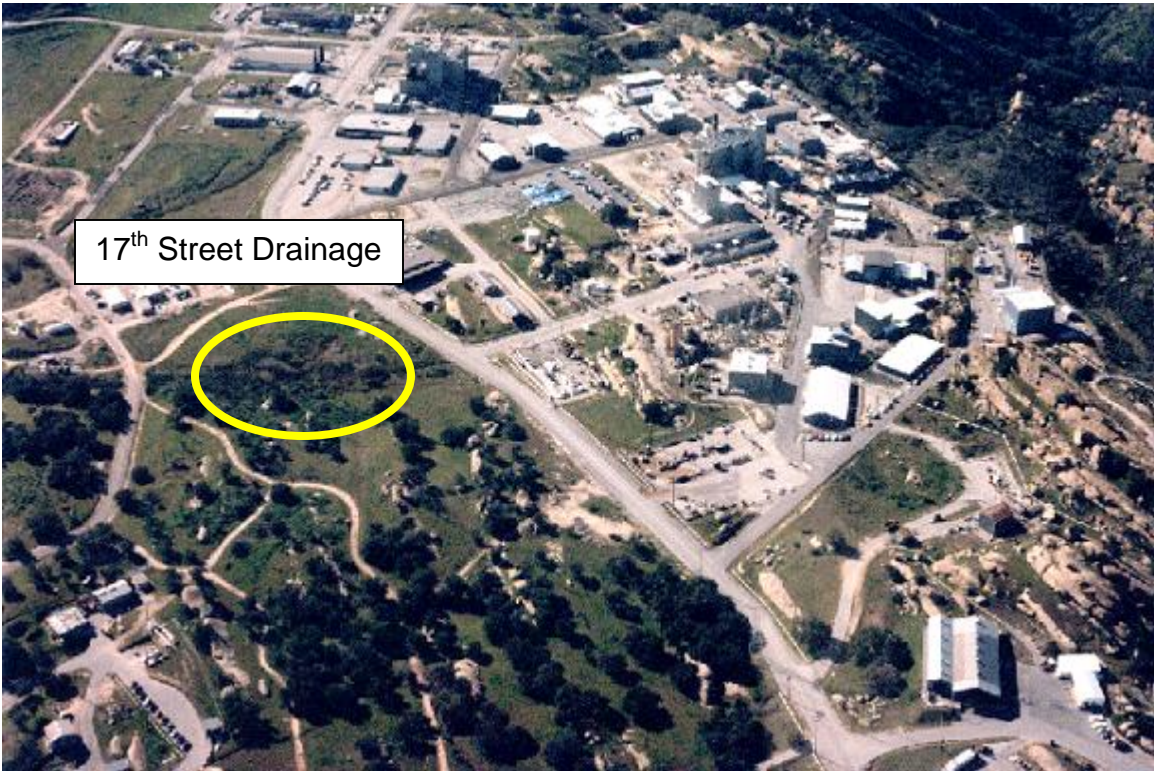
Photograph – 17th Street Drainage

- The 17th Street Drainage Area is the site of a natural rainwater channel where a berm was constructed in 1962 to permit the area to serve as a hold-up pond. Over time, the area became overgrown with shrubs and trees and filled with silt.^{2,3}
- The 17th Street Drainage Area is located south of the intersection of G and 17th Streets in the central portion of Area IV. The former hold-up pond area measures approximately 85 square meters. The entire impacted area measures 2,230 meters.¹

- The 17th Street Drainage is now dry and overgrown with grass and shrubs.
- DHS released the 17th Street Drainage for unrestricted use in 2004.⁶
