Group R

Site Summary Group R
 AREA IV
 Santa Susana Field Laboratory, CA

Site Summary – Building 4011

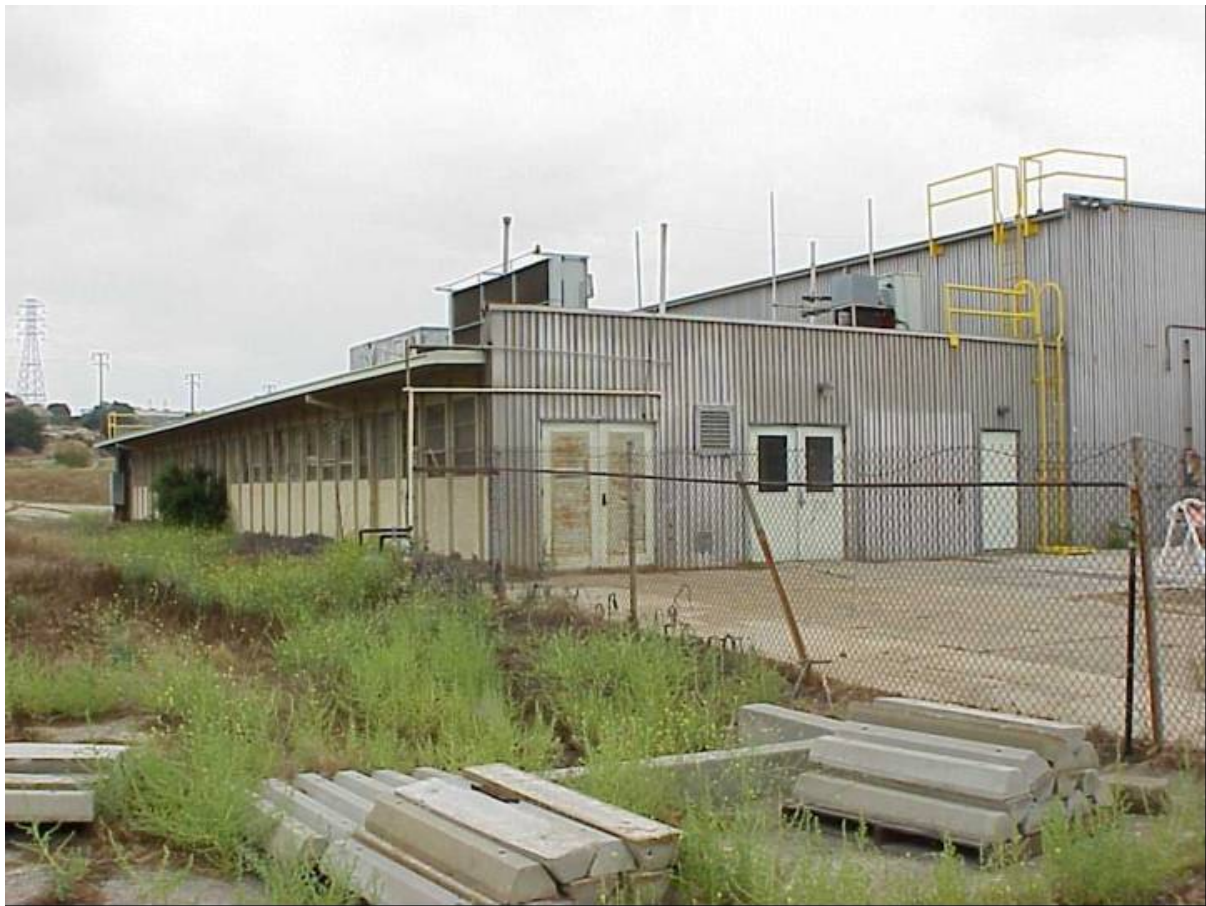
Photograph – Building 4011

- Building 4011 is a 15,120-square-foot building that was constructed out of steel.¹
- Building 4011 had an associated leachfield. The leachfield was removed in 2000.²
- Serviced by Substation 4711.
- Serviced by Traffic Dispatch Building 4403.

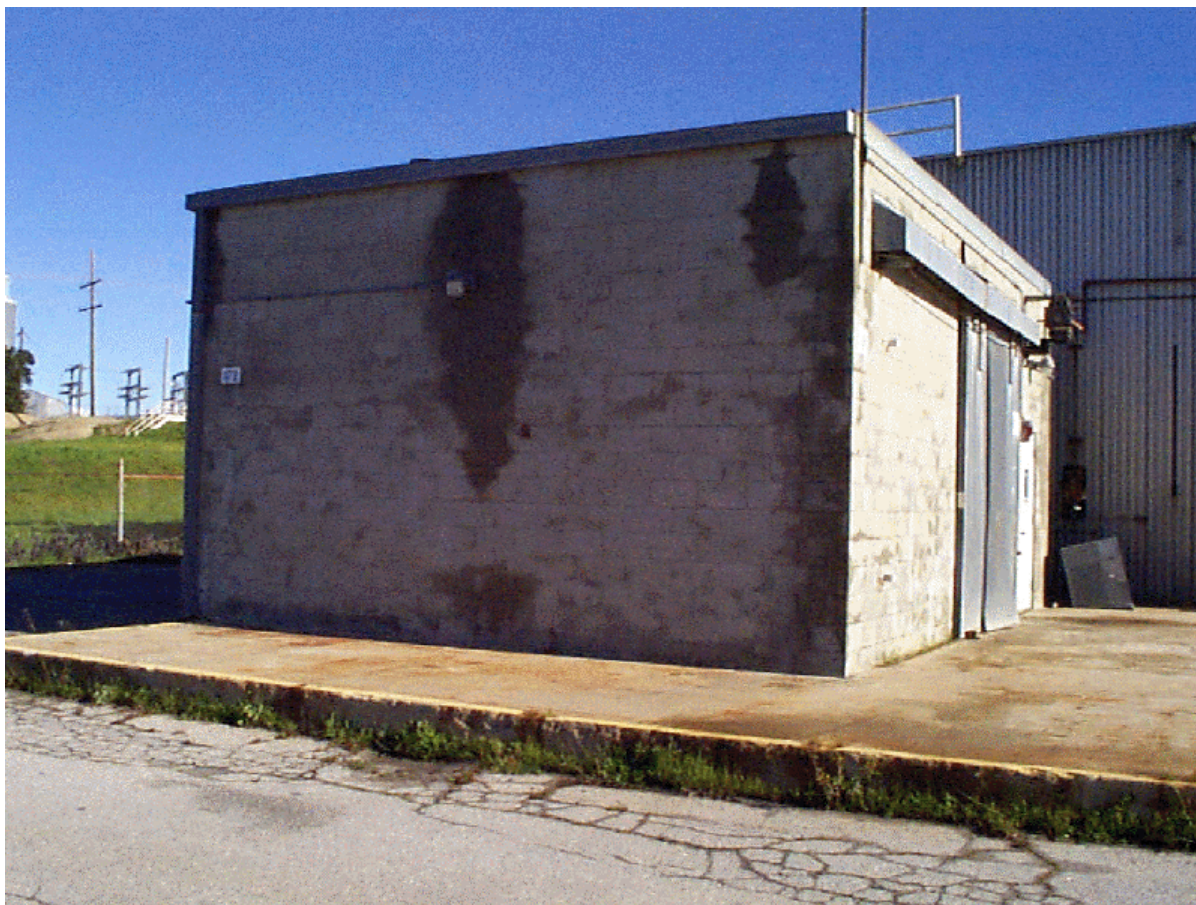
Photograph – Building 4172

- Constructed in the early 1970s.¹
- Building 4172 was used as an X-ray room and for storage of sealed sources that were checked every six months to ensure no leakage occurred.²
- Demolished in 2000.³

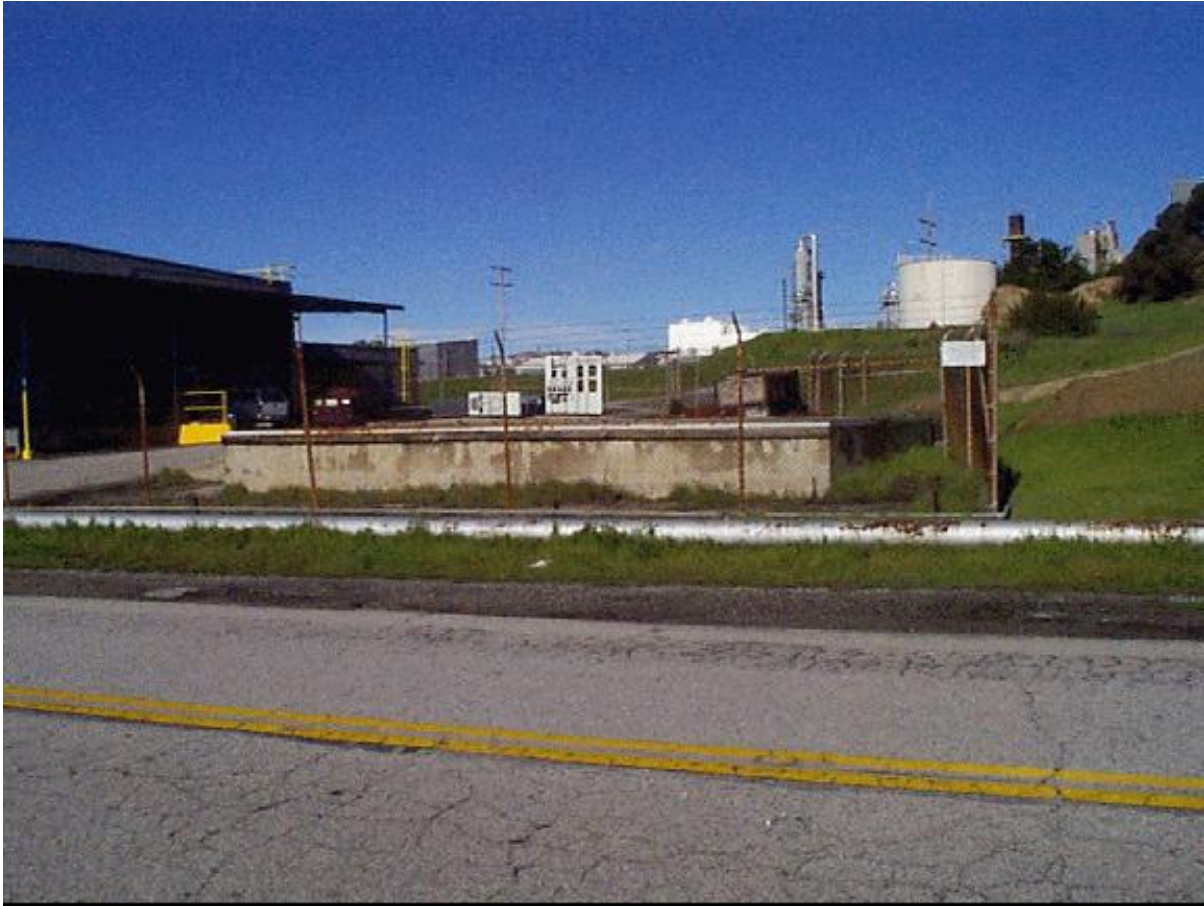
Photograph – Building 4500

- Building 4500 was a small shed built on a concrete pad.²

- The walls and foundation of Building 4500 are still in place.

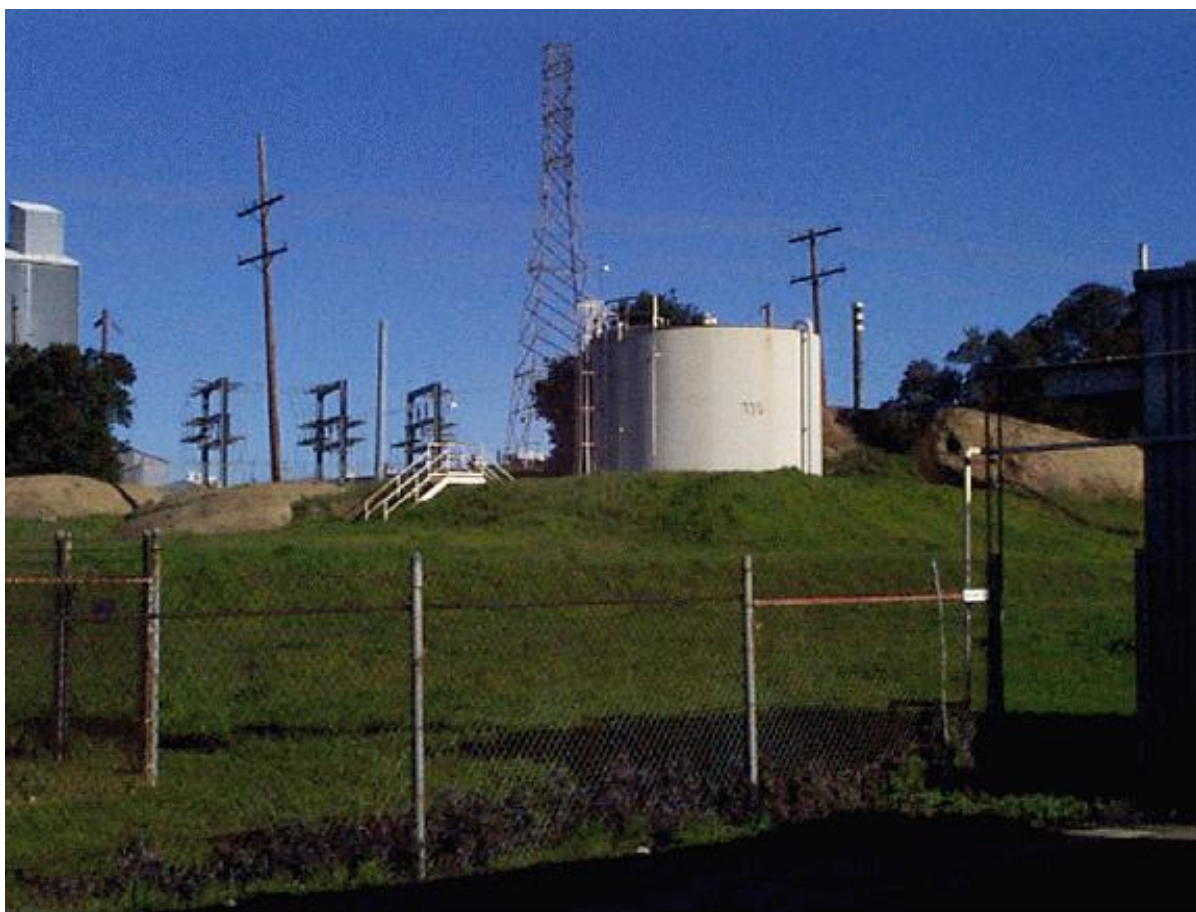
Photograph – Fuel Tank 4735

- Fuel Tank 4735 had a capacity of 86,000 gallons, was 26 feet in diameter and 24 feet tall. It was an above-ground vented structure constructed of carbon steel. A pump station was adjacent to the tank, and it contained a concrete pad with two pumps. The area was fenced.¹
