Group V

Site Summary Group V
AREA IV
Santa Susana Field Laboratory, CA

Site Summary – Building 4038

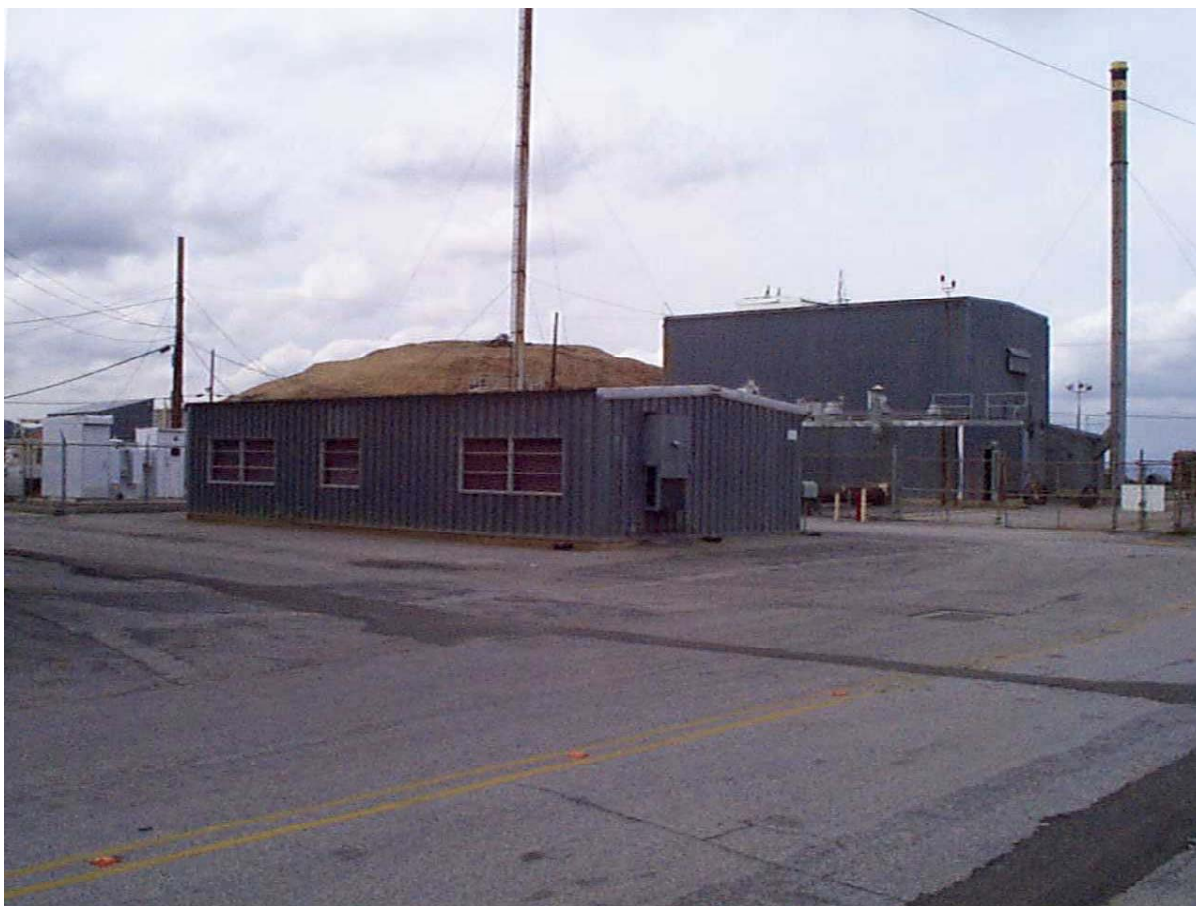
Photograph – Building 4039

- Building 4039 was a single-story structure constructed of galvanized steel walls and roof that were anchored to a concrete slab floor. Various types of internal walls and partitions were used.¹

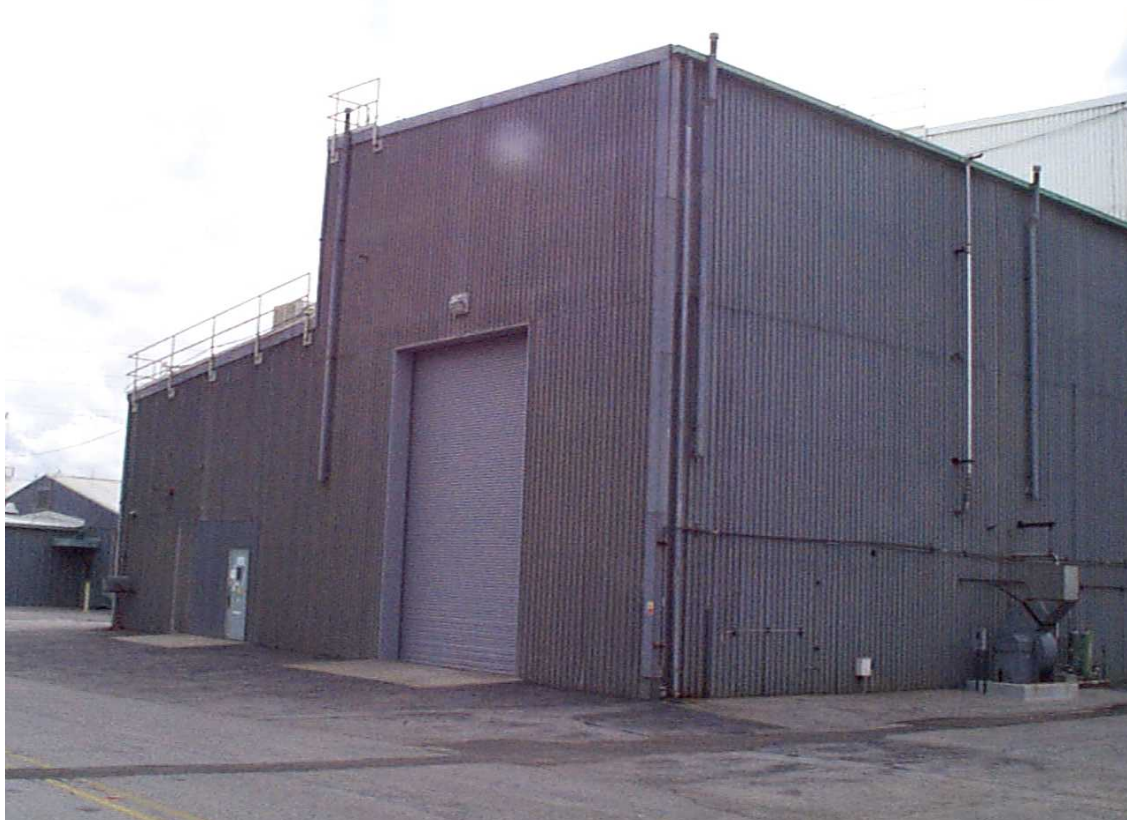
Photograph – Building 4057

- Building 4057 was constructed of a steel frame, siding and roof anchored to a concrete slab. The building had both 5-ton and 20-ton cranes. The ceiling height is 23 feet and 20 feet 6 inches at the two respective levels.¹
- Serviced by Substation 4757.
