GO Number	S/A Number	Page 1 of	Total Pages	Rev. Ltr/Chg. No. See Summary of Chg.	Number
97055	36120	25	26	A	EID-04461
Program Title CLOSURE OF ETEC (R21-RF)					
Document Title FINAL REPORT FOR DECONTAMINATION & DECOMMISSIONING OF THE DESOTO 104 HELIUM MASS SPECTROMETER LABORATORY					
Document Type D&D Report			Related Documents		
Original Issue Date 08-19-99	Release Date RELEASE 9-24-99 CW		Approvals R. D. Meyer	Date 08-04-99	
Prepared By/Date D. Stelman / July 27, 1999	Dept. 916	Mail/Addr T006	P.H. Horton	07-29-99	
IR&D Program? Yes <input type="checkbox"/> No <input checked="" type="checkbox"/>			S. E. Reeder	07-29-99	
If Yes, Enter Authorization No.			M. E. Lee	08-02-99	
Distribution			Abstract

*	Name	Mail Addr.	This report documents the activities and results of the decontamination and decommissioning of the DeSoto 104 Helium Mass Spectrometer Laboratory.

FINAL REPORT FOR DECONTAMINATION & DECOMMISSIONING OF THE DESOTO 104 HELIUM MASS SPECTROMETER LABORATORY

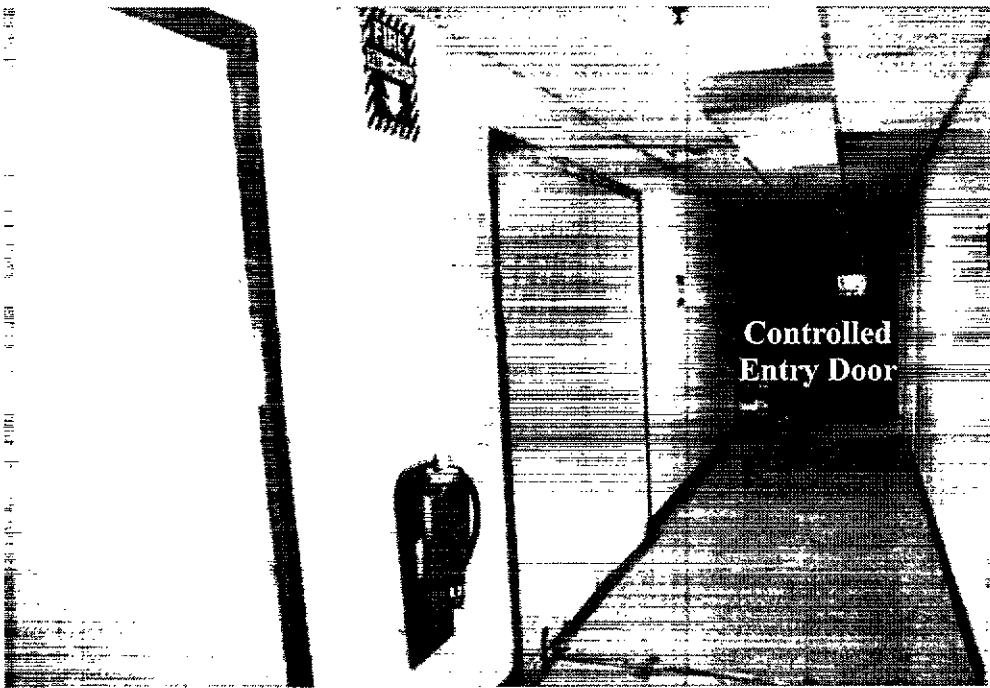
Figure 4. Barriers isolating the remediation area from the rest of the facility.

Figure 5. Barriers isolating the remediation area from the rest of the facility.

Figure 6. Barriers isolating the remediation area from the rest of the facility.

The remediation began in November 1997. Prior to the start of remediation activities, a radiological survey identified contamination levels on equipment and materials within the area. Barrier walls were installed to isolate the affected labs from the rest of the facility, as shown in Figures 4 to 6. This prevented non-remediation personnel from entering the area and ensured containment of material within the area. The entrance to the area was enlarged to accommodate the equipment to be employed (i.e. a small forklift and a small tractor-backhoe).
