ETEC Building Demolition

Summary

Demolition of the Sodium Pump Test Facility (SPTF)

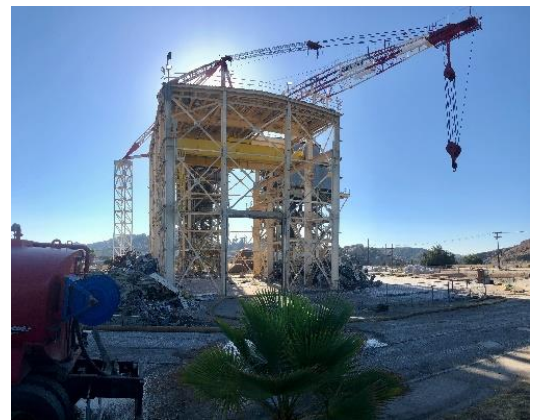
Sodium Pump Test Facility mid-demolition

The SPTF was too tall to use conventional demolition methods of long-reach shears and there were elevated risks to workers’ safety with other demolition techniques. SPTF demolition included the one-time use of shaped charges, directed explosives that concentrate force in a particular direction. This ensures that the structures fall in a predetermined area, minimizing potential for impacts. The use of shaped charges followed strict safety protocols, added a layer of protection for workers, and DOE air monitoring data confirmed that it posed no risk to the community.

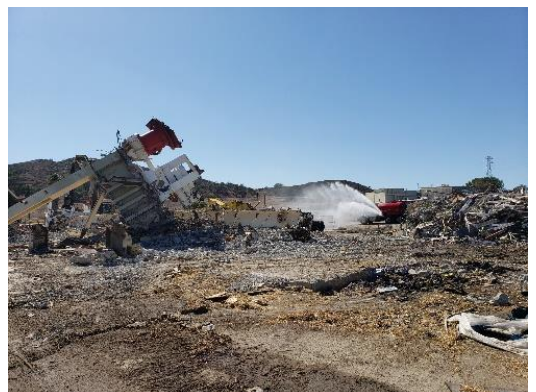
Sodium Pump Test Facility post-demolition dust suppression

A variety of dust control techniques were used in ETEC building demolition. For demolition of the SPTF, the buildings and surrounding areas were pre-wetted for dust suppression. Experts determined that pre-wetting the ground and structure itself was as effective as water cannons for dust control for demolition of this nature. The prolonged use of water cannons also posed additional concerns with water runoff.

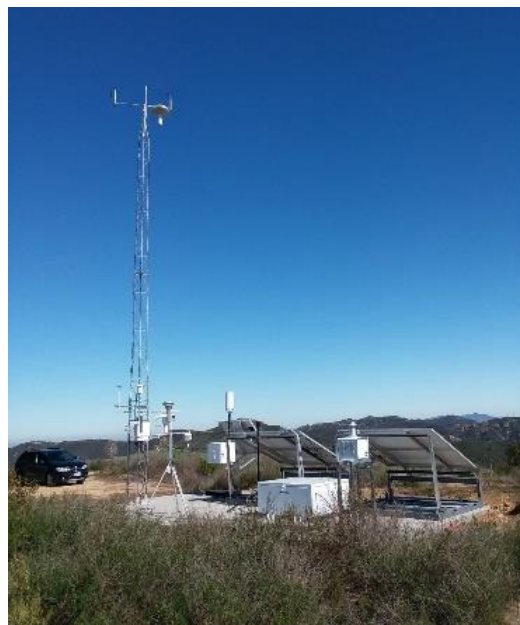
On-site air monitoring

In addition to the four perimeter air monitor sites installed before ETEC demolition, three additional local air monitors were positioned in immediate proximity to the SPTF – two units downwind and one unit upwind. DOE monitored air quality prior to and throughout the demolition process and found no increase in particulate matter around the perimeter of the site from any building demolition, including the activity on October 1, 2021.
