ENERGY TECHNOLOGY ENGINEERING CENTER

No. SSWA-ZR-0001 Rev.
Page 1 of 72
Orig. Date 01/14/94
Rev. Date

SAFETY REVIEW REPORT (SRR)

TITLE: FINAL RADIOLOGICAL SURVEY REPORT OF BUILDING 064 INTERIOR

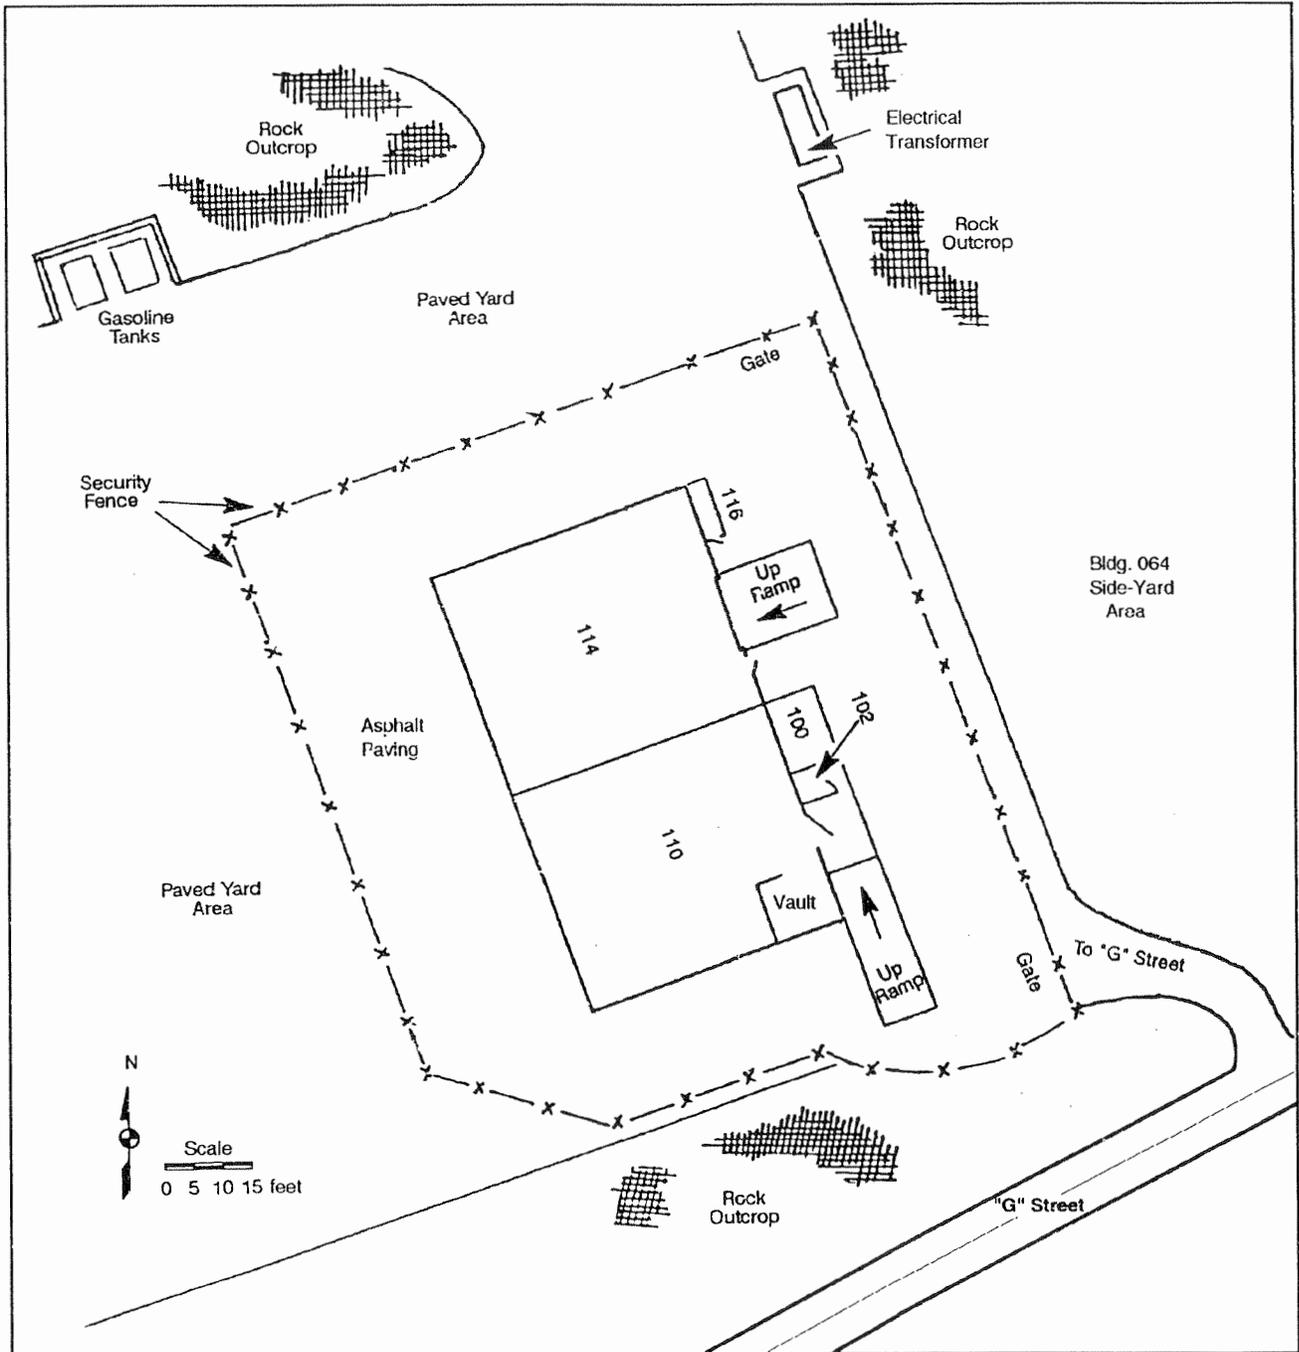
Figure 4. Building 064 Plan View

Figure 4 is a plot plan of the building and immediate surrounding yard area. The facility sits atop a plateau about 25 ft above "G" Street and slightly above the 513 parking lot. Rock outcroppings exist upslope to the north-northeast and downslope in every other direction. Water runoff is primarily due east at the southern end of the facility. A sanitary leach field existed several years ago just north of the access road to "G" Street on the southeast section of the property. The building is surrounded by a chain link fence which is located from 20 to 30 ft from the exterior walls of the building. The area it encloses, including the building, is about 11,000 ft².

There are three points of access to the site location of Building T064. One access is directly from the north through the 513 parking area which is on the east side of 10th Street. A second point of access is directly off 10th Street at the NW corner of the facility, and the third is a short paved roadway connecting the SE corner of the facility with "G" Street to the east. There are two gates for accessing the fenced-in storage yard. One from the northeast corner, off of the 513 parking lot. The other from the southeast corner, off of "G" Street. Figure 5 is an aerial photo of Building T064 as viewed from the east side of the facility including the dock, office, crane, and main entrance.

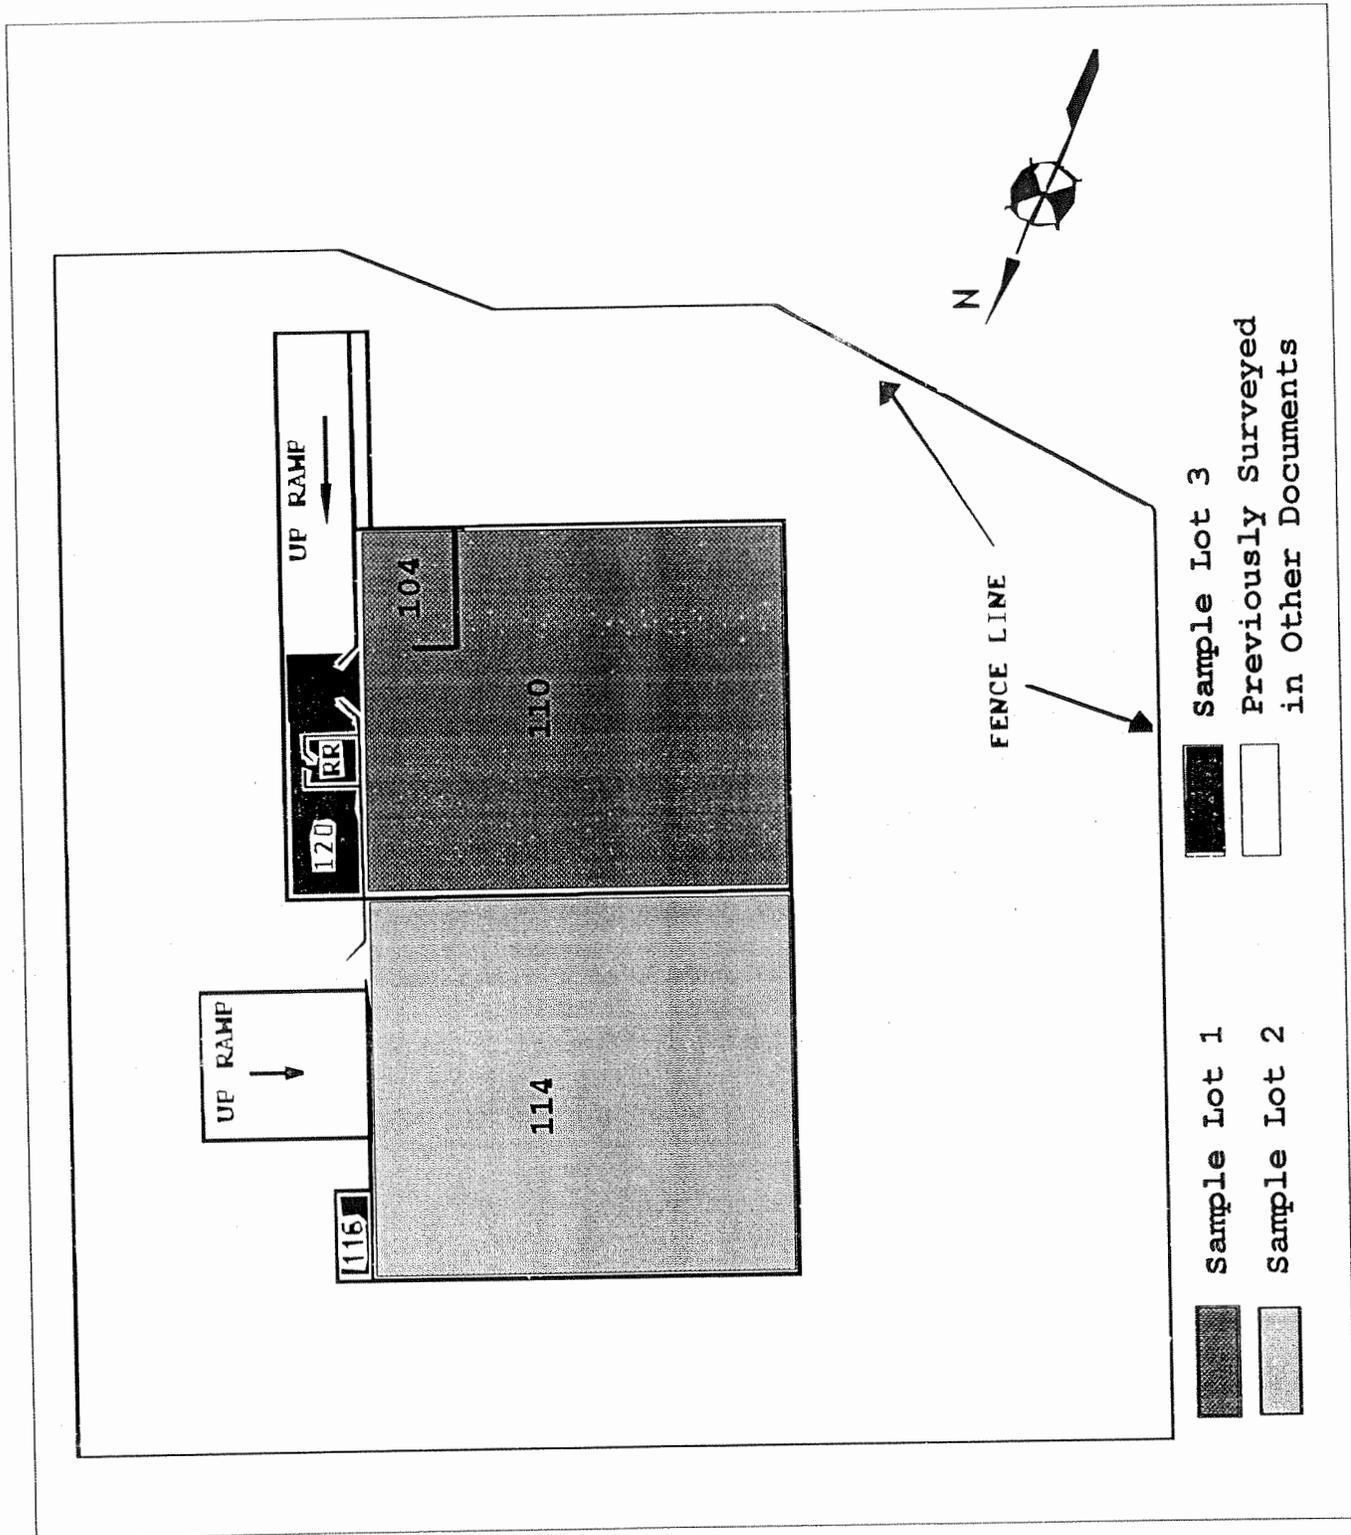
Figure 6: Building 064 Interior Sample Lot Identification

For the final radiological survey of Building 064, the interior rooms and office were separated into sample lots. These sample lots are graphically shown in Figure 6. Sample lots were treated separately for the purposes of statistical data analyses. Distinguishable properties for selecting the sample lots were areas or rooms which contained contaminated components that were recently decontaminated. The chosen sample lots or areas are shown in Table 1 with the corresponding type of survey performed. (The Fenced-In Yard has been surveyed and reported [Ref. 12]. The Side Yard, to the east, has also been surveyed and reported [Ref. 13]).

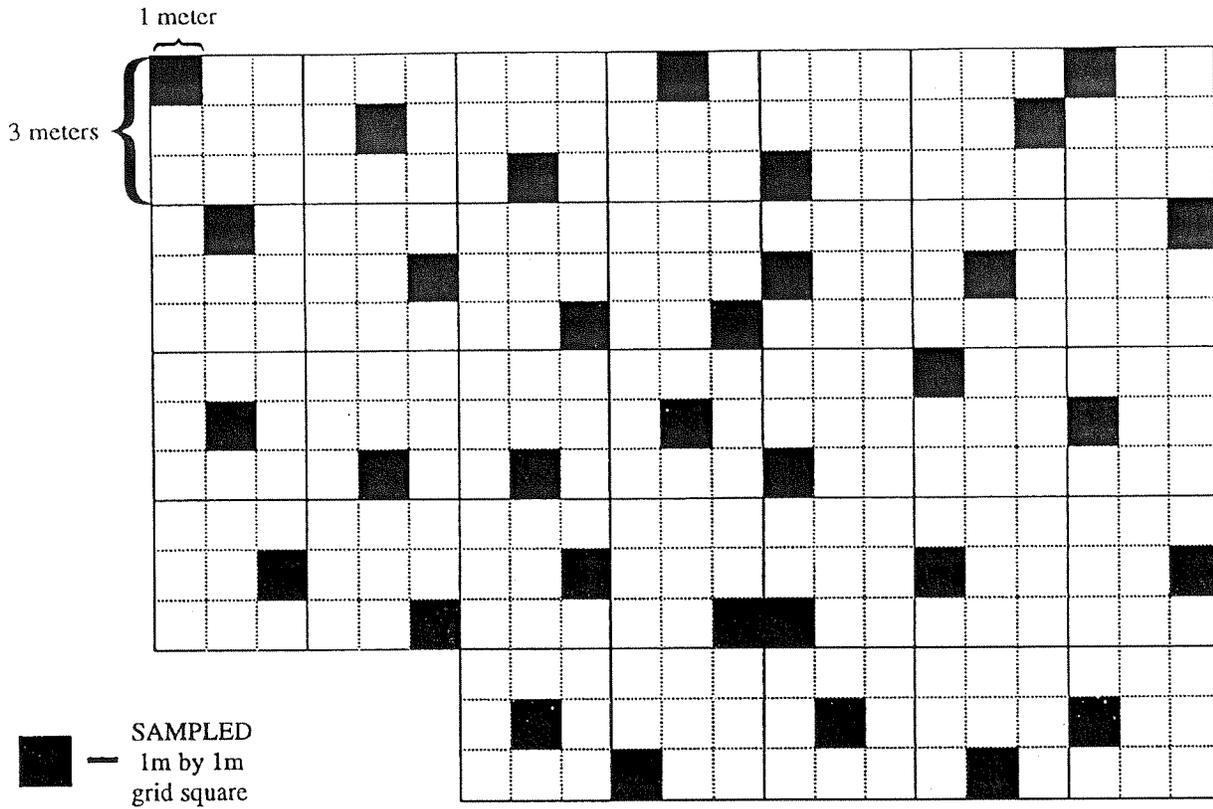
Figure 7: Typical Room or Area 3-Meter by 3-Meter Grid Markings

The method and type of survey measurements depended on the type of surfaces involved. For each sample lot, a 3-meter by 3-meter grid was superimposed on the floors, walls, ceilings, or ground of the entire sample lot area. A 100% direct frisk of each 3-m by 3-m grid was then performed using a G-M pancake probe. A 1-meter by 1-meter area was then selected from each 3-m by 3-m area based on previous D&D knowledge, randomly, or indications of elevated readings from the 100% direct frisk.

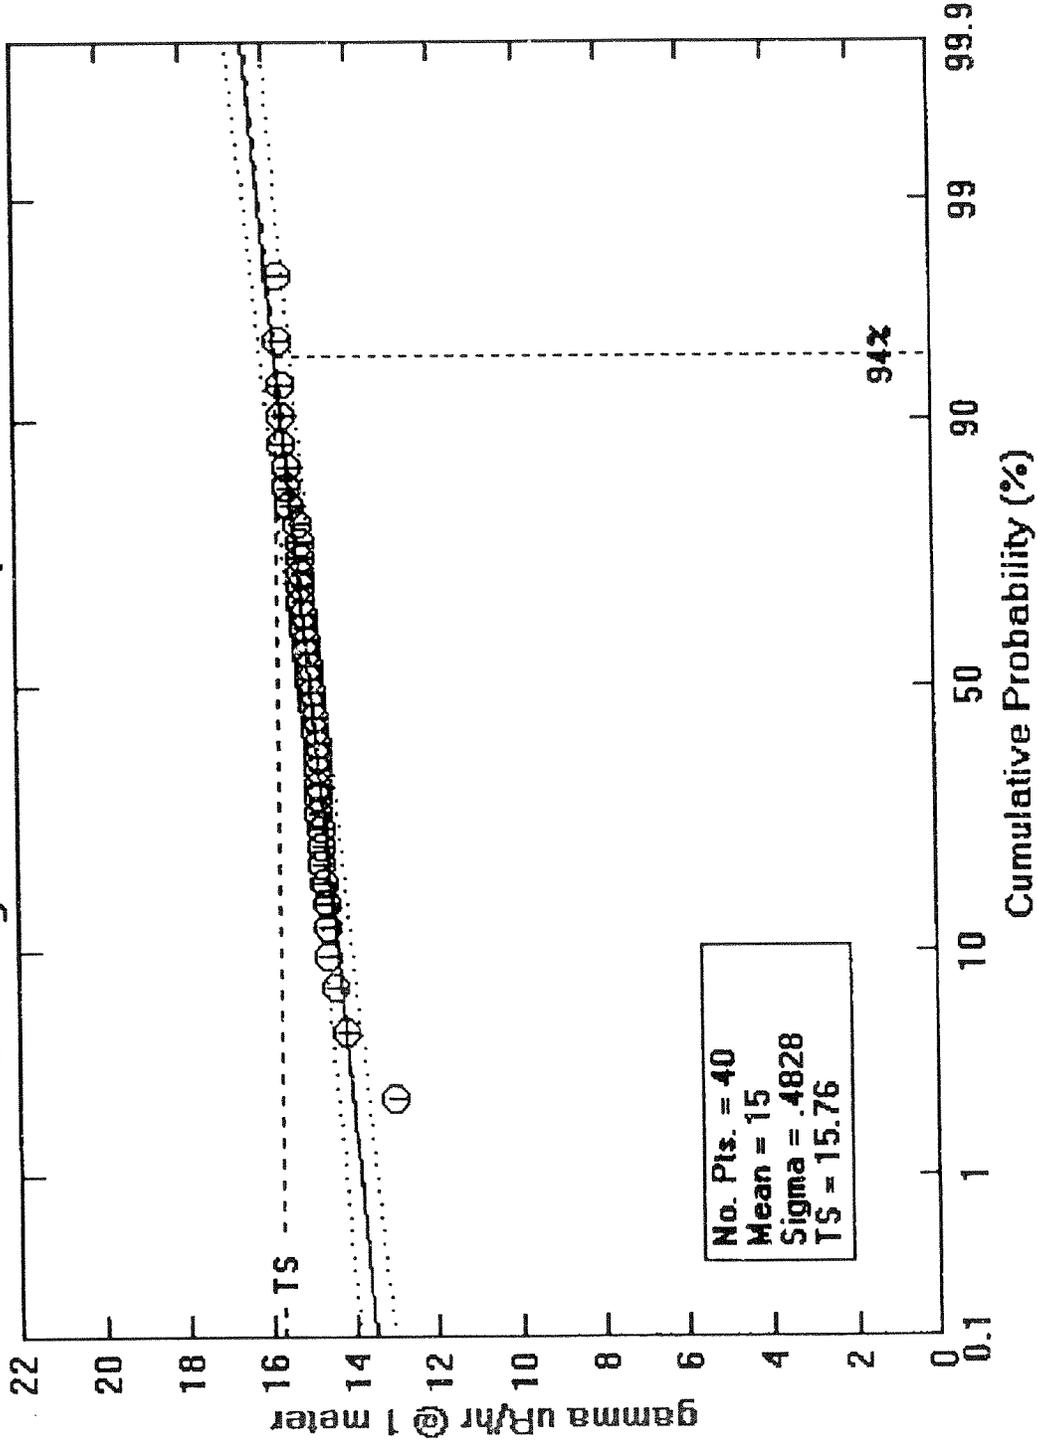
All tests for surface contamination showed that the facility is suitable for release without radiological restrictions. Interpretation of the gamma exposure rate measurements for the Building 064 interior is based on the average gamma exposure rate background value (15.76 $\mu\text{R/hr}$) for a building of similar construction (Building S445) that

has never been used for any radiological purposes. The probability distributions of the comparisons between these measurements shows no local contamination, except for two measurements that were affected by the near proximity of smoke alarm units containing approximately 80 μCi Am-241. The results indicate a natural/normal background distribution for the building, with an average value of 14.7 $\mu\text{R/hr}$. Therefore, the Building 064 interior average gamma exposure rate is consistent with the average gamma exposure rate for Building S445.

Figure 8: Gamma exposure rate measured in Bldg. 445. Concrete building (Bldg. 445) has construction similar to that of T064 and no radiological history. Confidence bounds (95%) on least-squares fit of data are close to the derived Gaussian line. One value is anomalously low due to measurement near doorway. See Appendix B for data measurements.

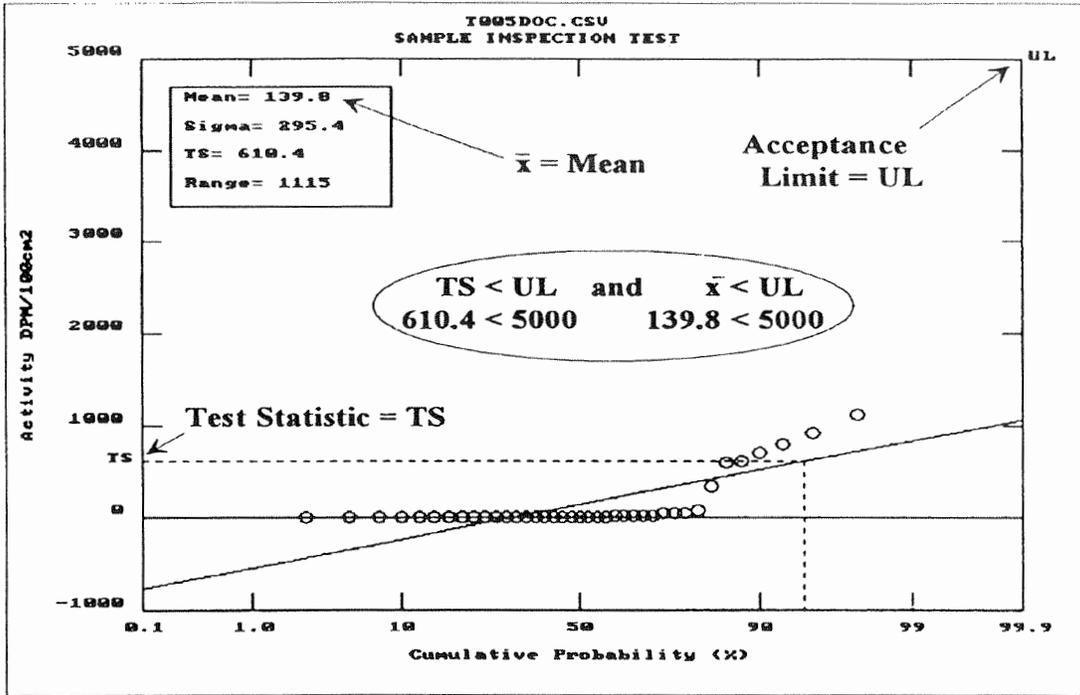
Figure 9. Example of Sample Lot Acceptance, where $TS(=\bar{x}+ks) \leq UL$ and $\bar{x} \leq UL$

- a) Acceptance: If the test statistic ($\bar{x} + ks$) is less than or equal to the limit (UL), accept the region as clean. (If any single measured value exceeds 80% of the limit, decontaminate that location to as near background as is possible, but do not change the value in the analysis.) See Figure 9 for an example of the sample lot acceptance by the test.

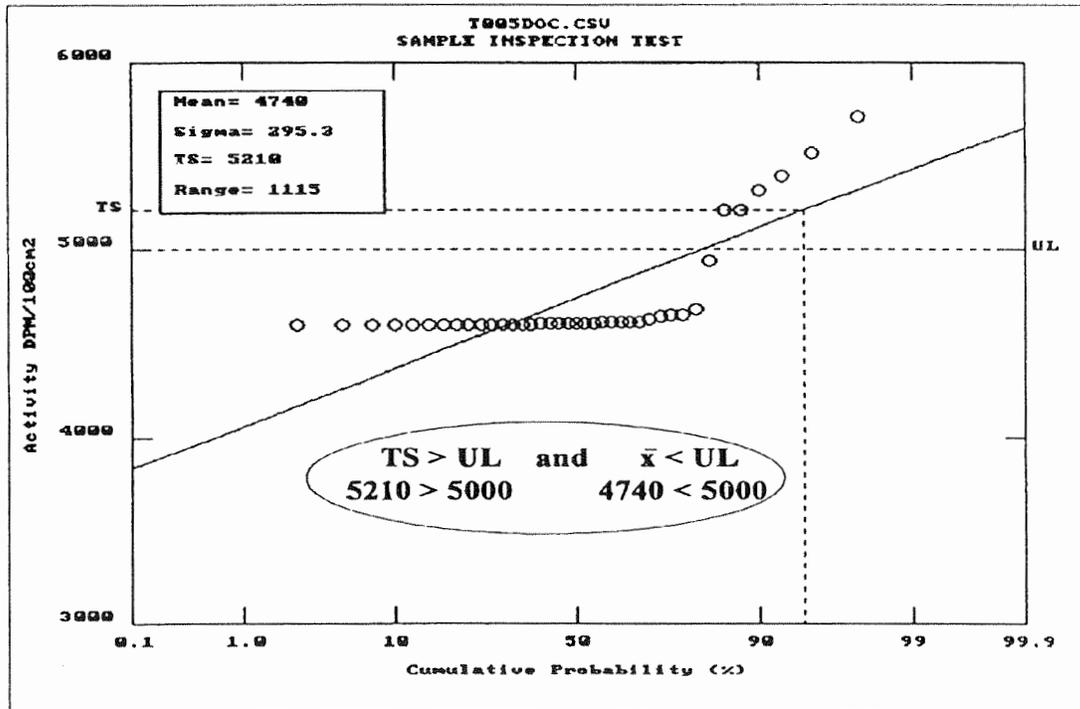
Figure 10. Example of Sample Lot Requiring Additional Measurements, where $TS(=\bar{x}+ks) > UL$ and $\bar{x} < UL$

- b) Collect additional measurements: If the test statistic ($\bar{x} + ks$) is greater than the limit (UL), but \bar{x} itself is less than UL, independently resample and combine all measured values to determine if $\bar{x} + ks \leq UL$ for the combined set; if so, accept the region as clean. If not, the region is contaminated and must be remediated. See Figure 10 for an example of additional measurements that must be taken in the sample lot to accept or reject it.
- c) Rejection: If the test statistic ($\bar{x} + ks$) is greater than the limit (UL) and $\bar{x} > UL$, the region is contaminated and must be remediated. See Figure 11 for an example of sample lot rejection by the test.

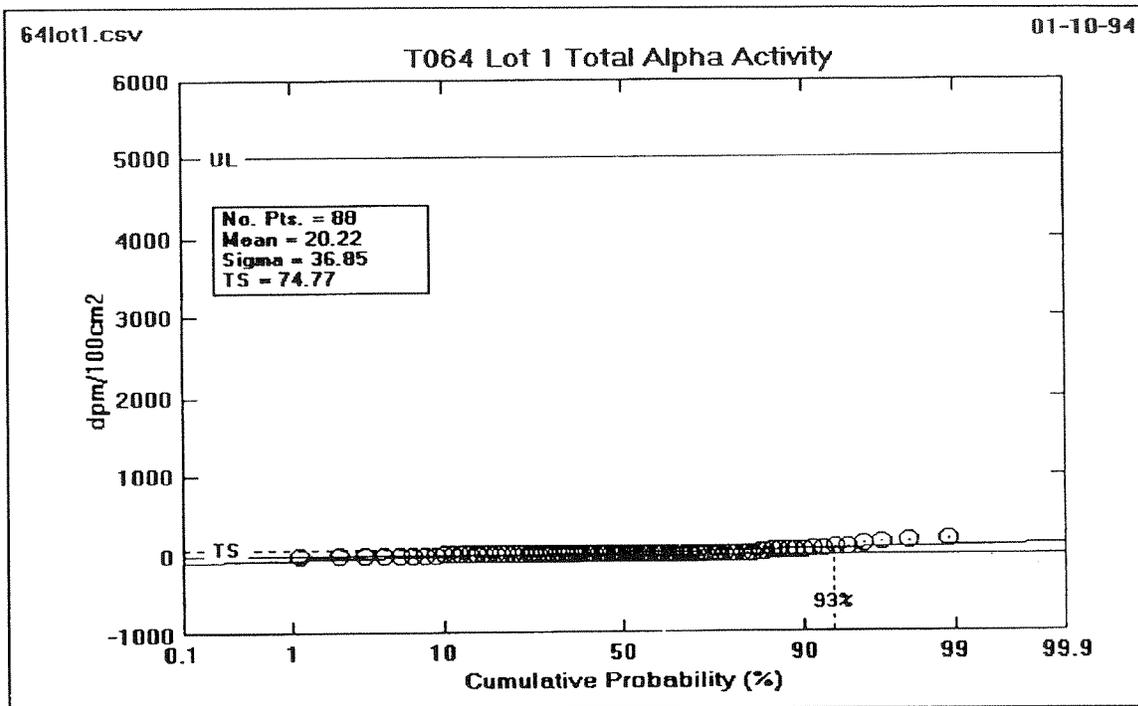
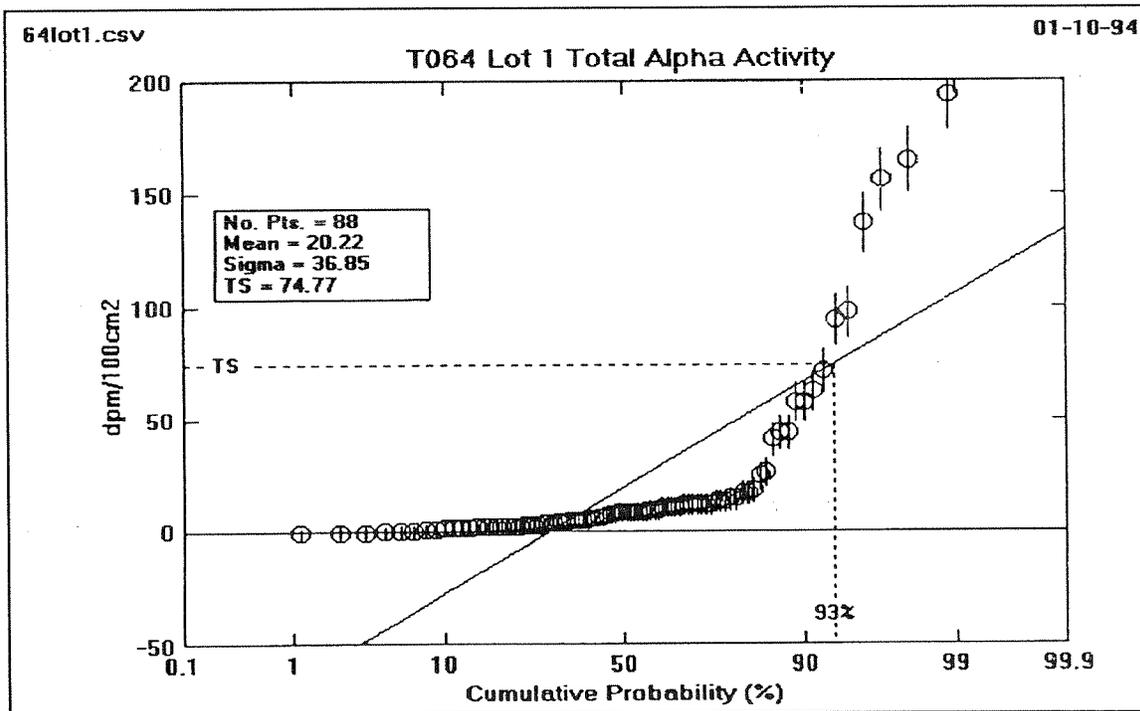
Figure 12: T064 - LOT 1 Total Alpha Activity

Figures 12 through 16 and Table 4 demonstrate that for each applicable acceptance limit (UL) from Table 2, the corresponding test statistic (TS) value is less than the UL or $TS < UL$. Therefore, the nine figures for Sample Lot 1 pass the "sampling inspection by variables" test and are "Accepted" as radiologically clean. Or in other words, the Building 064 Sample Lot 1 survey corresponds to assuring with a 90% confidence that 90% of Sample Lot 1 has residual contamination below 100% (a 90/90/100 test) of the applicable NRC, DOE, and State of California limits described in Table 2.

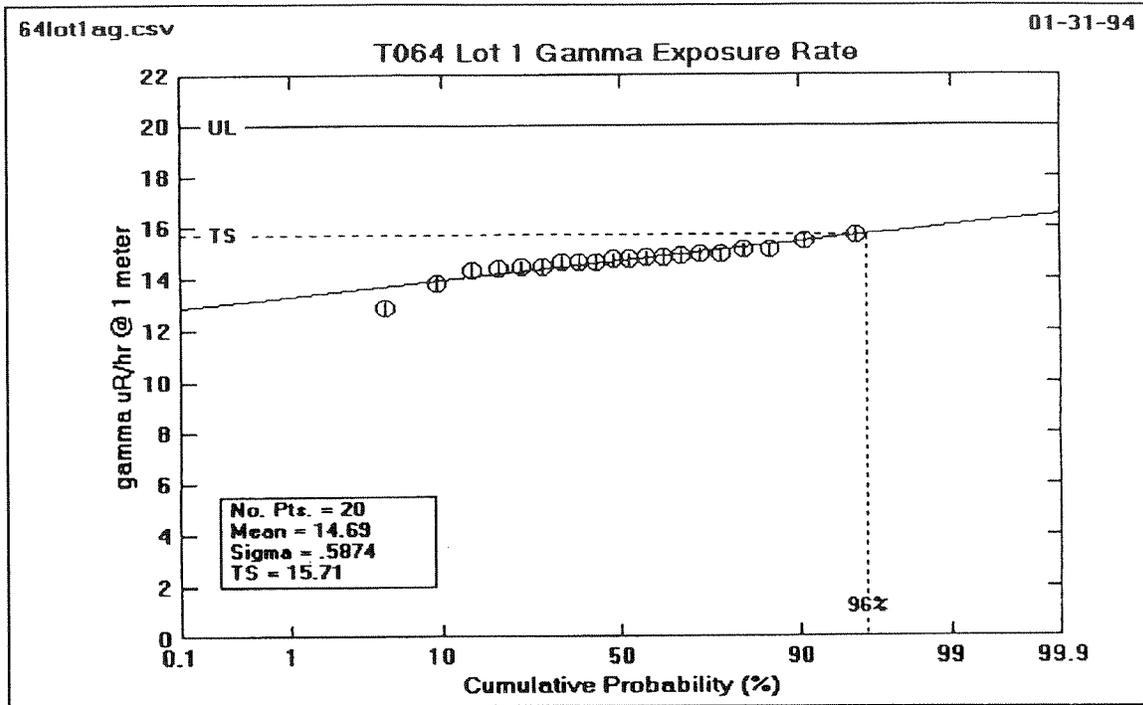
Figure 16: T064 - LOT 1 Floors Ambient Gamma Exposure Rate

Initial review of the gamma exposure rate data, by use of the cumulative probability plot, showed an apparent discrepant value of 17.54 $\mu R/hr$ at floor grid location 5,12. On investigation, it was found that a wall-mounted smoke alarm unit was approximately 1 meter away from the gamma detector during the measurement.

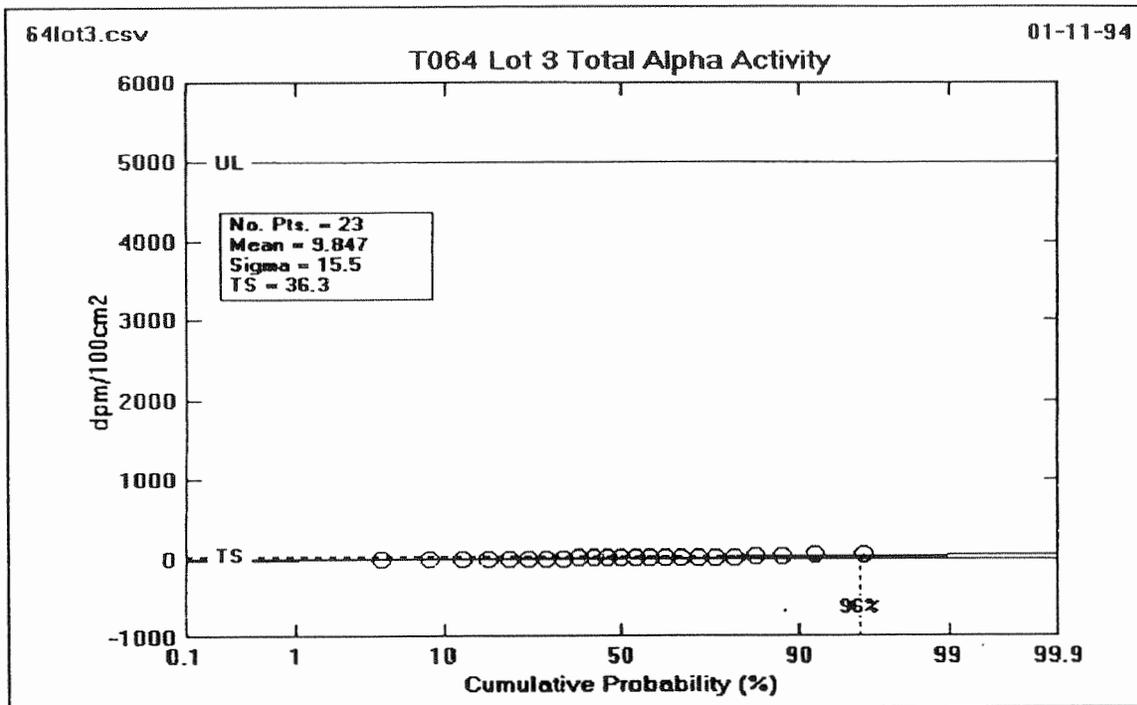
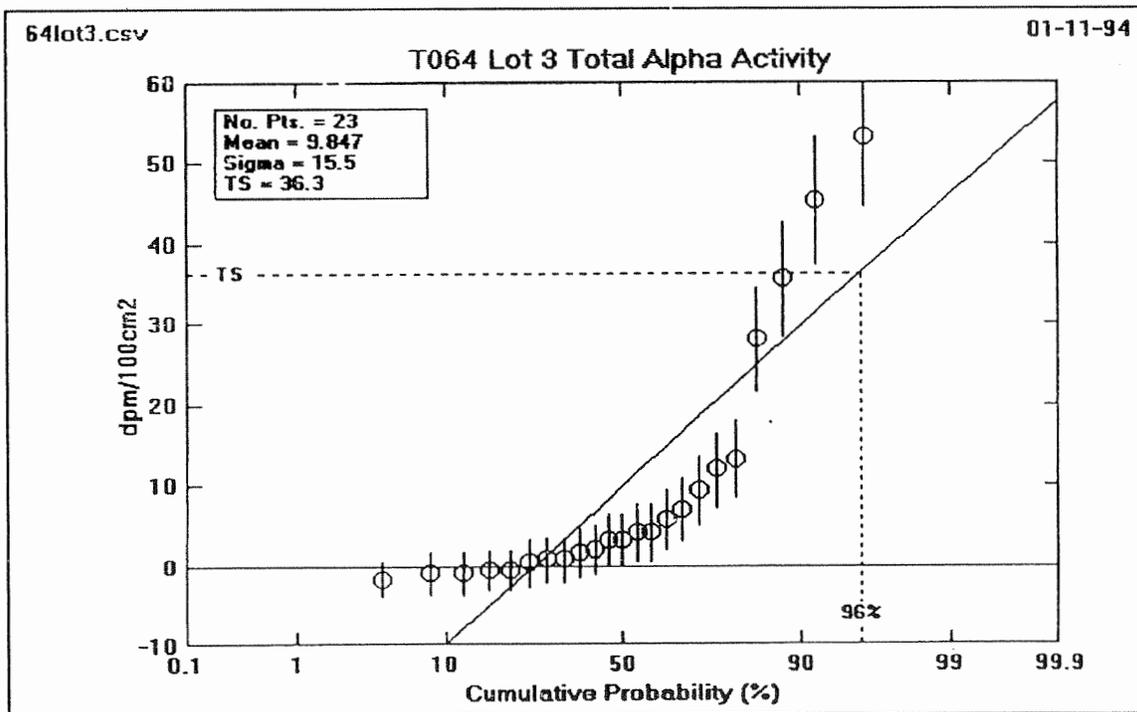
Figure 22: T064 - LOT 3 Total Alpha Activity

Figures 22 through 26 and Table 6 demonstrate that for each applicable acceptance limit (UL) from Table 2, the corresponding test statistic (TS) value is less than the UL or $TS < UL$. Therefore, the nine figures for Sample Lot 3 pass the "sampling inspection by variables" test and are "Accepted" as radiologically clean. Or in other words, the Building 064 Sample Lot 3 survey corresponds to assuring with a 90% confidence that 90% of Sample Lot 3 has residual contamination below 100% (a 90/90/100 test) of the applicable NRC, DOE, and State of California limits described in Table 2.

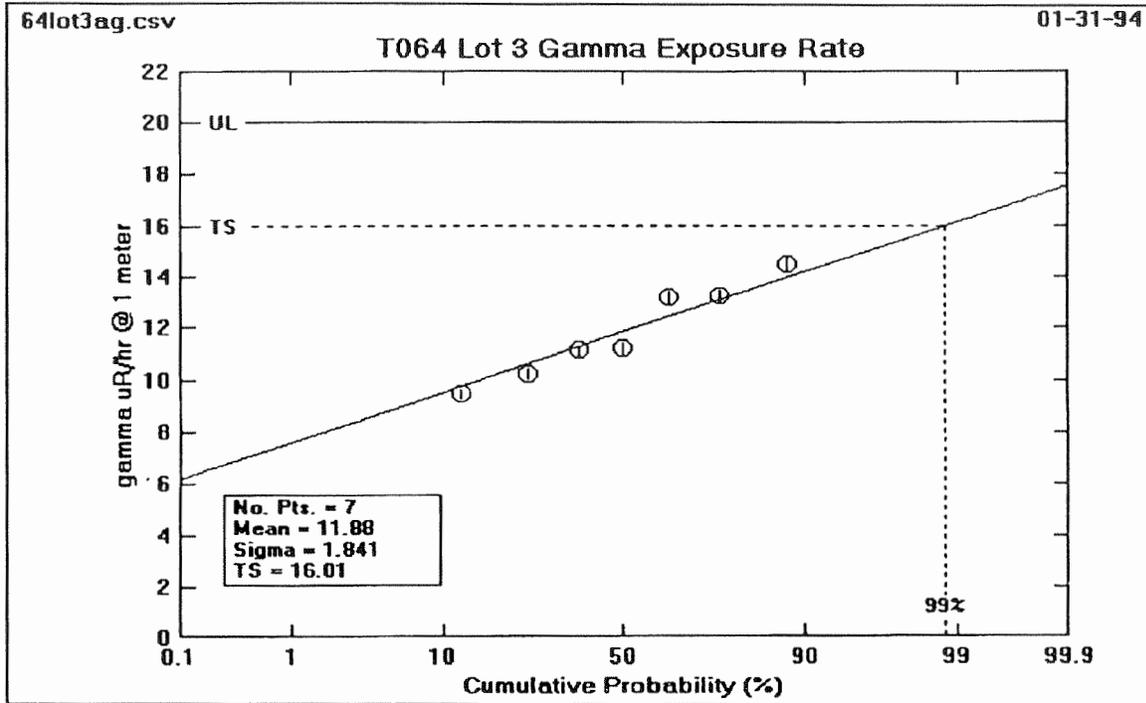
Figure 26: T064 - LOT 3 Floors Ambient Gamma Exposure Rate

This lot also showed an outlier in the gamma exposure rate data. As in Lot 1, this elevated value was due to the close proximity of a smoke alarm unit. The measured value, $17.32 \mu R/hr$, was reduced by $2.79 \mu R/hr$ to $14.53 \mu R/hr$ for statistical interpretation. The original measured value has been left in the tabulational results.
