ENERGY TECHNOLOGY ENGINEERING CENTER

No. 029-AR-0001 Rev. ____
Page 1 of 34
Orig. Date 3/28/96
Rev. Date ____

TITLE: FINAL D&D REPORT FOR BLDG. T029

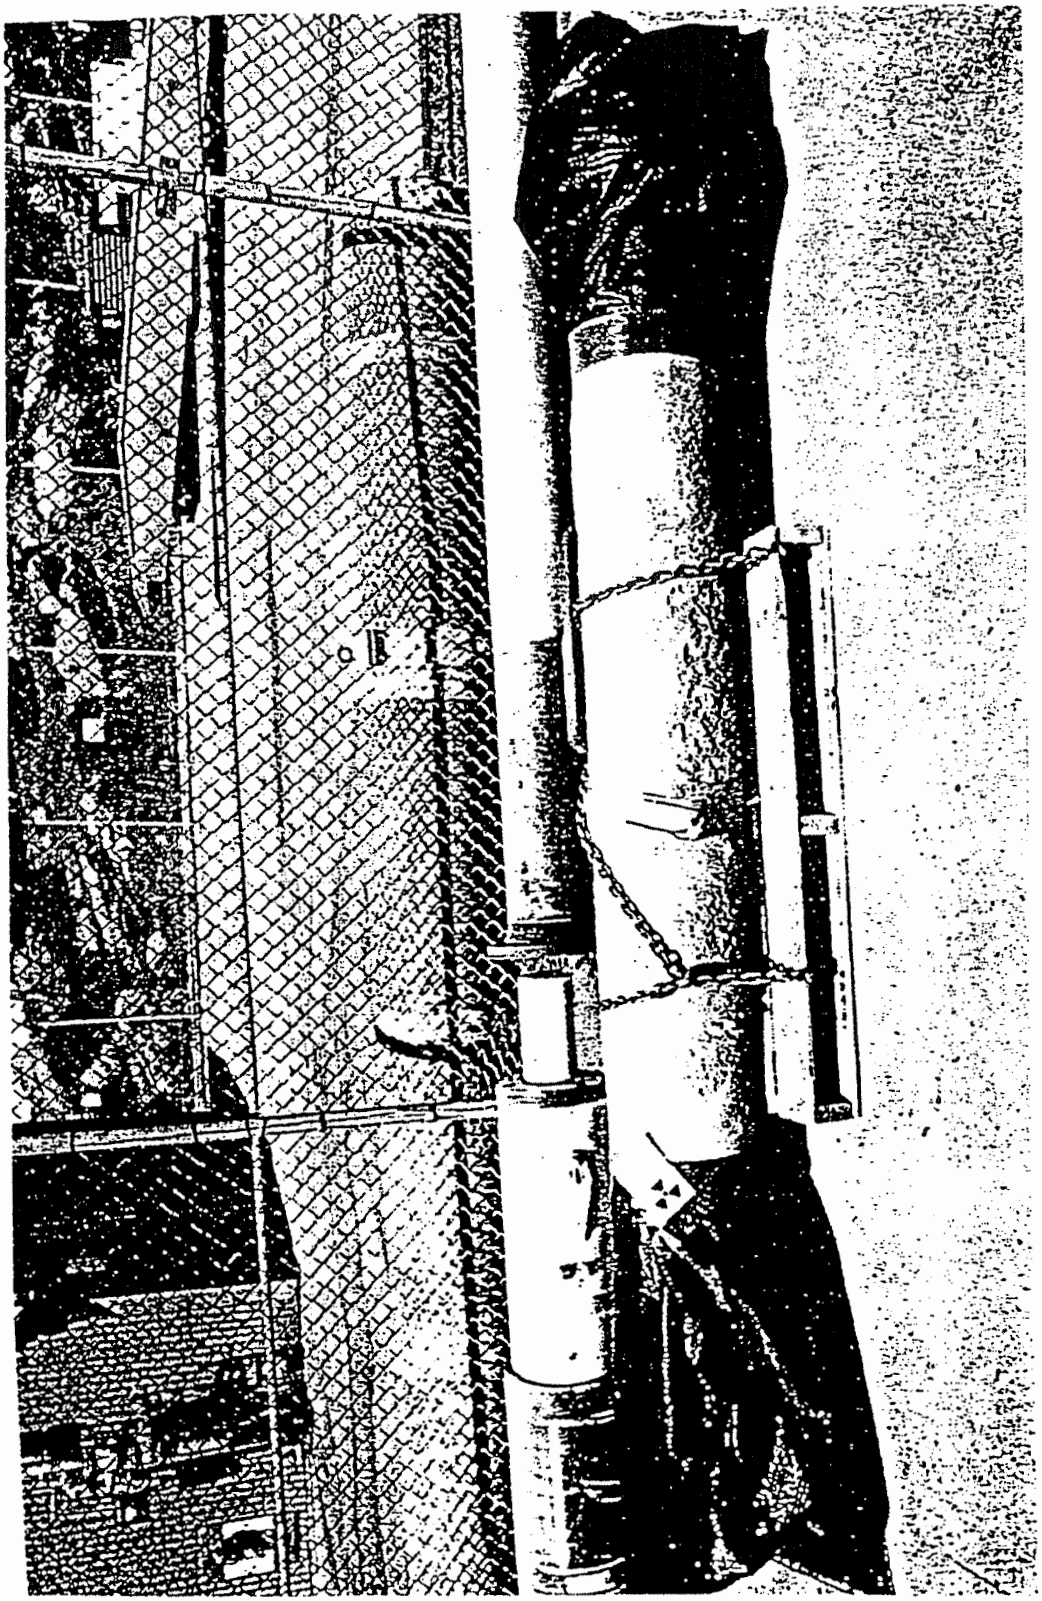
Figure 4–2. Photograph of Ra–226 Source Storage Well Upon Transfer to RMDF from T029 (front–most from fence)

Routine smear surveys were performed on the surfaces of the thimbles. Swabs were taken from within the interiors of the thimble tubes after the casing was excavated. Results of the smear survey showed normal background activity, while the swabs showed, as expected, alpha–contaminated interiors. Therefore, it was determined that the source storage well must be disposed of as low–level radioactive waste. Accordingly, to facilitate its packaging, the casing was cut longitudinally into two pieces and the concrete embedment was separated from the casing and the three inner tubes. Figure 4–6 shows a photograph of the disassembled casing. All of the components shown were then packaged for disposal as low–level radioactive waste at an authorized site.

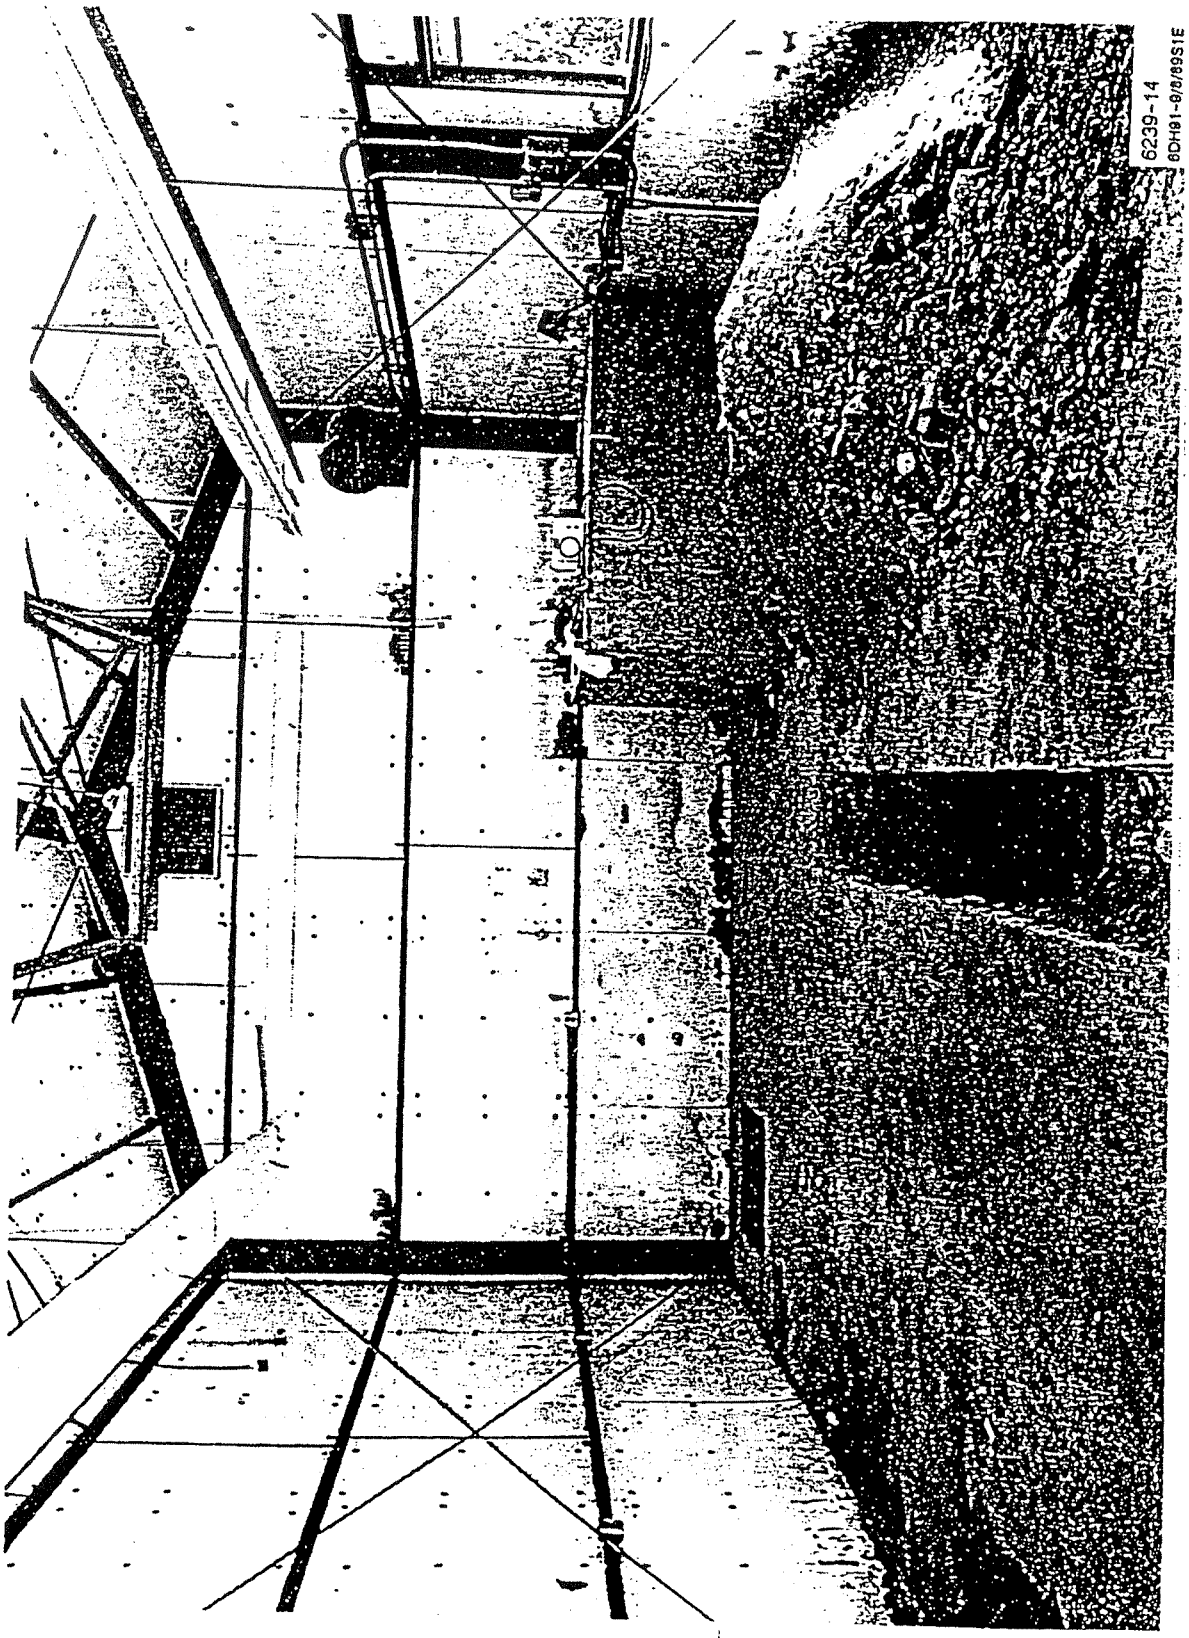
Figure 4–3. Photograph of Excavated Area of Ra–226 Source Storage Well in T029; Square Pit on Far Left at Floor Level is Former Location of PuBe, PoBe Sources. Former Co–60 Source Cell Block is to the Far Right

Following temporary removal of the material stored inside the building, a rectangular area of the floor surrounding the Ra–226 source storage well was excavated (see Figure 4–1) using concrete saws and jack–hammers. A back–hoe was used to dredge the soil from the cut–up area. A vacuum cleaner was then used to remove soil in the immediate vicinity of the 12–in.–diameter casing. Removal of the soil in this manner loosened the casing from the soil, with its inner contents of contaminated source thimble tubes (shown previously in Figure 1–9) still intact. A sling was attached to the casing and a fork–lift was used to move it to the floor where it was covered with plastic bags, tagged as radioactive material and transported to the Radioactive Material Disposal Facility (RMDF) at the SSFL. Figure 4–2 shows a photograph of the casing upon its arrival at the RMDF. A photograph of the excavated area of the well after removing the casing is shown in Figure 4–3. The Co–60 source cell and the pit where the PuBe and PoBe sources were formerly located are seen to the right and left side of the excavation respectively.

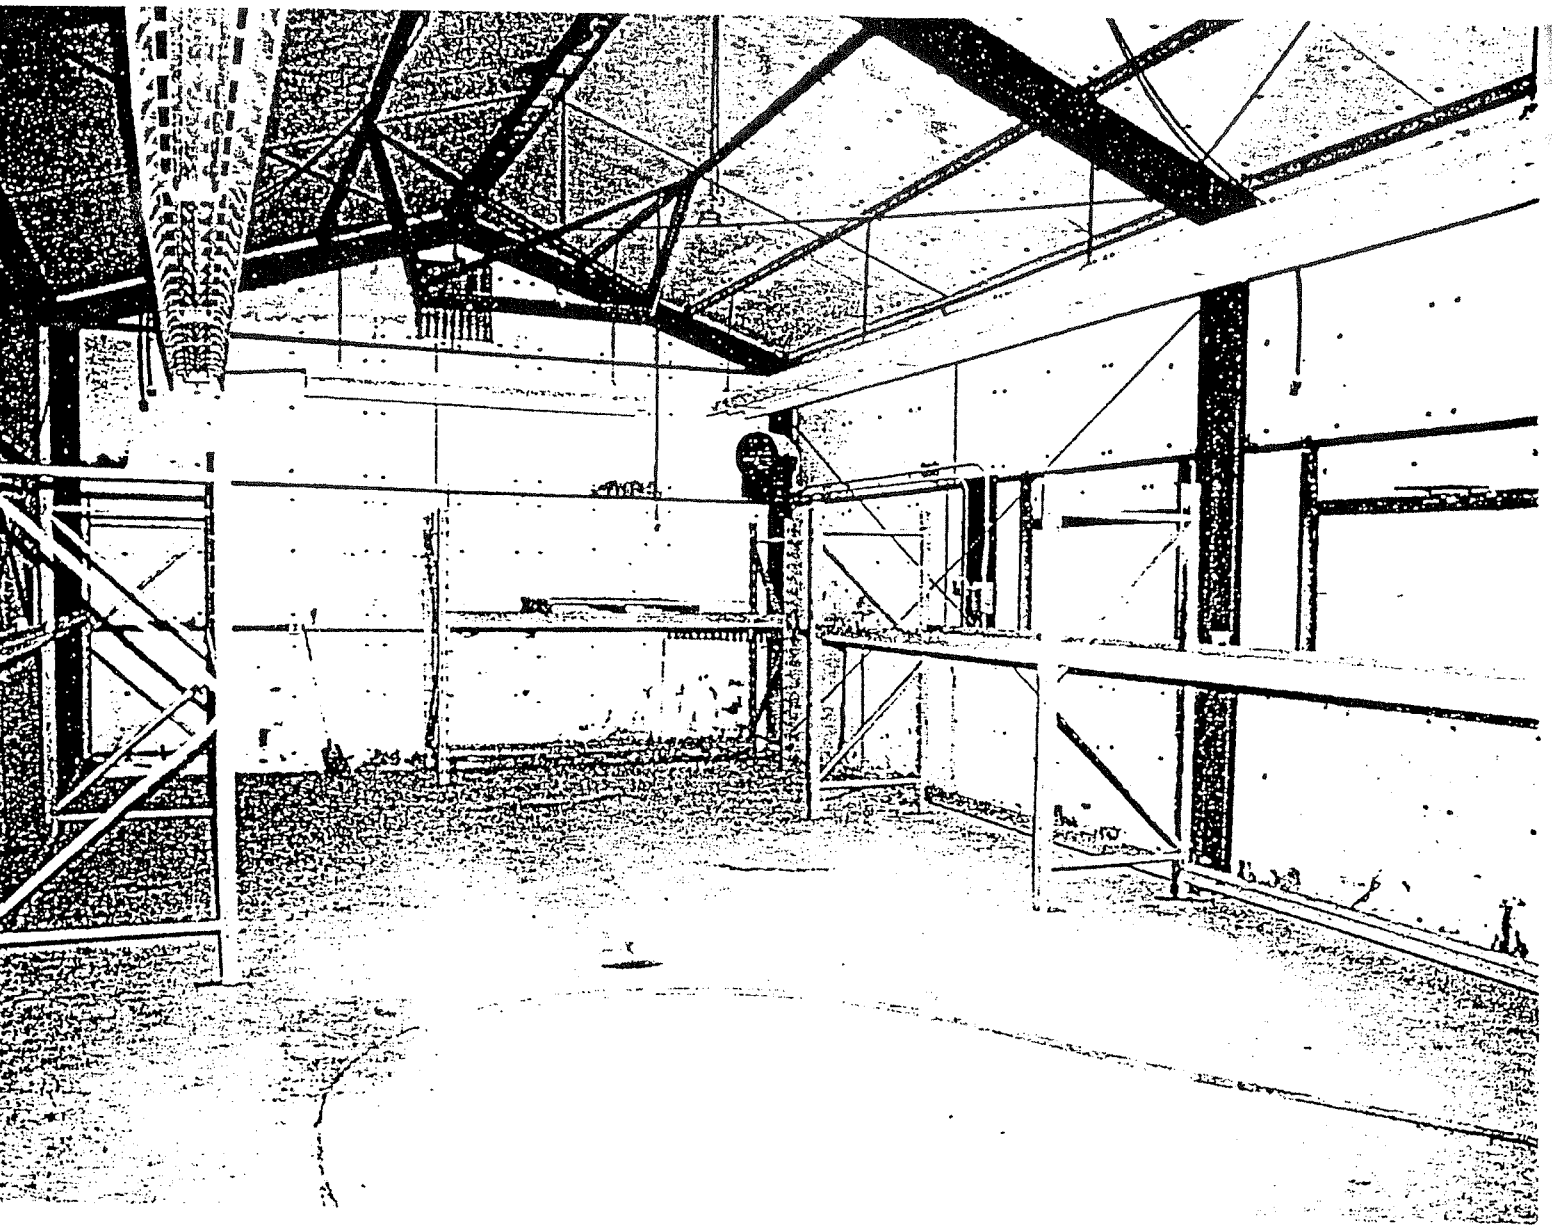
Figure 4–8. Interior of Building T029 Following Restoration

Upon removal of the source storage wells and other equipment, the excavated area was re-filled and re–surfaced. Figure 4–8 shows a photograph of the interior of the facility after completion of these restorations. Nonradioactive materials (principally metallic sodium in 55–gallon drums), which had been stored in the building and were temporarily stored outside during the removal operations, were returned to the reinstalled racks shown in the photograph. Building T029 continues as a nonradioactive hazardous materials storage facility.
