Addendum No. 4 to

Master Work Plan/Field Sampling and Analysis Plan, Co-Located Chemical Sampling at Area IV Santa Susana Field Laboratory, Ventura County, California

EPA Subarea 5D North Soil Sampling

May 2011

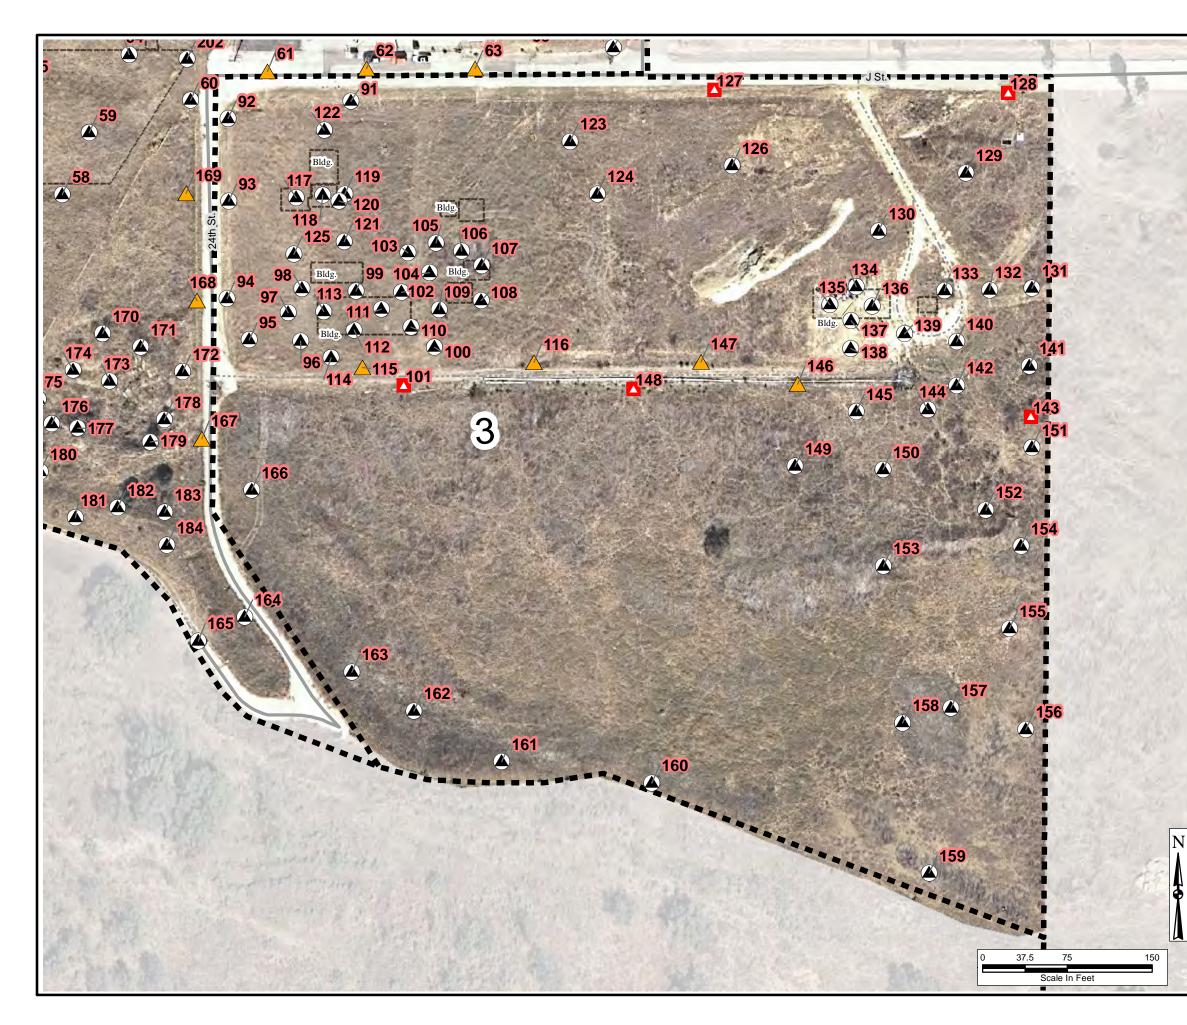
HGL—Subarea 5D North Addendum to FSP for Soil Sampling for Area IV Radiological Study, SSFL—Ventura County, CA Figure 4 Subarea 5D North Group 3 Sample Locations Santa Susana Field Laboratory TED STA U.S. EPA Region 9 PRO Legend Demolished Buildings Existing Buildings Subarea 5D North Groups Drainage and Subsurface Sample Subsurface Sample \wedge Surface and Subsurface Sample (Grayed Symbols Represent Soil Samples from Previous Subareas) Y:\Santa_Susana\EP9038\Soil_Sampling\SubArea5D\ (4)Group3ProposedSampleLocations_11x17_5DN.mxd 5/4/2011_sdrallos-kopecky Source:HGL 2010, CIRGIS 2007
