**FINAL
GEOPHYSICAL INVESTIGATION REPORT**

**AREA IV RADIOLOGICAL STUDY
SANTA SUSANA FIELD LABORATORY
VENTURA COUNTY, CALIFORNIA**

**U.S. EPA Contract Number: EP-S7-05-05
Task Order Number: 0038**

December 02, 2011

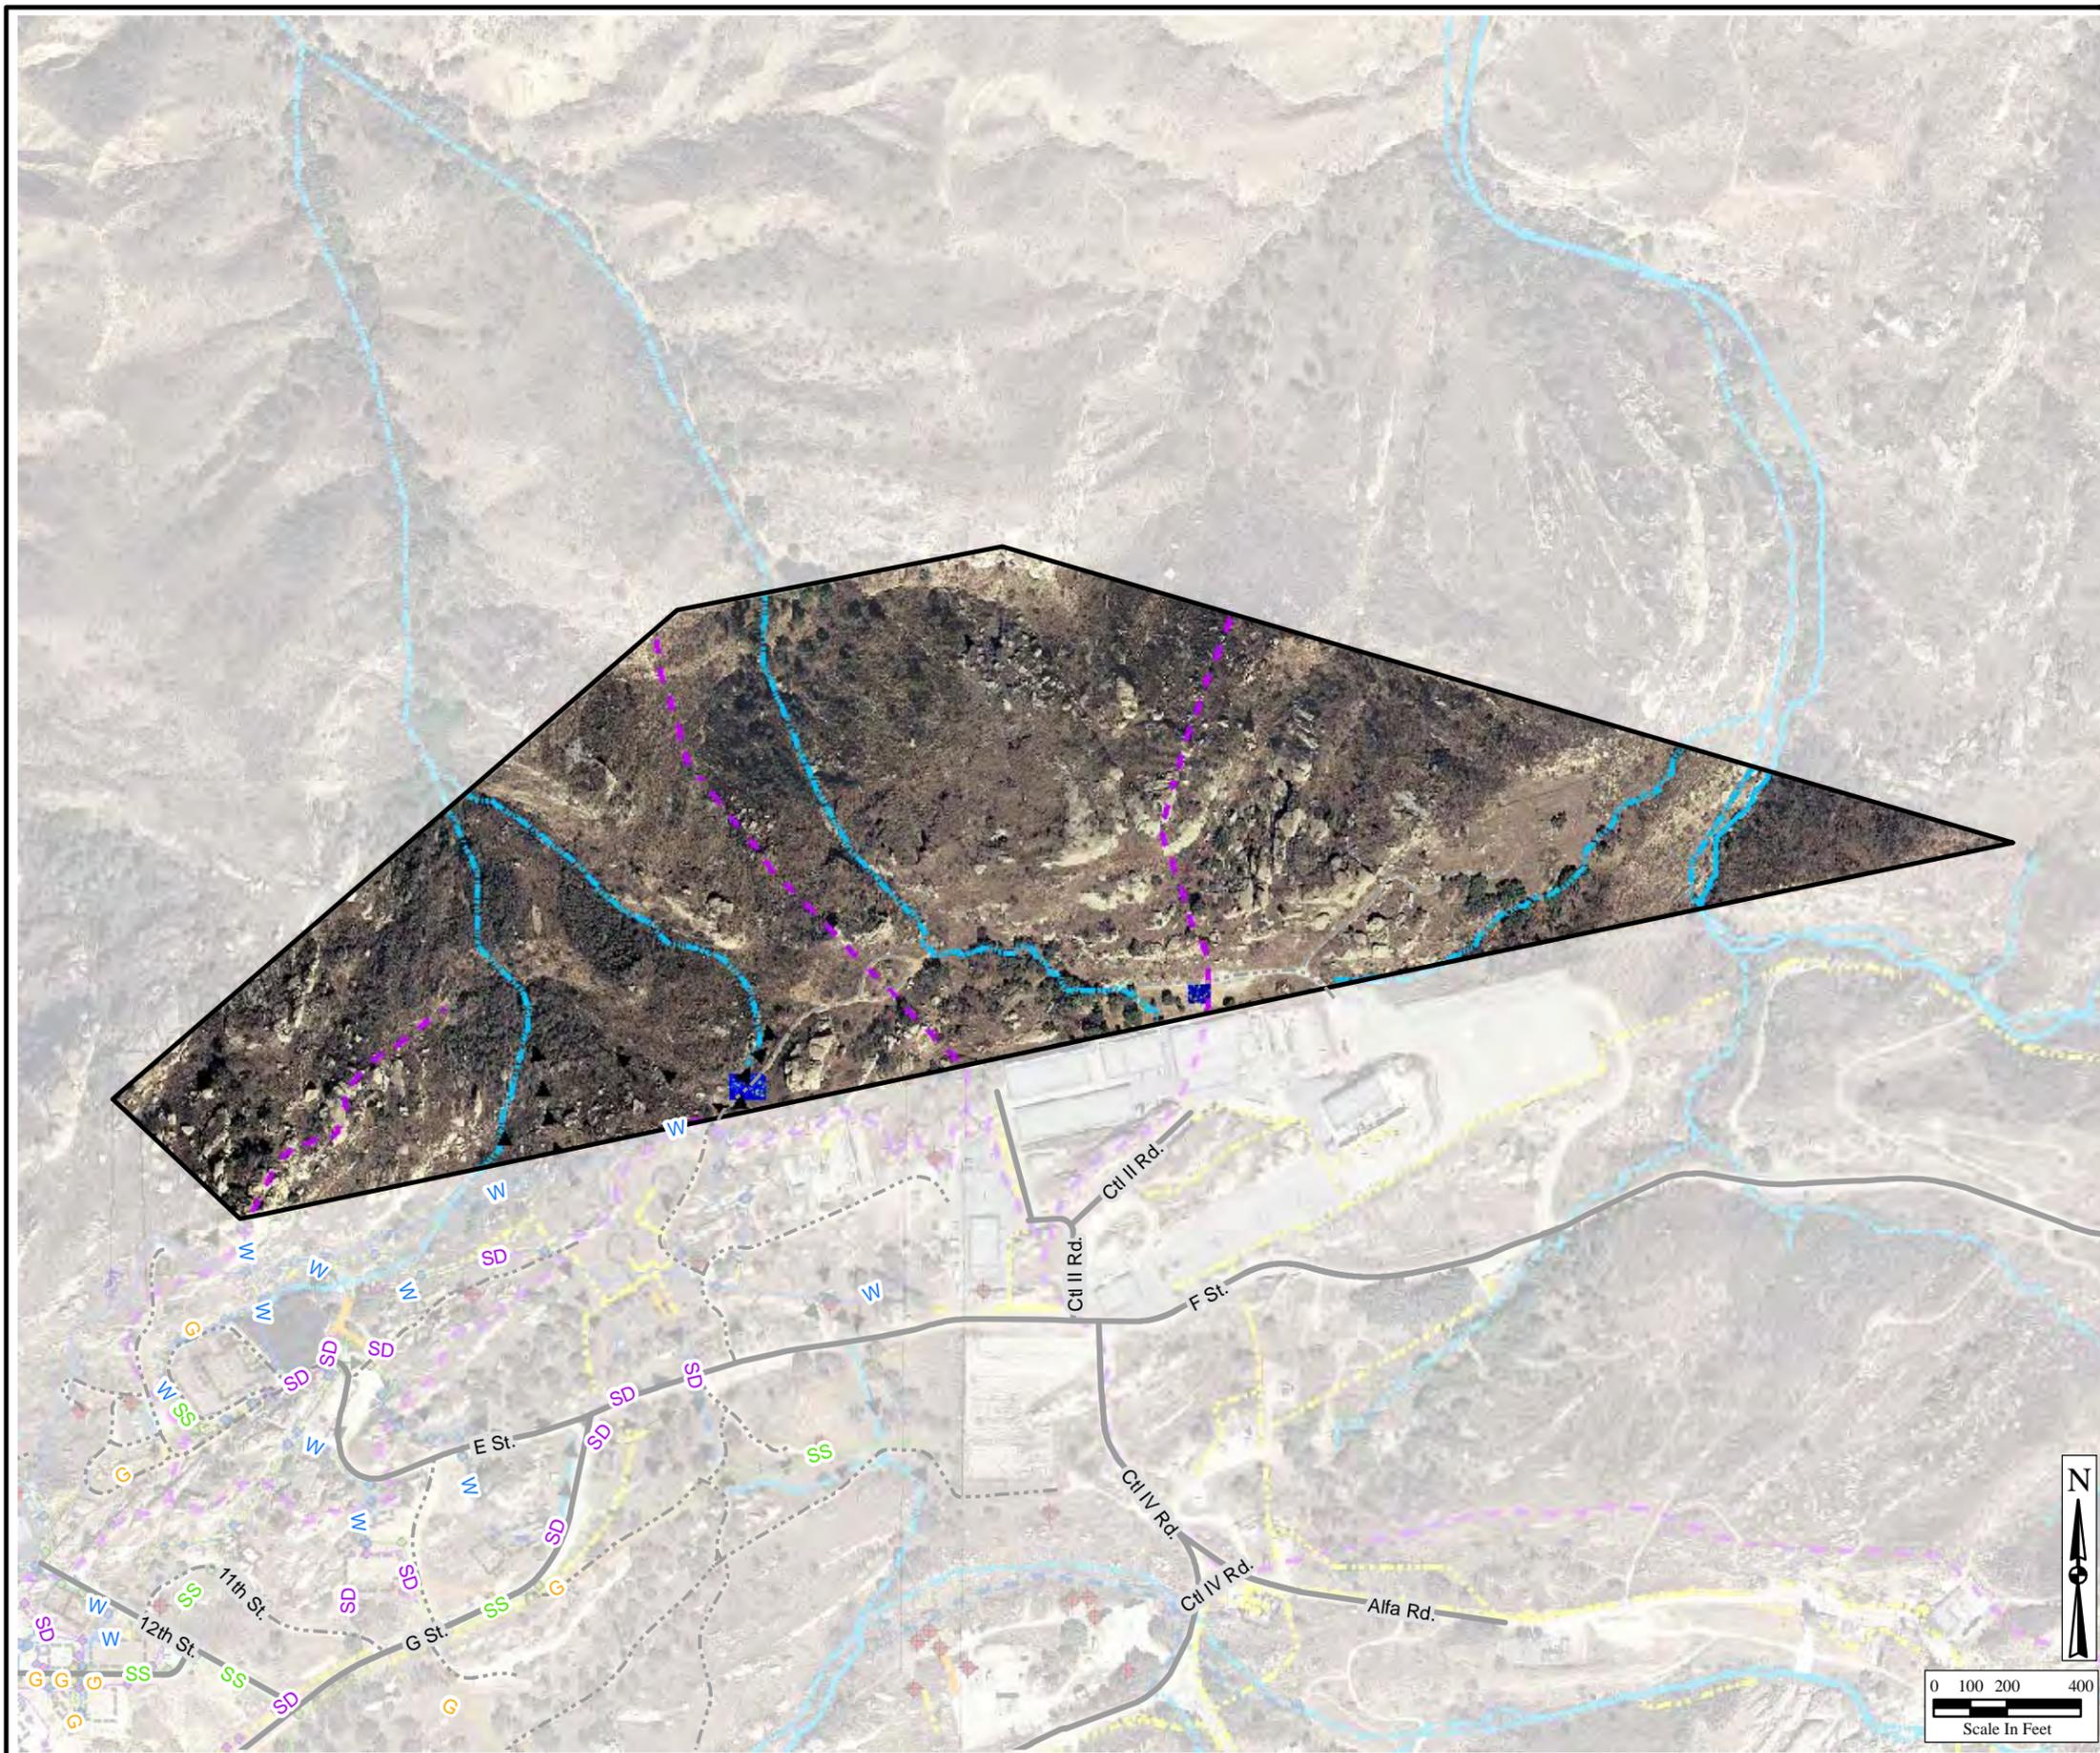
Figure 11d.2
Ground Penetrating Radar
Northern Buffer Zone-Northeast
Santa Susana Field Laboratory

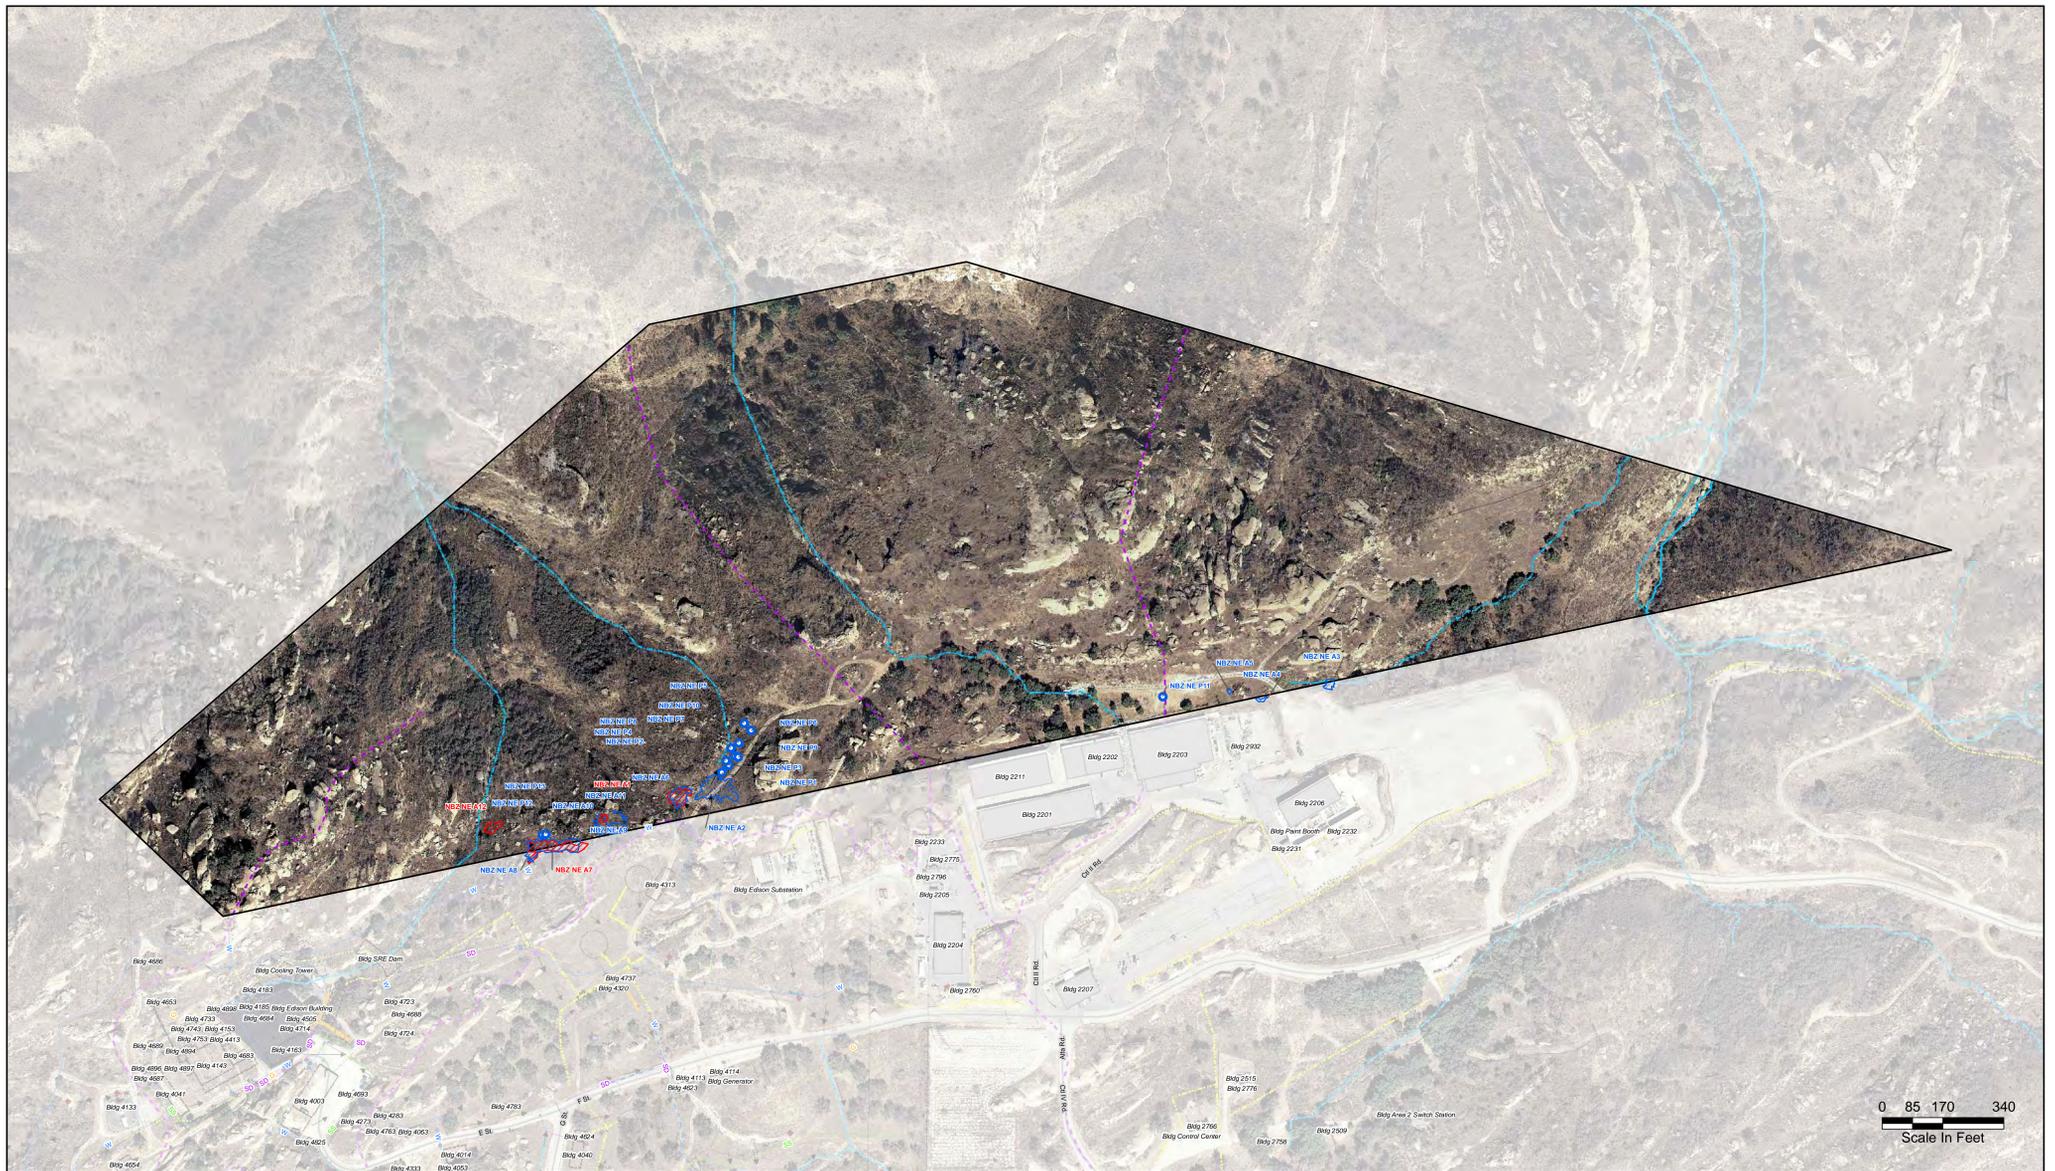
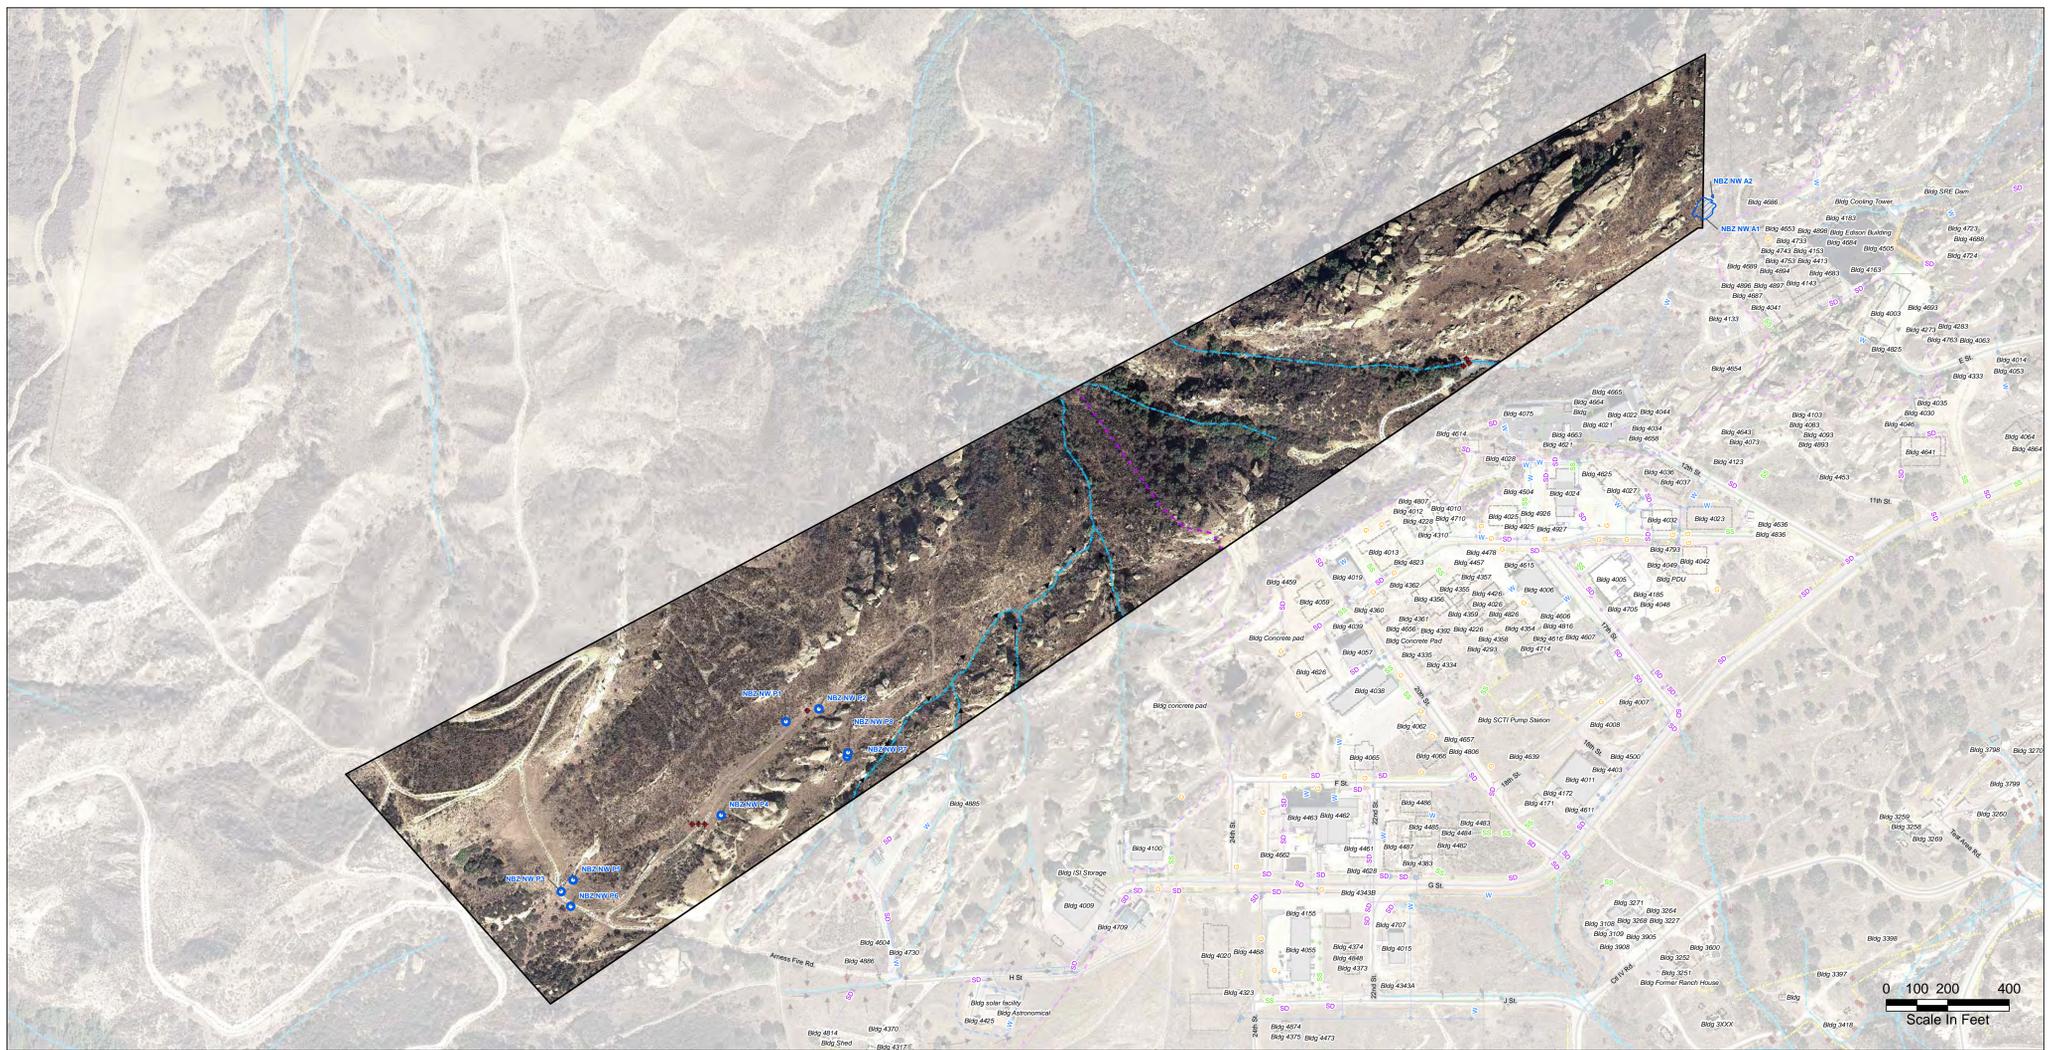
Legend				HGL—Geophysical Investigation Report, SSFL—Ventura County, California	
Centerline Roads Primary Roads Secondary Roads Tertiary Roads	Geophysical Anomalies Terrain Conductivity Magnetometer Ground Penetrating Radar Cut and Fill Boundaries Magnetometer Anomaly Linear Terrain Conductivity Anomaly Linear Ground Penetrating Radar Interpreted Drain Remnant Point Source Magnetometer Anomaly Point Source Terrain Conductivity Anomaly	Surface Water Intermittent Stream Permanent Stream Surface Water Lined Channel Surface Water Flow Surface Water Flow (From Boeing Database, 2008) Drains Wells	Surface Features Channel Drain Drainage Divide Gutter Tank Vault Well	Utilities Gas Storm Drain Sanitary Sewer Water Water (Removed) Water (Removed) Pipes (Unknown Type) Pipes (Unknown Type)	Figure 12j Northern Buffer Zone Anomalies Santa Susana Field Laboratory U.S. EPA Region 9

Area	Anomaly Identification	Instrument	Anomaly Description
NBZ Northwest	Area A: Wells Area		
	P1-P8	CVM	Scattered point source anomalies were identified indicating small ferrous materials.
	Area B: AD HOC Area		
	A1, A2	CVM	Interpreted to be disposal grounds for magnetite/concrete debris as evident by several magnetite/concrete nodules found on the surface. There may be buried metal associated with this disposal area as well*.
NBZ Northeast	Area C: Northern Storage PCB Areas 1 and 2		
	A1, A2, A6	EM, CVM	Identified substantial buried ferrous materials and debris fields.
	P1-P10	CVM	Scattered point source anomalies identified various buried ferrous materials.
	A7-A11 P12, P13	EM, CVM	Anomalies near the debris fields indicated surface and buried material, empty 55-gallon drums were observed.
	A12	EM	Area of high terrain conductivity was interpreted to be a drainage pathway to the debris field.
	Area D: North of Building 203 Complex

A5 P11	CVM	Small anomalies and point source anomalies were observed in portions of the area.
	A3, A4	CVM	Anomalies identified light debris fields with small amounts of buried metal.
