SRE FUEL ELEMENT DAMAGE

AN INTERIM REPORT

THE ATOMICS INTERNATIONAL AD HOC COMMITTEE

(Nov 15, 1959)

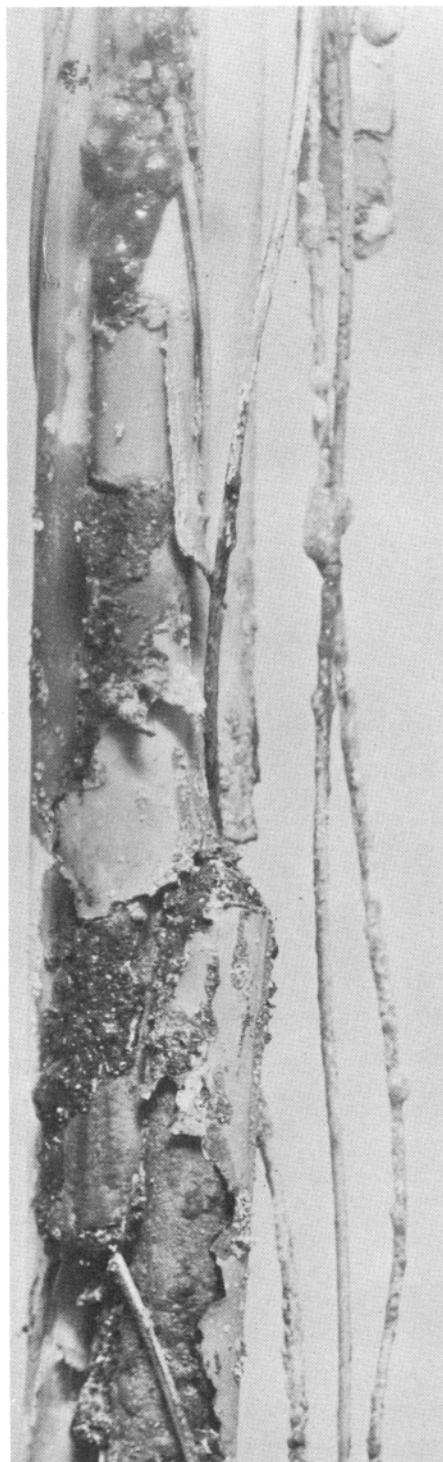
Figure IV-A-7. Midsection of Damaged Element in Channel 55

The time spent on detailed visual examination in the hot cell has been small. All of the damaged elements appear quite similar; therefore, a fairly careful visual examination was made only on the first element. These positions of fracture are determined to be between 1/3 and 2/3 of the length, measured from the top of the element. It is not planned to examine each damaged element unless the visual inspections indicate more than one type or mechanism of damage. A typical damaged element is shown in Figures IV-A-6, IV-A-7, and IV-A-8. The composition of the fuel in that element is shown in Figure IV-A-9. At least one damaged element will be transported to the Component Development Hot Cell (CDHC) for more detailed study.

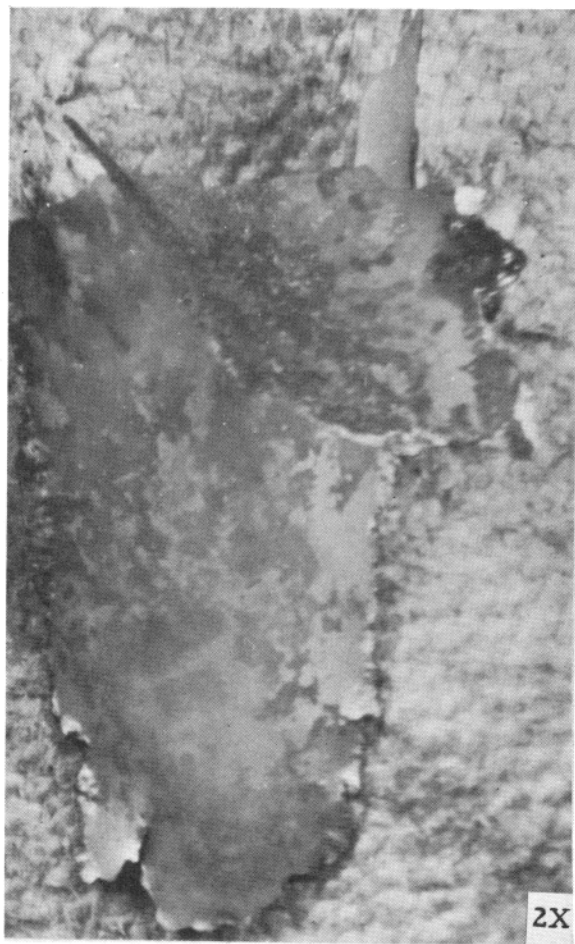
Figure IV-A-10. Small Piece of Cladding I from Element in Channel 55

Pieces of clad, wire wrap, and fuel slugs have been examined in greater detail at the CDHC using microscopy, magnifying glasses, and stereo-photos. Small sections of clad were available from damaged elements from channels 55 and 12. These pieces fell off during fuel-element-removal operations. Photographs of the cladding from the element in channel 55 are shown in Figures IV-A-10 and IV-A-11. Typical sections of the damaged clad were observed. The inside of the clad contained a thick, rough, adherent layer of material. Chemical analysis indicated 71 wt % U and 5 wt % Fe. This section of clad had a very jagged edge and contained some holes.

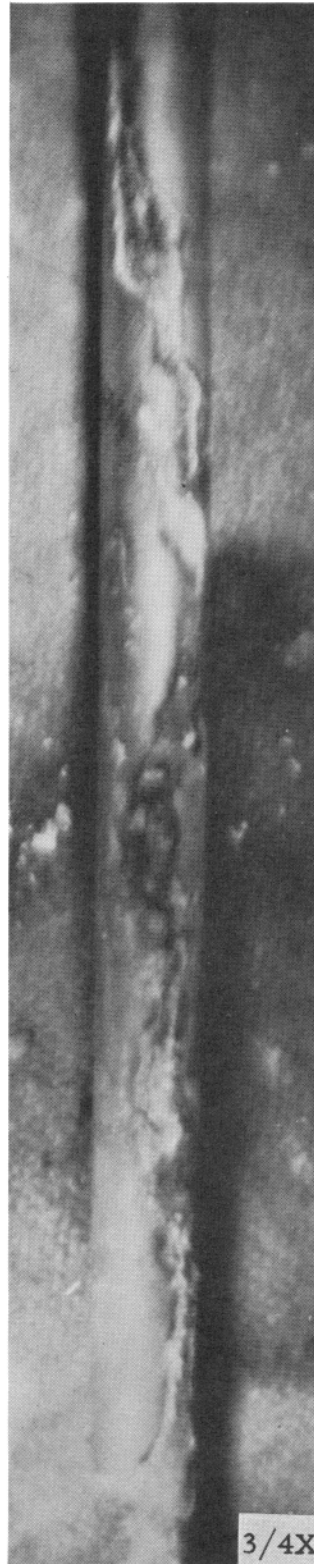
Figure IV-A-14. Streaming Reaction I on Cladding
from Element in Channel 12
