Site Summary Group CC  
AREA IV  
Santa Susana Field Laboratory, CA

## Site Summary – Building 4009

Building 4009  
Organic Moderated Reactor (OMR)  
Sodium Graphite Reactor (SGR)  
Includes Buildings 4709, Substation

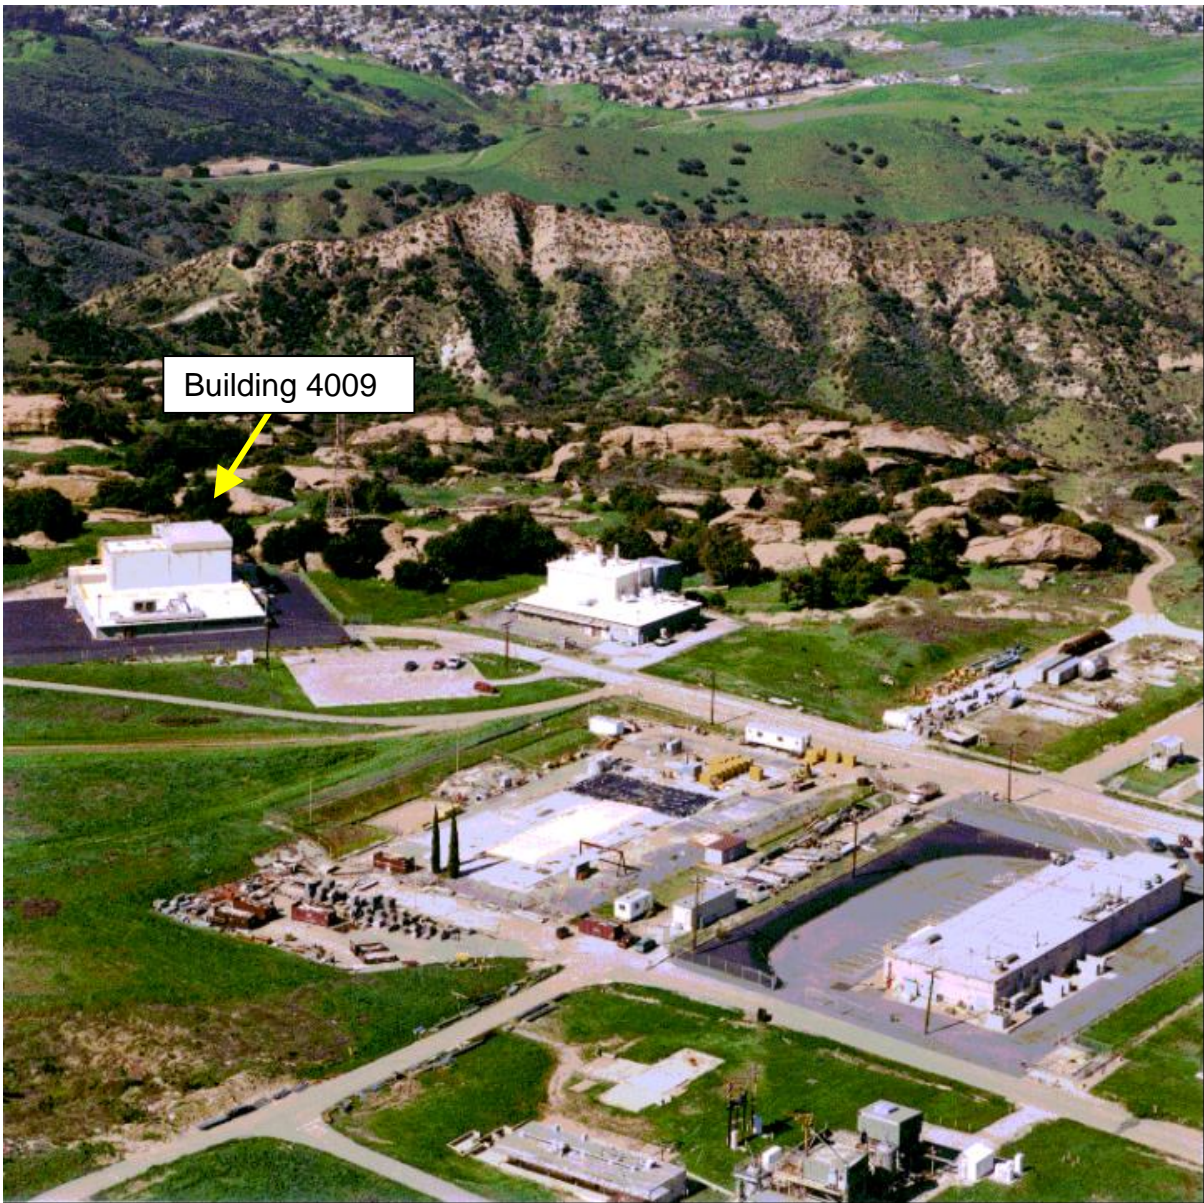
Photograph – Building 4009

- Building 4009 housed two different reactors. The SGR side consisted of a concrete high bay building 70 feet long by 40 feet wide with a 37-foot high concrete roof and housed the critical assembly cell and a fuel-and-graphite storage area. A concrete block penthouse containing the critical assembly control rod drive mechanisms sat above the critical assembly cell and was serviced by a 5-ton crane that sat above the facility. A contaminated waste holdup tank was buried to the northeast of the SGR side. The adjoining low bay area was a steel frame structure covered with insulated sheet metal and a tar/gravel roof. The low bay supported both sides of the facility housing control rooms, offices and miscellaneous supporting laboratories. The OMR side consisted of a concrete shielded high bay containing the critical assembly area and fuel storage. It was approximately 35 x 63 feet with shield thickness ranging from 1 to 4 feet (depending on height and location) with a built up roof (no shielding). A 45-foot
